BLUE DROP

Watch Report

BLUE DROP WATCH REPORT 2023: TECHNICAL ASSESSMENT OF THE CONDITION OF MUNICIPAL DRINKING WATER TREATMENT AND DISTRIBUTION SYSTEMS IN SOUTH AFRICA

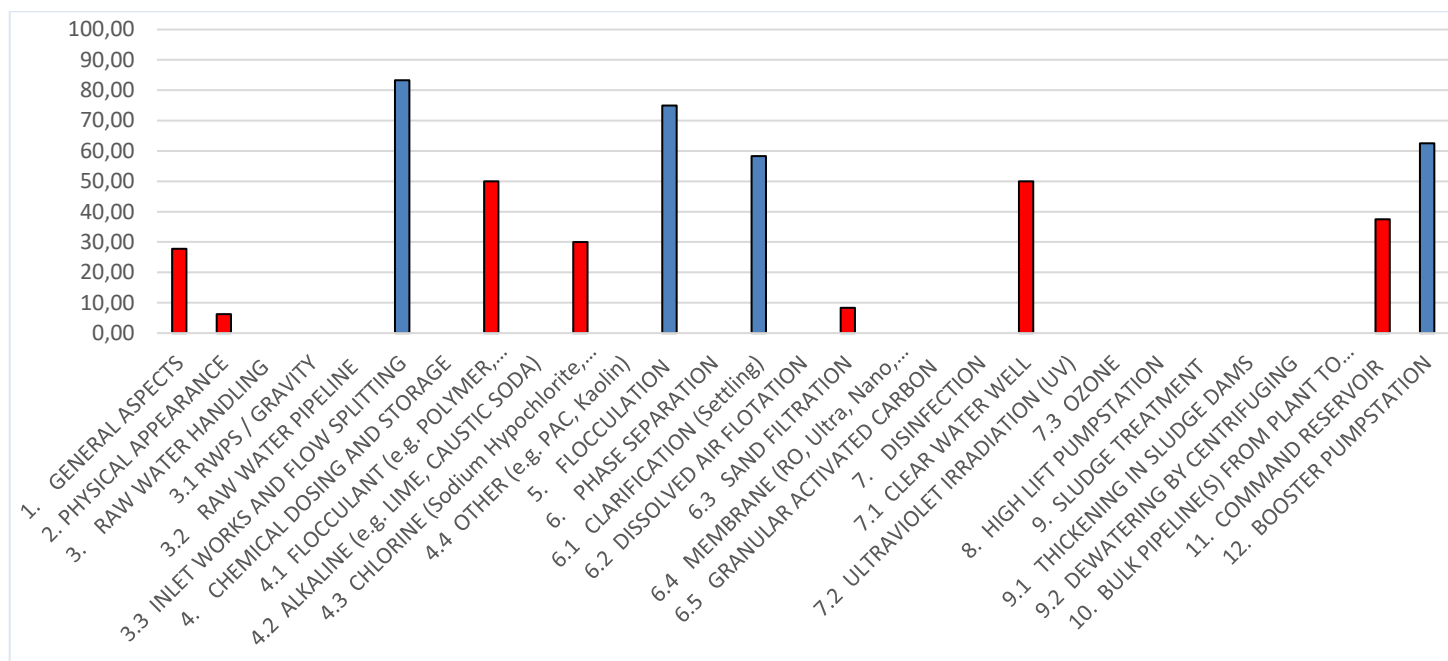
The following process units were inspected and rated according to the % score on the y-axis. Process units that score <50% are marked in red and need urgent intervention.

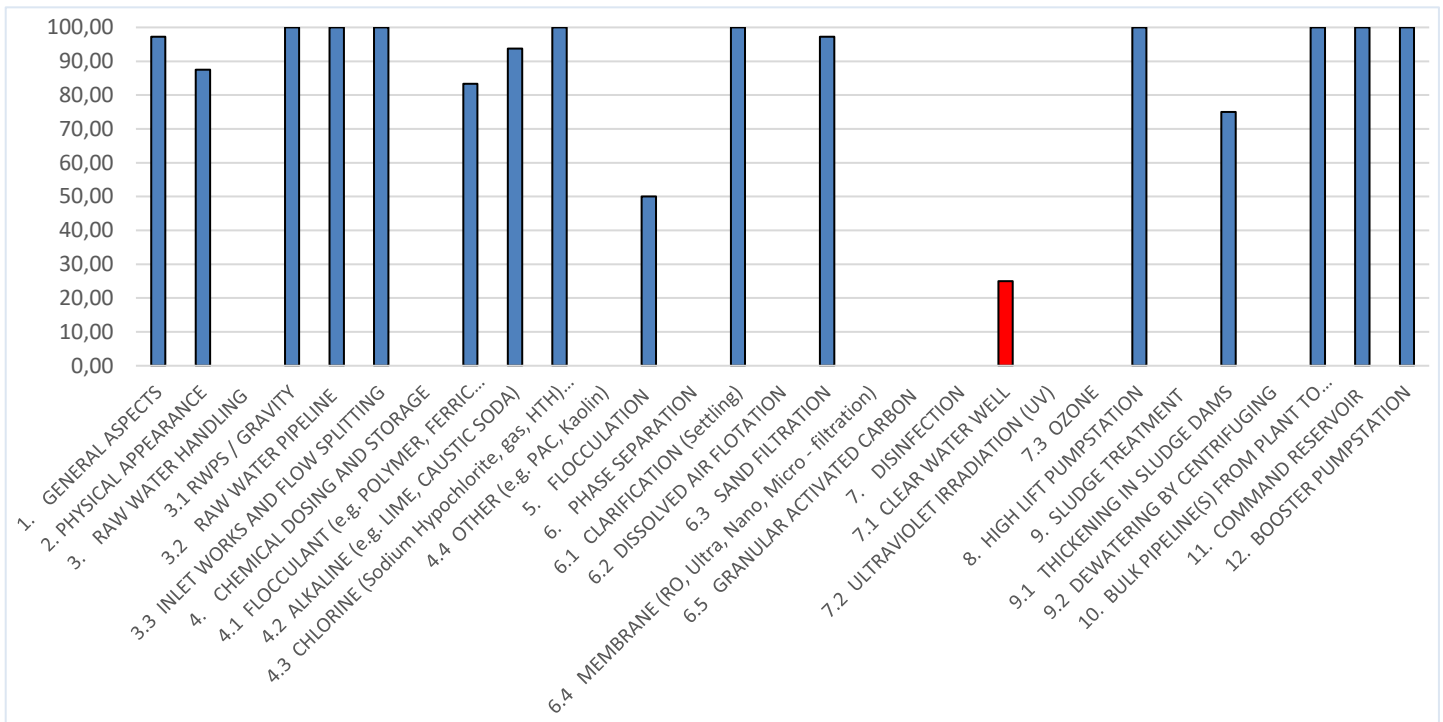
The following process units were inspected and rated according to the % score on the y-axis. Process units that score <50% are marked in red and needs urgent intervention.

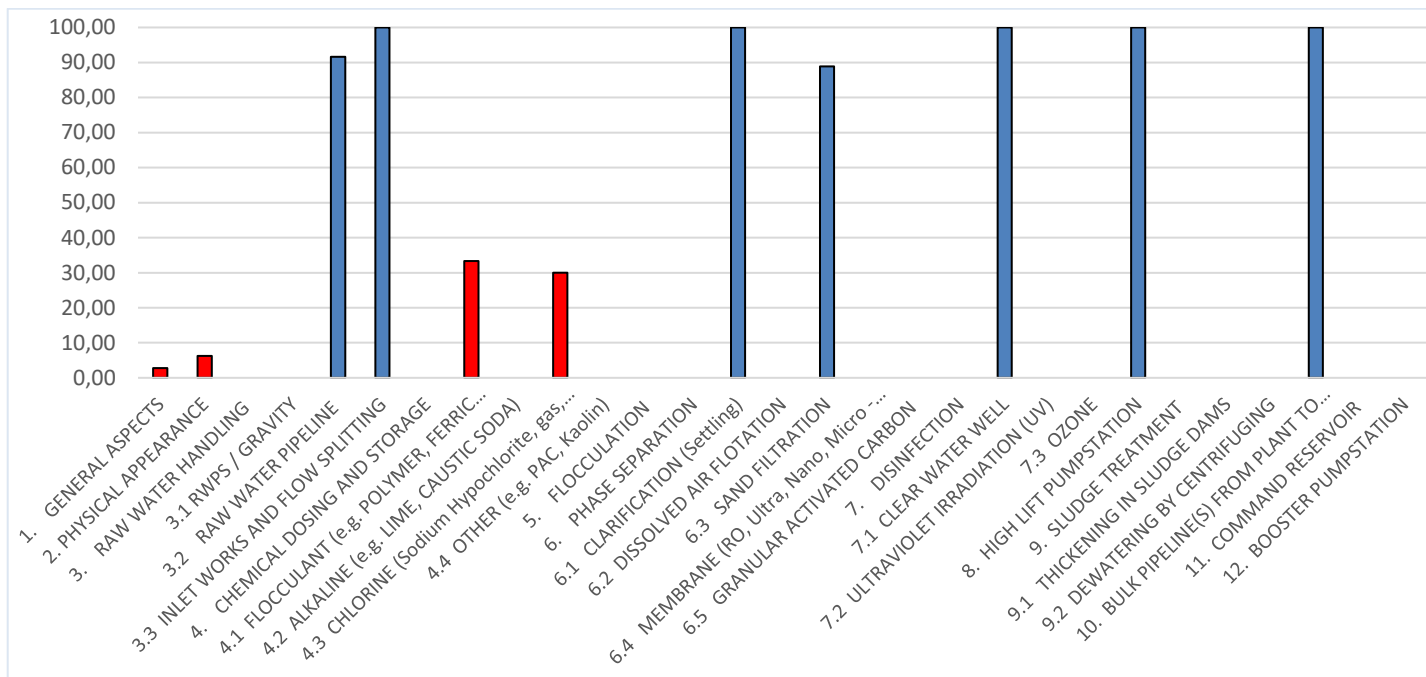
The following process units were inspected and rated according to the % score on the y-axis. Process units that score <50% are marked in red and need urgent intervention.
