Outcomes of the Water Research Commission's independent investigation on the recent Cholera outbreak in Hammanskraal

Dr Eunice Ubomba-Jaswa National Press Club Media Briefing 26 July 2023

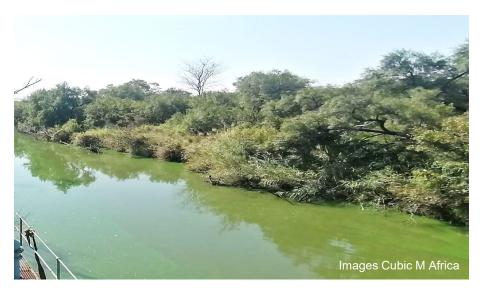
CLIMATE VARIABLES AND WATER QUALITY CONDITIONS OF DAMS IN THE HAMMANSKRAAL AREA

Above-average rainfall

Feb 2023 experiencing **almost threefold** the monthly average rainfall.

Air temperature

Range of 19°C to 28°C between November 2022 and May 2023.

Optimum weather conditions for *V. cholerae* Both rainfall and temperature conditions favourable for the survival of toxigenic *V. cholerae* if present.

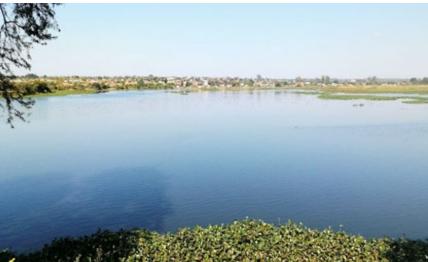
Blue-green algae and water hyacinth

present in the Leeukraal Dam and Pienaars river have been shown to be carriers of *V. cholerae* bacteria.

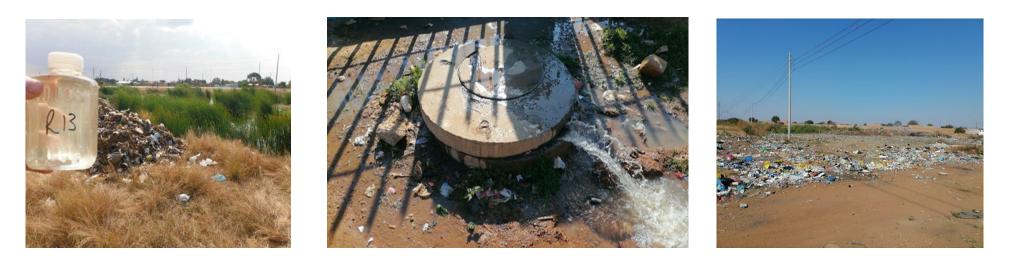
ASSESSMENT OF RUNOFFS FROM SOLID WASTE DUMP SITES AND SEWAGE OVERFLOWS

Numerous illegal dumping sites and sewer overflow

Some sites had nappies - high possibility for faecal contamination.

High levels of *E. coli* found in samples analysed.

Some samples also positive for *Salmonella* and *Shigella* which can cause gastrointestinal illnesses.

No V. cholerae

found at any of the respective monitoring points.

A proper waste collection system

should be implemented to avoid illegal dumping of municipal solid waste.

Sewage infrastructure must be maintained

to prevent overflow into the surrounding environment – bearing in mind heavy rainfall patterns.

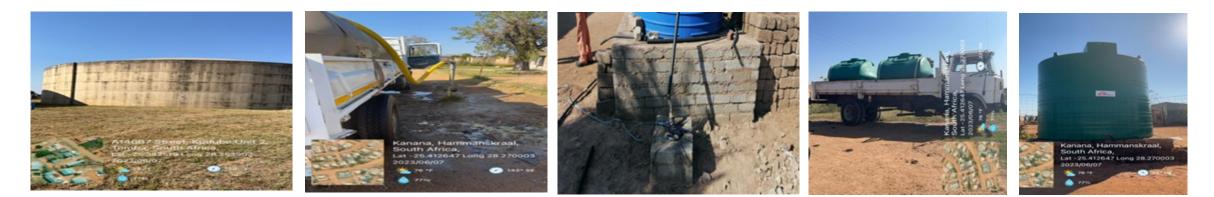
ASSESSMENT OF WATER SOURCES & STORAGE FACILITIES

- **Temba Water Treatment Plant** (*Township/RDP*) Use directly from tap without storage
- Klipdrift Water Treatment Plant (Informal) Use directly from tap without storage
- Tankers from Rand Water pipeline (Township/RDP/Informal/Rural) Buckets & Polycan Drums; 'JoJo' tanks for emergency
- Bottled water from retail stores (Township/RDP/Informal)

Groundwater through private boreholes (*Rural*) Buckets & Polycan Drums; 'JoJo' tanks for emergency

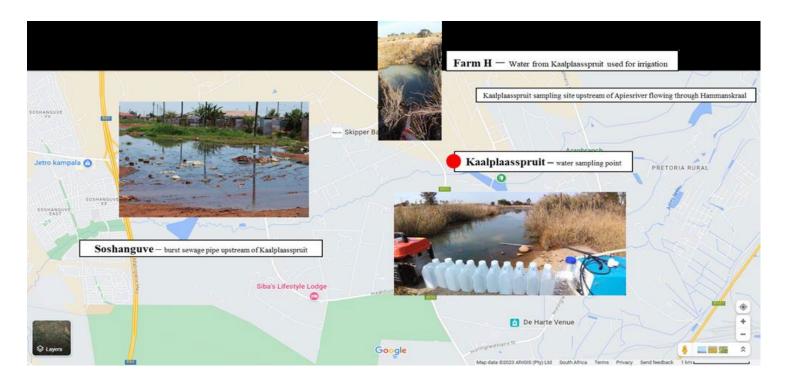
ASSESSMENT OF IRRIGATION WATER

- *V. cholerae* (still to be confirmed as toxin producing) found in water sample obtained from the Kaalplaasspruit irrigation water point.
- A burst sewer pipe was located upstream of the spruit.
- Water is **used to irrigate** a pea farm.
- Spruit flows into the Apies River further **downstream in the Hammanskraal area**.

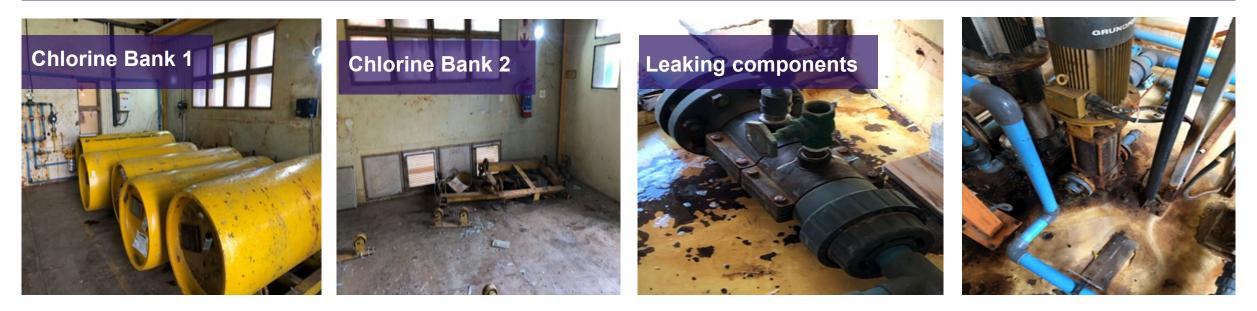
ASSESMENT OF TEMBA DRINKING WATER TREATMENT PLANT

PLANT	FUNCTIONALITY	COMPLIANCE	VIBRIO CHOLERAE	CRITICAL ISSUE(S)
Temba Water Treatment	Operating below capacity	Water does not meet the SANS 241 Drinking water Standards	Negative (in raw water and water after chlorination)	 Breaks in chlorine disinfection Chemical dosing is not optimised Lack of proper process control and operation

Temba drinking water treatment plant

must operate according to standard procedure; ensuring that chemicals are available for correct dosing – blue drop requirements

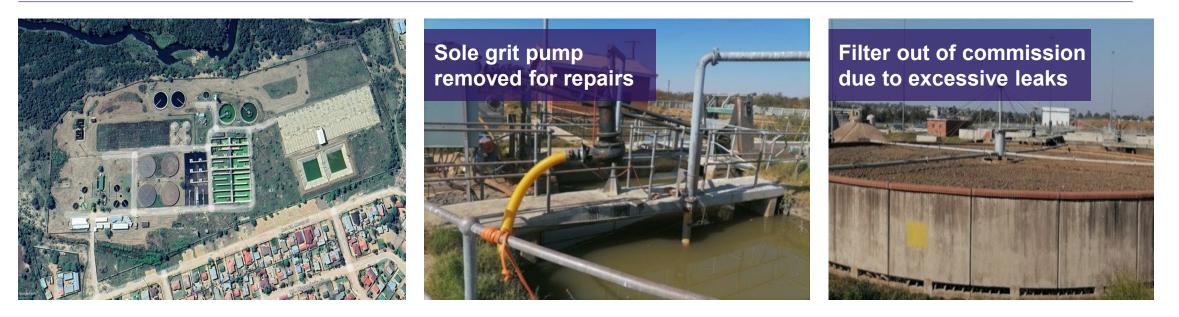
ASSESSMENT OF TEMBA WASTEWATER TREATMENT PLANT

PLANT	FUNCTIONALITY	COMPLIANCE	VIBRIO CHOLERAE	CRITICAL ISSUE
Temba Wastewater	Partially	Effluent does not meet standards for release	Negative	Lack of maintenance Partial construction of some components of the plant

Rooiwal and Temba wastewater treatment works

- (1) refurbished and recommissioned urgently, to achieve at least sanitation of wastewater;
- (2) upgraded, ultimately, to achieve best environmental practice, including reclamation of final effluent to drinking water standard – green drop requirements

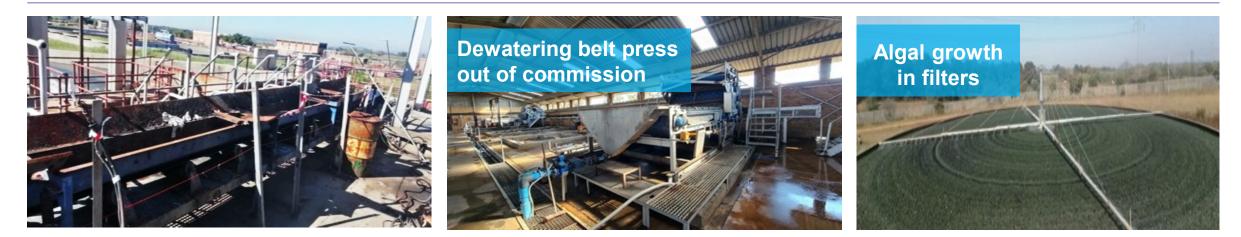
ASSESSMENT OF ROOIWAL WASTEWATER TREATMENT PLANTS

PLANT	FUNCTIONALITY	COMPLIANCE	VIBRIO CHOLERAE	CRITICAL ISSUE
Rooiwaal Wastewater (Made up of Rooiwal Northern Works, Rooiwal Eastern Works and Rooiwal Western Works)	Dysfunctional	Effluent does not meet standards for release Green Drop Watch Report – classified Northern Works as "high risk"	Negative	Operating above design capacity Plant needs to be overhauled Different process units do not work well together – masterplan required
