BLUE DROP

Watch Report

BLUE DROP WATCH REPORT 2023: TECHNICAL ASSESSMENT OF THE CONDITION OF MUNICIPAL DRINKING WATER TREATMENT AND DISTRIBUTION SYSTEMS IN SOUTH AFRICA

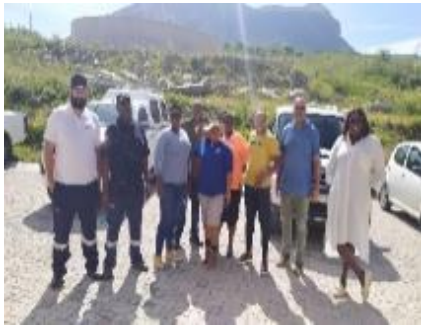
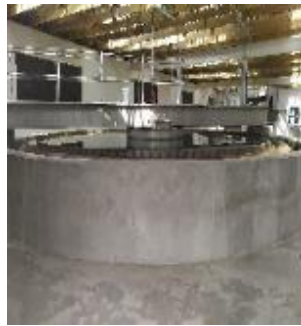
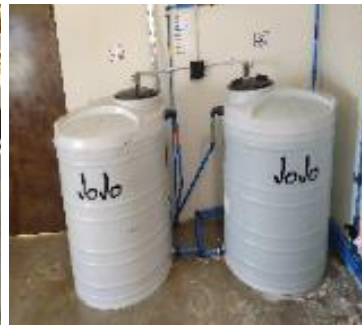
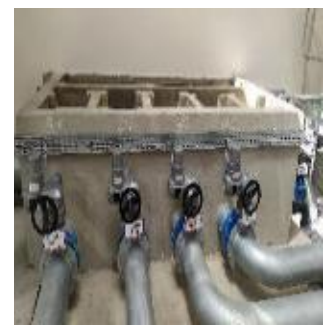
Watch #	Process Unit Assessed	% TSA	Observations
1	General aspects	63.8	Class B plant, repairs and maintenance loaded using job cards, daily log sheet with operations monitoring is in place, there was no notice board in place to display the PFD or other relevant notices. No signage at the gate as this was in the process of being replaced by the contractor doing the refurbishment, with contact no. of staff.
2	Physical appearance	71.8	Access to the works was easy with a newly paved road. Some general housekeeping was required, other than that the facility was in a good condition
3	Raw water handling

High risk areas OR Key Hardware Risks/ Defects

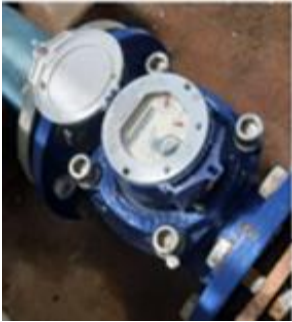
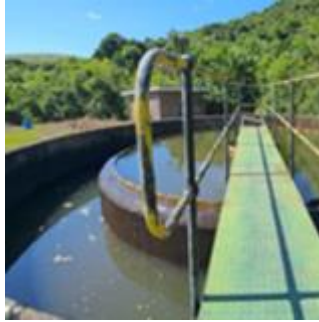
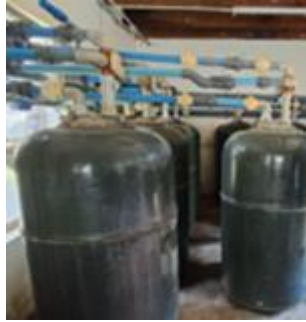
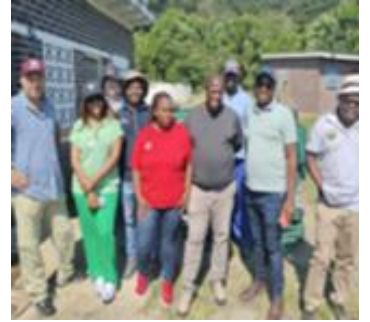
Watch #	Process Unit Assessed	% TSA	Observations
1	General aspects	94.4	Class D plant, Classification Certificate and PFD. Logbooks up to date. Process monitoring equipment functional and calibrated, electricity consumption recorded.
2	Physical appearance of plant	81.3	Plant is fenced, gated and entrance is signposted. Good housekeeping, high workplace satisfaction. No OHS contraventions.
3	Raw water handling		
	Raw water pipeline	100	Gravity supply from the Morgans Bay Dam. Flow meter is operational, and flow is recorded.
	Inlet works	100	Inline flocculant dosing and mixing.
4	Chemical dosing and storage		
	Flocculant	58.3	Duty and standby dosing systems operational Adequate storage capacity for treatment chemicals but area not bunded. Emergency wash station non-operational.
	Chlorine	70.0	Duty/standby chlorine gas dosing units operational with scales but no automatic change over. Limited chlorine gas stocks on site due to the national shortage of chlorine gas - HTH used as interim measure.

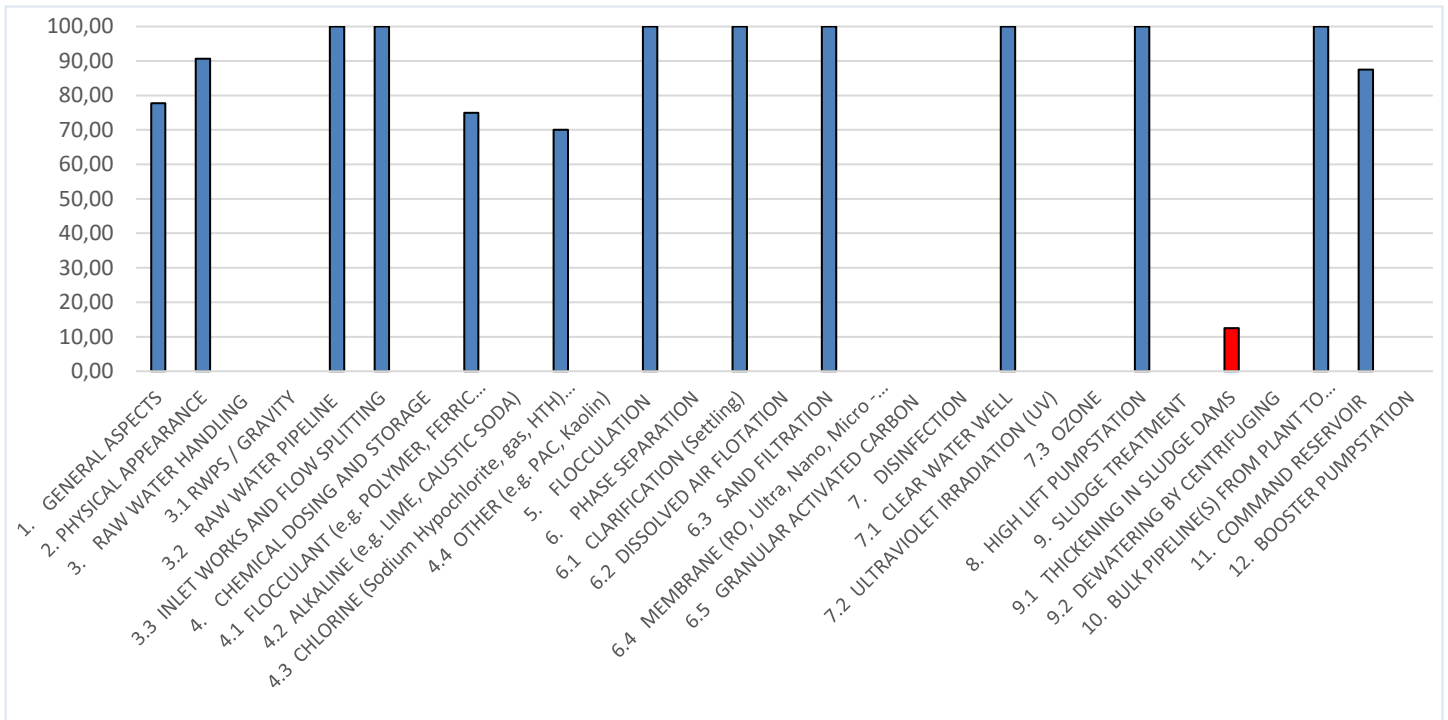
The following process units were inspected and rated according to the % score on the y-axis. Process units that score <50% are marked in red and require urgent intervention.

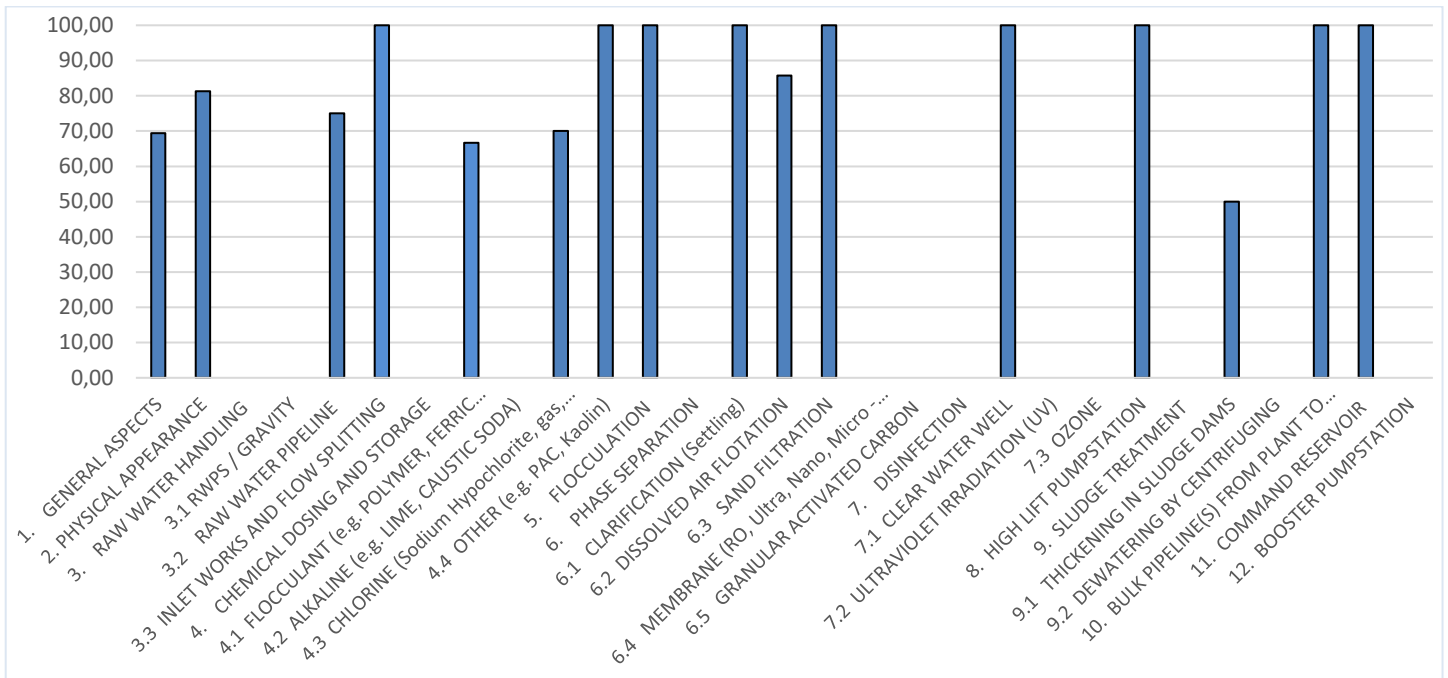
The following process units were inspected and rated according to the % score on the y-axis. Process units that score <50% are marked in red and require urgent intervention.

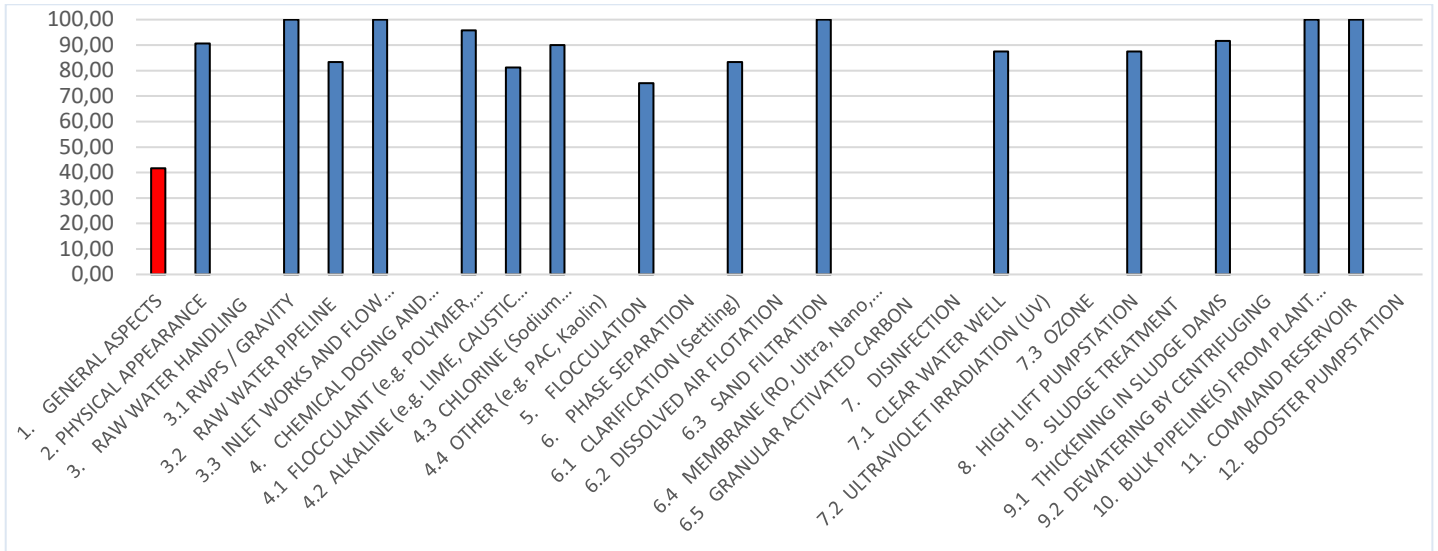
The following process units were inspected and rated according to the % score on the y-axis. Process units that score <50% are marked in red and need urgent intervention.

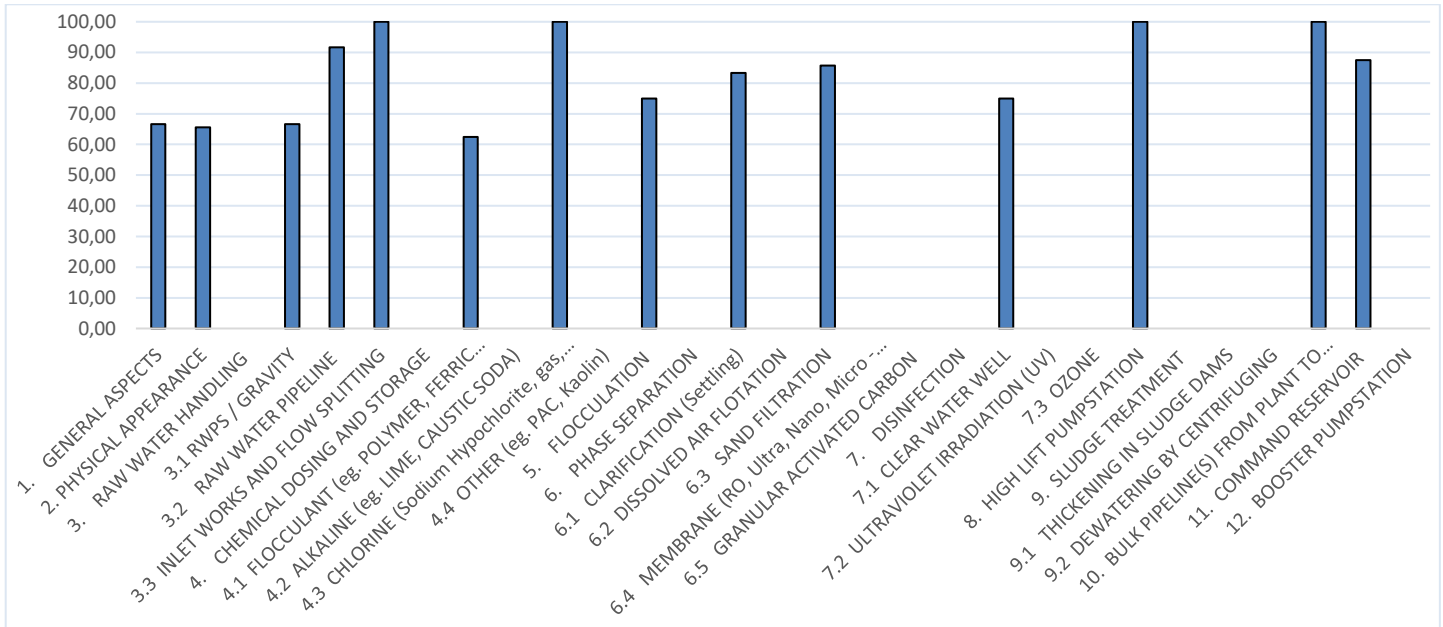
The following process units were inspected and rated according to the % score on the y-axis. Process units that score <50% are marked in red and need urgent intervention.

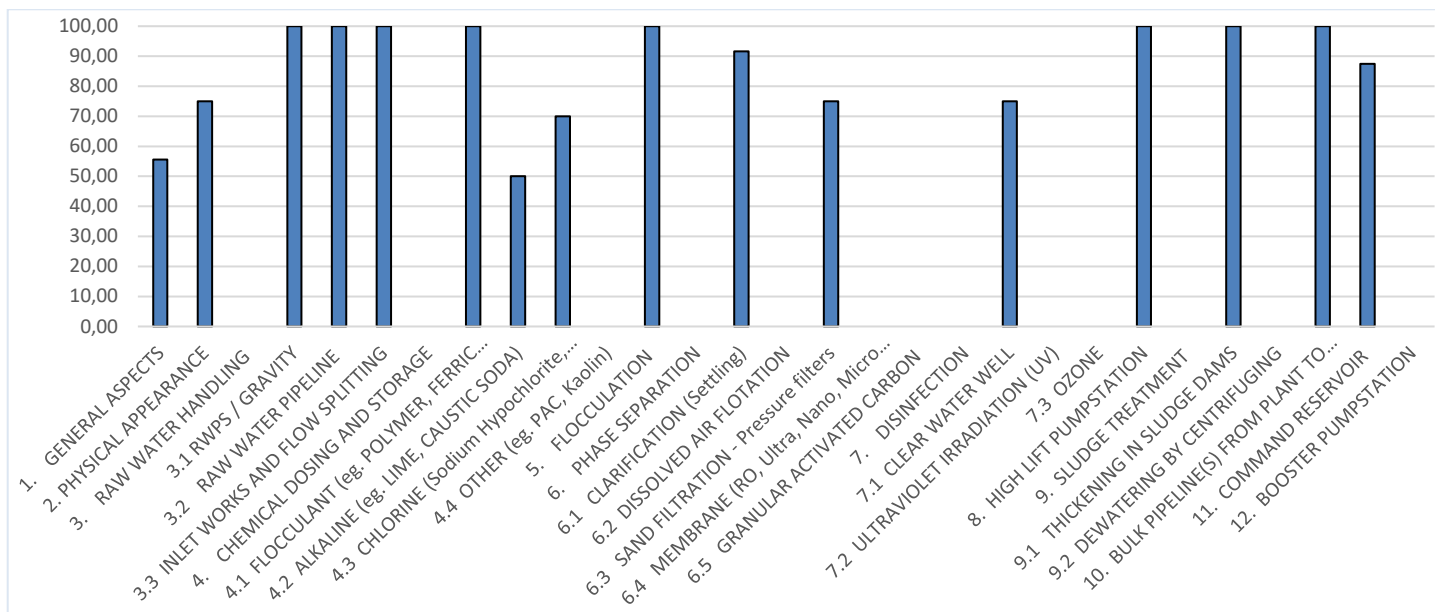
The following process units were inspected and rated according to the % score on the y-axis. Process units that score <50% are marked in red and need urgent intervention.

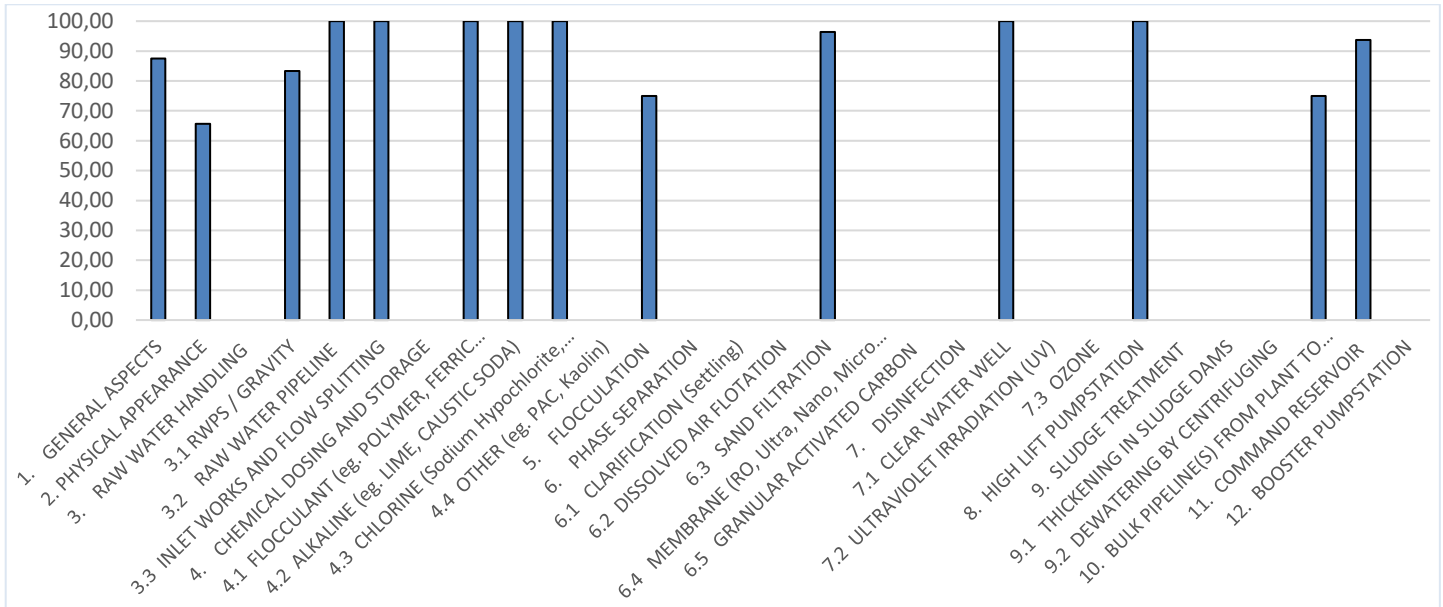
The following process units were inspected and rated according to the % score on the y-axis. Process units that score <50% are marked in red and need urgent intervention.

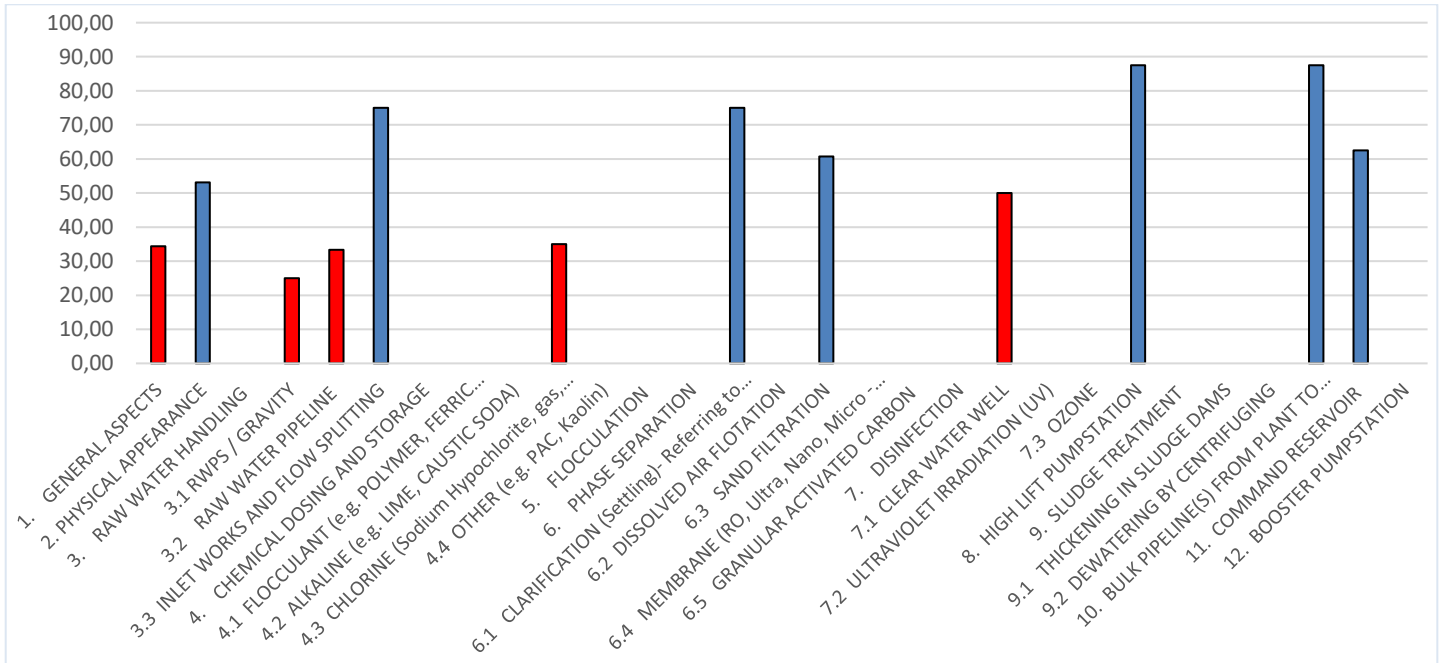
The following process units were inspected and rated according to the % score on the y-axis. Process units that score <50% are marked in red and need urgent intervention.

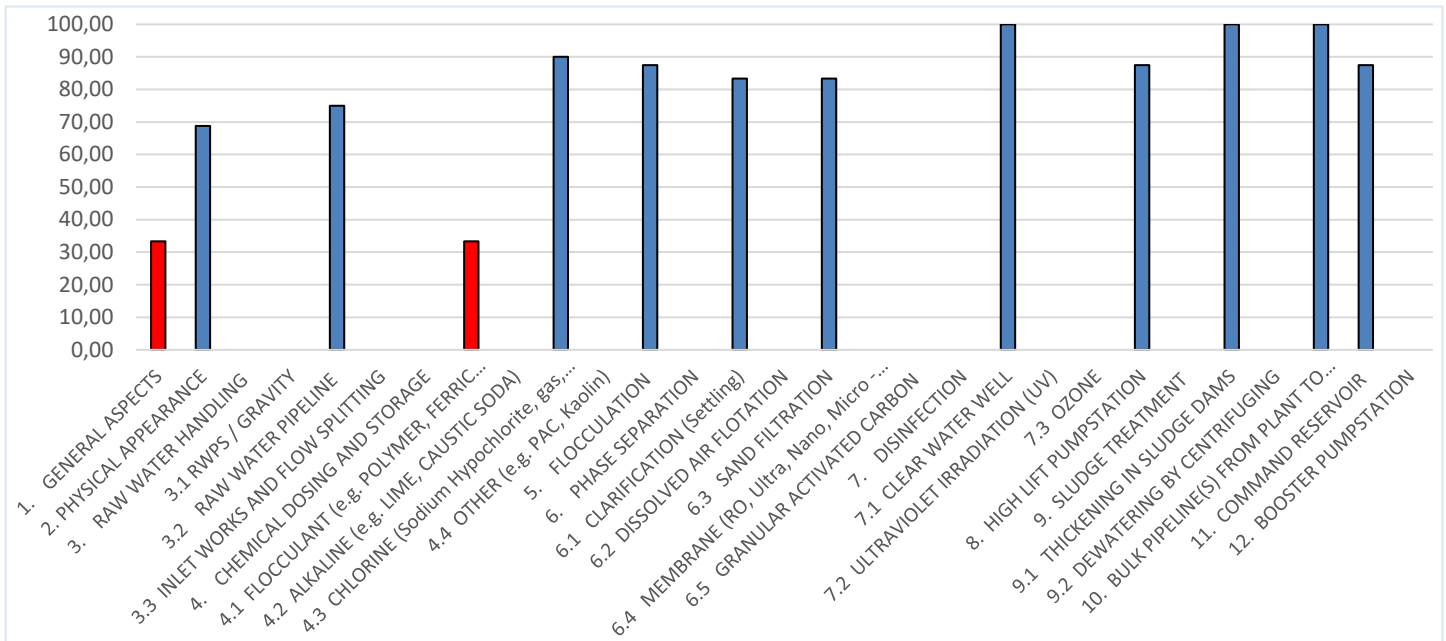
Watch #	Process Unit Assessed	% TSA	Observations
1	General aspects	27.8	Class C plant, no PFD, O&M Manual, or classification certificate displayed. Logbook with daily entries. Process monitoring equipment is functional but not calibrated. Electricity consumption not recorded.
2	Physical appearance of plant	68.8	Plant is fenced and gate and entrance signposted. Good housekeeping, high workplace satisfaction. Garden maintenance poor. Construction site limits safe access to process units.
3	Raw water handling		
	Raw water pipeline	75.8	Gravity supply from the Howiesonspoort Dam. No pipe leakages were observed. Flow records captured and plotted at the SCADA but not used for process optimisation.
	Inlet works	0.0	Inlet works temporarily bypassed due to upgrading of plant - impacting on treatment efficiency.
4	Chemical dosing and storage		
	Flocculant	33.3	Duty and standby flocculant dosing systems operational. Dosing area clean but spillages cannot be contained. Inadequate storage capacity for treatment chemicals and area not bunded. No emergency wash station.

Chlorine	90.0	Duty and standby chlorine gas dosing units operational with automatic change-over. No chlorine gas stock on site due to national shortage of chlorine gas - HTH used as an interim measure.
5	Flocculation		Good floc-formation is observed, concrete structure in good condition. Additional flocculation channel under construction.
6	Phase Separation		
	Clarification (settling)	87.5	Limited floc carry-over, daily de-sludging. concrete structure in good condition. Additional clarifier under construction.
	Sand filtration	67.5	Duty/standby pumps operational, no standby for blower. Even bubble distribution during backwash but blower appears to be over-rated and "aggressive" bubbling results in sand wash-out. Filter sand in good condition.
7	Disinfection		
	Clear water well	100.0	Contact time in 2 ML onsite reservoir is >30 minutes, Residual Cl ₂ monitoring at outlet.
8	High lift pumpstation	87.5	Duty and standby pump set operational and well maintained. Production flow recorded but no interpretation.

9	Sludge treatment		
	Thickening in sludge dams	100.0	Four newly constructed sludge dams in operation.
10	Bulk pipeline from plant to command reservoir	100.0	No leaks detected by process controllers or maintenance team.
11	Command reservoir	87.5	Reservoir is secure, telemetry is operational, structure is in good condition.
	Total	68%

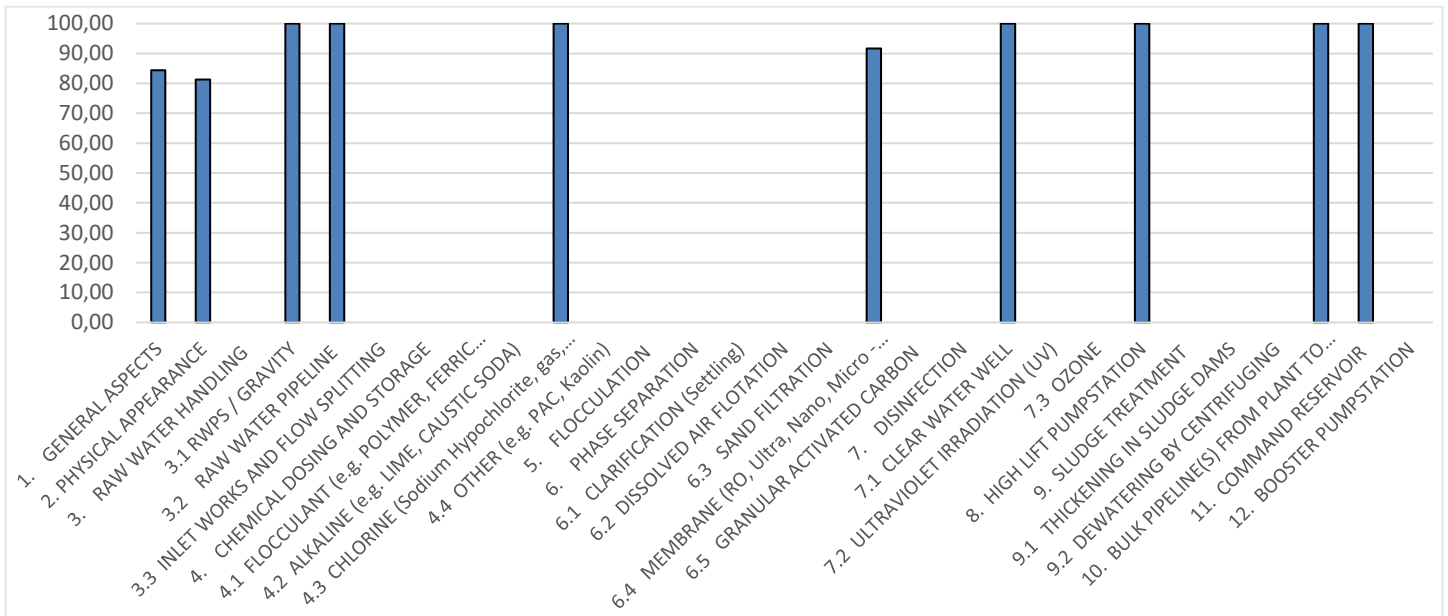
Watch #	Process Unit Assessed	% TSA	Observations
1	General aspects	84.3	Class C plant, Classification Certificate and PFD on SCADA. Logbooks with daily entries. Process monitoring equipment is functional but not calibrated. Electricity consumption is recorded.
2	Physical appearance of plant	81.3	The site is neat, plant is fenced, gated but not signposted. Good housekeeping in RO building, high workplace satisfaction. No OHS contraventions. Process control room and ablutions to be refurbished.
3	Raw water handling		
	Raw water pumpstation/ gravity feed	100.0	Water from boreholes is pumped directly to the plant.
	Raw water pipeline	100.0	No leakages on pipes to raw water storage reported. Flow meter operational and captured on the SCADA.
4	Chemical dosing and storage		
	Chlorine	100.0	Duty/standby sodium hypochlorite dosing system operational, more than 30 days storage available.
6	Phase Separation

Membrane	91.7	Duty/standby dosing and CIP facilities for RO system operational and in good order. Adequate storage capacity for necessary chemicals, but storage area not bunded.
7	Disinfection		
	Clear water well	100.0	Contact time in the 2 ML reservoir is >30 minutes, Residual Cl ₂ monitoring at outlet.
8	High lift pumpstation	100.0	Pumps operated in a duty/standby configuration, flow meter in-place and operational, flow records captured on the SCADA.
9	Brine disposal	100.0	Brine wasted to ocean - Water Use License in place.
10	Bulk pipeline from plant to command reservoir	100.0	No leaks detected by process controllers or maintenance team.
11	Command reservoir	100.0	Reservoir is secure, structure is in good condition. Telemetry operational.
	Total	92%

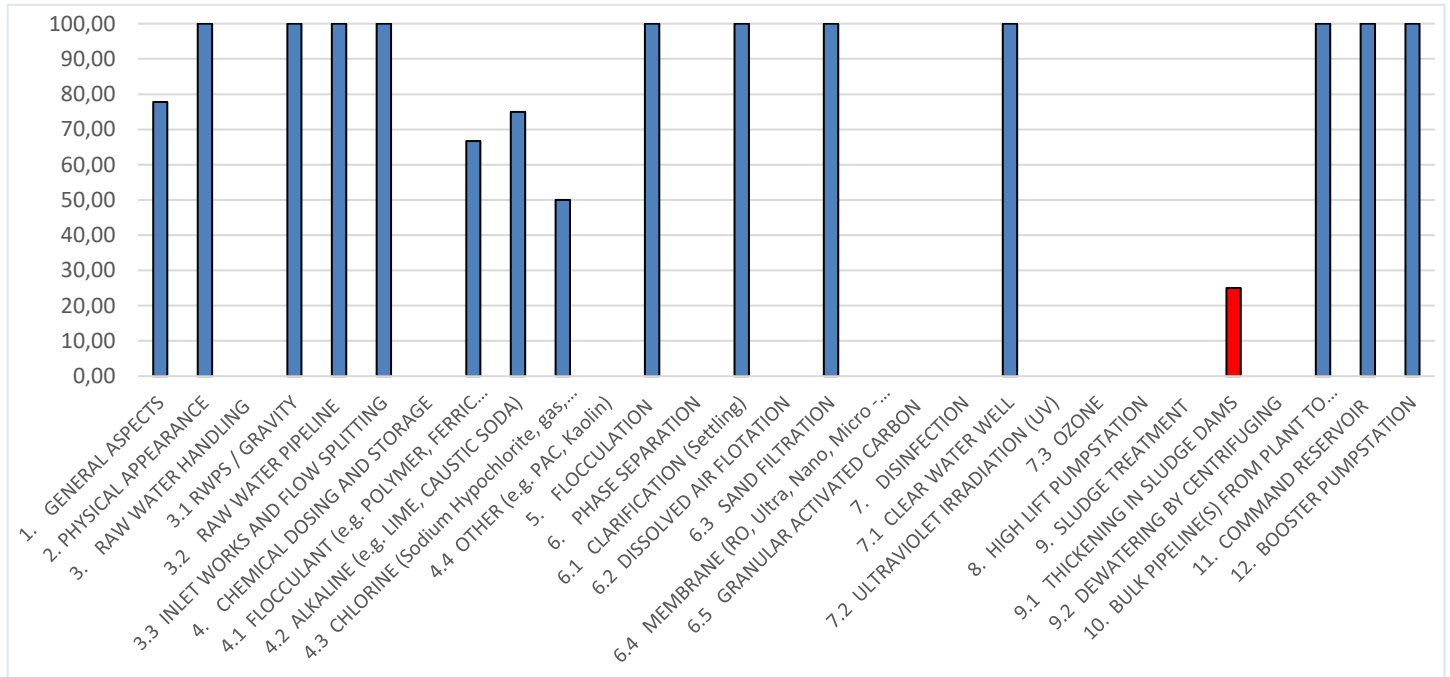
Watch #	Process Unit Assessed	% TSA	Observations
1	General aspects	77.8	Class C plant, Classification Certificate and PFD. Logbooks with daily entries. Process monitoring equipment is functional and calibrated. Electricity consumption not recorded.
2	Physical appearance of plant	100.0	Plant is fenced, gated and entrance is signposted. Good housekeeping, high workplace satisfaction. No OHS contraventions. Garden maintenance excellent.
3	Raw water handling		
	Raw water pipeline	100.0	Gravity supply from the Bulkriver Dam. Flow meter operational.
	Inlet works	100.0	Flocculant dosing visible but infrastructure requires refurbishment. Flash mixing sufficient.
4	Chemical dosing and storage		
	Flocculant	66.7	Duty and standby flocculant dosing systems operational. Dosing area not clean and spillages cannot be contained. Adequate storage capacity for treatment chemicals and area bunded. Emergency wash station non-operational

Alkaline	66.7	New installation of three dry lime dosing units in process of commissioning.
	Chlorine	50.5	Chlorine gas dosing unit operational, no standby. Limited chlorine gas stock on site due to national shortage of chlorine gas - HTH used as interim measure.
5	Flocculation	100.0	Good floc-formation observed and concrete structure in good condition.
6	Phase Separation		
	Clarification (settling)	100.0	Limited floc carry-over, de-sludging twice daily. Concrete weirs are clean with even overflow.
	Sand filtration	100.0	Duty/standby mechanical equipment operational, even bubble distribution during backwash, filter sand recently replaced. Good housekeeping and concrete structure in good condition.
7	Disinfection		
	Clear water well	100.0	Contact time in the 22.5 ML reservoir is >30 minutes, Residual Cl ₂ monitoring at outlet.
8	High lift pumpstation	100.0	Treated water gravitates to command reservoir.

9	Sludge treatment		
	Thickening in sludge dams	25.0	No sludge management facilities provided; sludge is discharged to the municipal sewer.
10	Bulk pipeline from plant to command reservoir	100.0	No leaks detected by process controllers or maintenance team.
11	Command reservoir	50.0	Reservoir is secure, structure is in good condition. Telemetry operational
12	Booster pumpstation	100.0	Duty and standby pump set operational, pumpstation fenced and locked, MCC in good condition.
	Total	87%

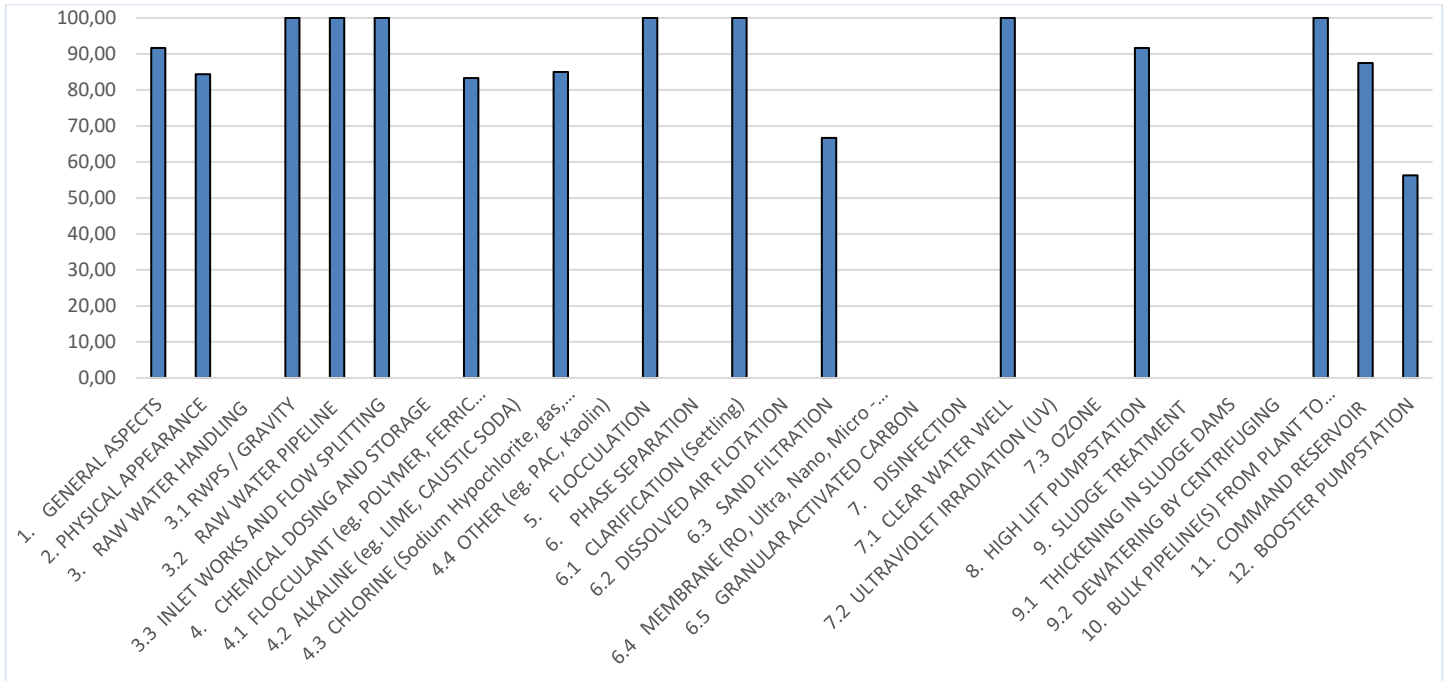
Watch #	Process Unit Assessed	% TSA	Observations
1	General aspects	91.6	Class C plant, maintenance and repairs are captured using the Job card system, Operational log was available with up-to-date entries, IMP was available, and the gate had adequate signage
2	Physical appearance	84.3	The works required some minor maintenance such as grass cutting and the removal of trash bags. Worker's facilities were being renovated at the time of the site visit. Roads require some minor maintenance as there are potholes that need to be filled, however delivery vehicles can reach the works with relative ease
3	Raw water handling

3.1	Rwps / gravity	100.0	When flow is high enough then gravity flow is used, however when flow is too low the pumps are used. All pumps are in working condition. The inlet works was flooded during the site visit.

4.3	Chlorine	85.0	2 scales are in place. However only one was working at the time of the site visit, and the switch over device is in place however as 1 scale is offline it is not being used. The Process controllers monitoring chlorine daily
5	Flocculation	50.0	No visible floc was observed during the sit visit
6	Phase separation

6.1	Clarification (settling)	100.0	Weirs are clear and allow for even flow
6.3	Sand filtration	66.6	there are 5 air blowers in total, and one was offline at the time of the site visit. Filter media was not smooth in all filters and depressions were noted in some filters
7	Disinfection

7.1	Clear water well	100.0	Free chlorine is sample collected at the 3 onsite reservoirs where the sample point is located, and is measured on site
8	High lift pumpstation	91.6	9 pumps are installed 8 are operational and in working order and 1 was sent off repairs. Pumps are operated as 4 x duty and 5 on standby.
10	Bulk pipeline(s) from plant to command reservoir(s)	100.0	Condition of the line is good as it was installed in 2-years ago with no leaks or major pipe bursts noted. Valve chamber is inspected by process controllers
11	Command reservoir	87.5	Reservoir facility is fenced Telemetry is in place but only 50% operational
12	Booster pumpstation	56.2	Only 1 of 4 pumps were in working order as the others were being refurbished. Building is secure with relevant signage post. MCC are accessible and in good condition
	Total	86%

1. Issues with pumps needing repairs or refurbishment was noted at various processes
2. Flooding at the inlet as noted
3. Sand filters had depressions during the site visit.

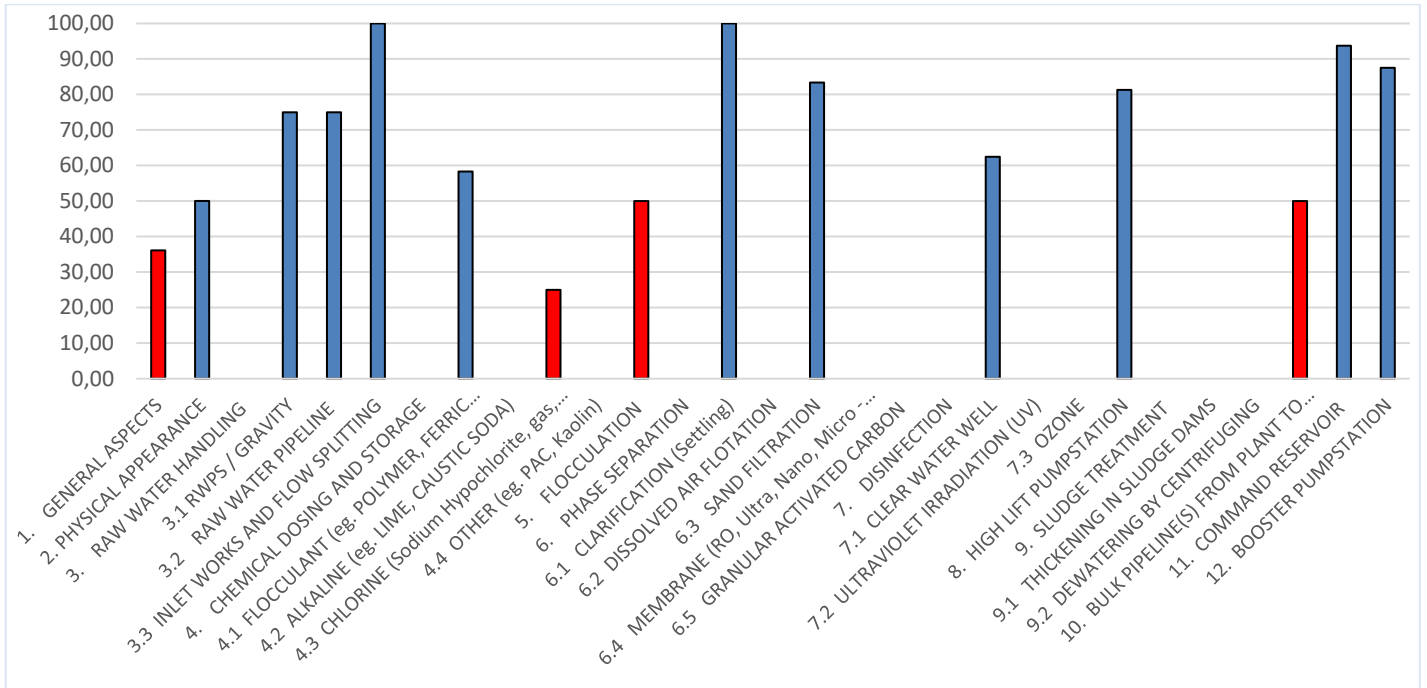
Watch #	Process Unit Assessed	% TSA	Observations
1	General aspects	36.1	There is a considerable amount of administration work that needs to be undertaken at the works. The templates are available however not being used to the works' advantage. The PFD is also rudimentary and should be more detailed in nature as it does not correctly capture the unit processes. Monitoring equipment needs to be fixed and put into operation
2	Physical appearance of plant	50.0	Some civil mechanical and electrical works needs attention. The Chemical dosing both for chlorine (under construction) and flocculation unit need attention to bring up to safety standards. General electrical work is also required as some doors are not in place and areas have extremely high temperatures that can affect the electrical systems.
3	Raw water handling		The inlet screens need to be adapted to accommodate the increase solid removal. Also, general, and regular maintenance on the pumps is critical to ensure life span and operational guarantee. General maintenance on the MCC boards is also required. Management administration needs improvement. Dosing Point and pumps need maintenance attention and service. Two pumps one on standby.

Sand Filtration	83.3	Sand filtration is completely according to the TSA requirements and backwashing was observed during the inspection. Only noted concern was the backup for the air blowers is required.
7	Disinfection		A makeshift chlorination process is in place until the construction of the new unit is completed. None of the present system complies to the OHS
	Clear water well	62.5	
8	High Lift Pump Station	81.2	Most infrastructure is in place with three pump system and monitoring. One of the three was in for repairs however a two operational on standby setup exists
9	Sludge Treatment		
	Thickening in Sludge Dams	0.0	A lot of work is to be undertaken at the sludge dams so much so that the municipality should consider the reconstruction of the sludge dams in concrete line units. No recycling is taking place
10	Bulk pipeline from plant to command reservoir	50.0	Main bulk lines feed to the three reservoirs and the high reservoirs in the system to allow for gravity feeding to the community. No leakages or maintenance was indicated by the officials. Valve chambers could not be inspected

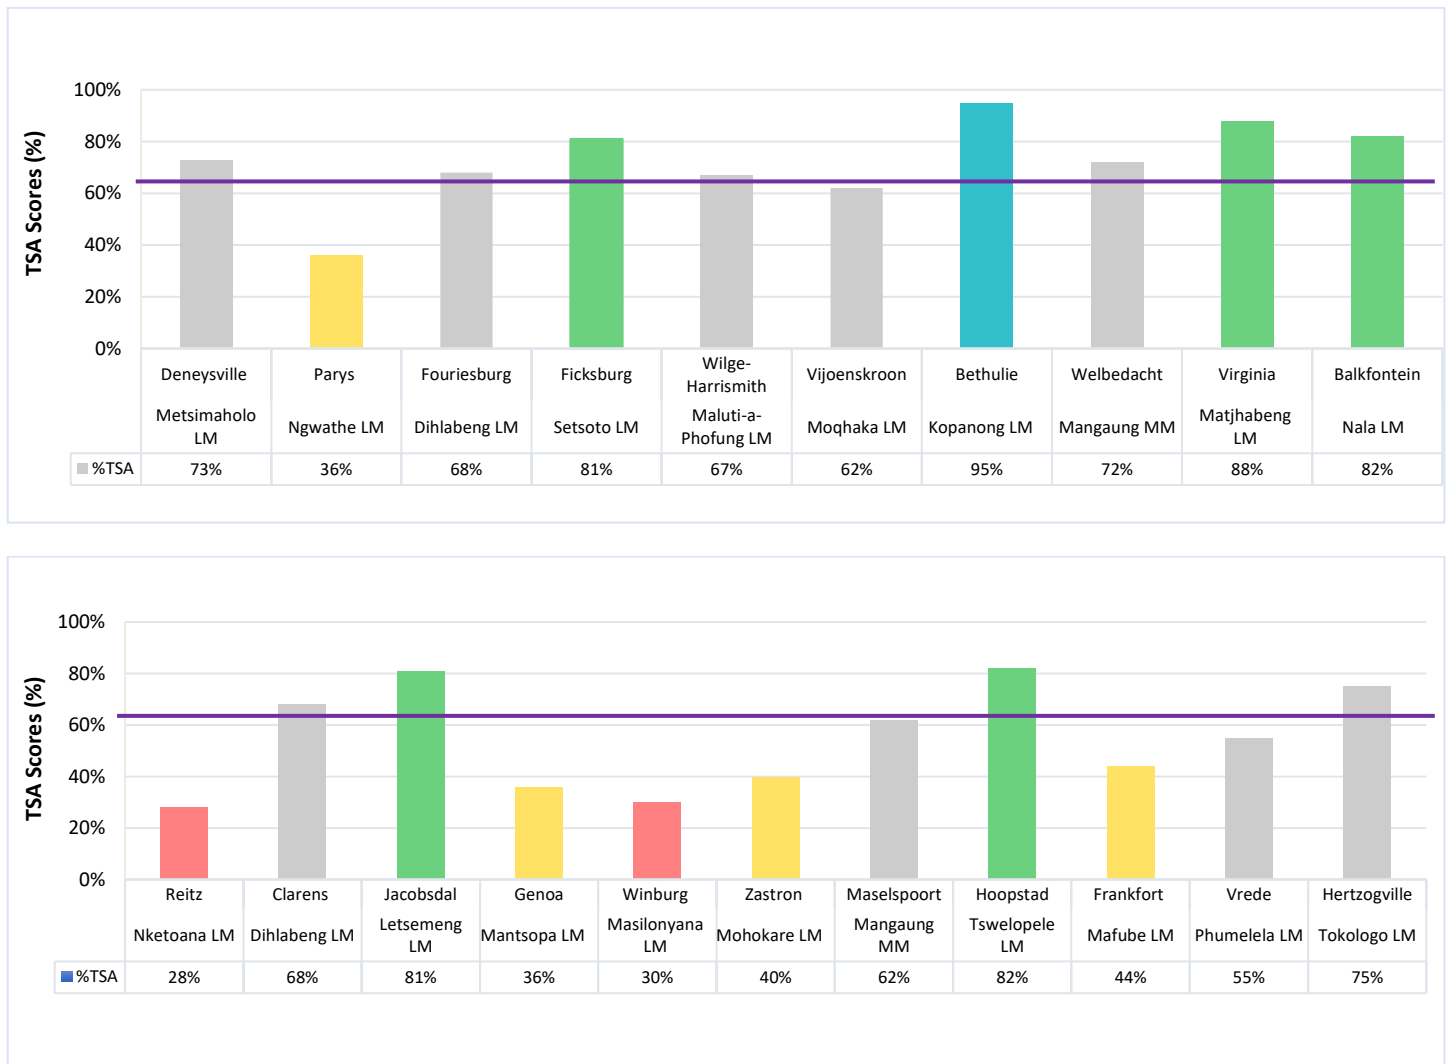
Figure 13 - FS TSA scores for all the BD Systems

An average of 63% was achieved for the 21 systems assessed, which means that infrastructure and processes are partially functional with an average performance. The best overall performance was found for Kopanong, followed by Matjhabeng, Nala and Tswelopele. The water boards provided most of the better performing systems. Lower performances were observed for Reitz and Winburg.

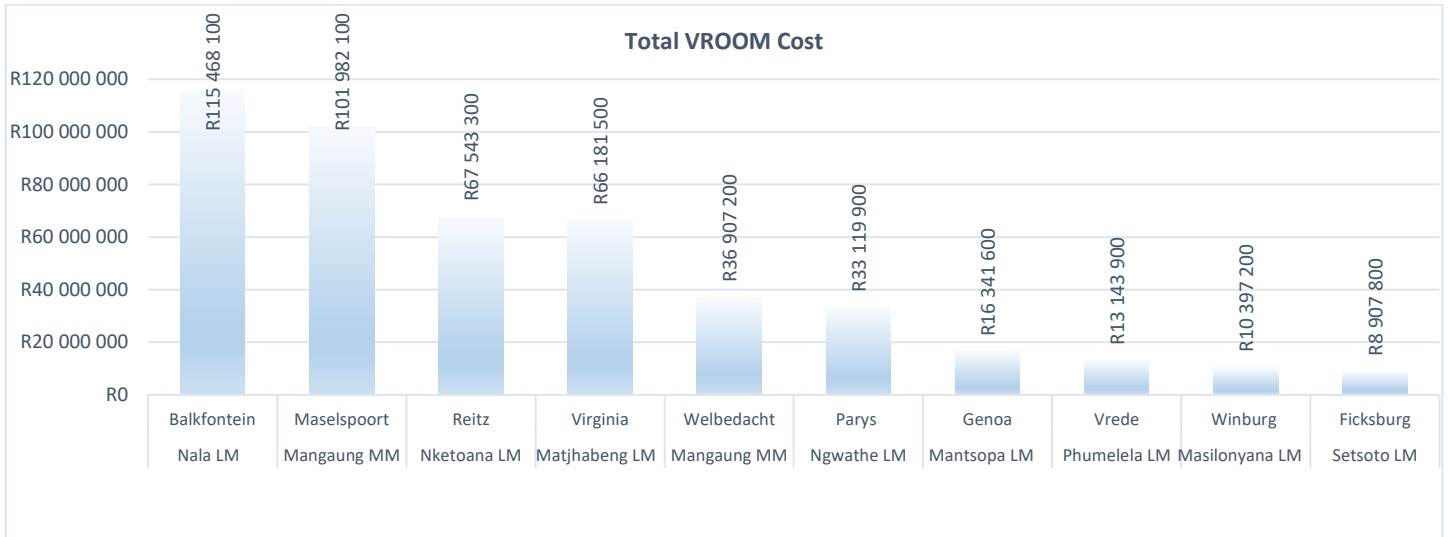
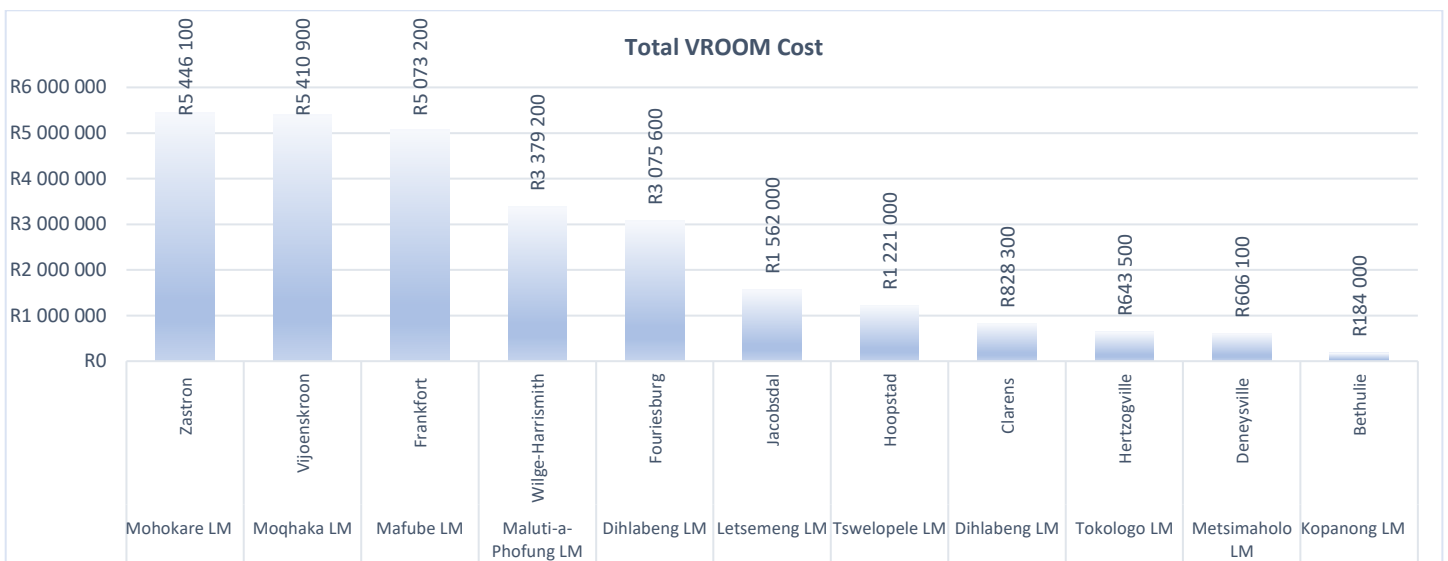
Figure 16 - Total VROOM Cost for the BD Systems Assessed

The associated VROOM costs for the 21 water supply systems assessed amounts to R497.4 million, with the bulk of investment needed for Balkfontein (Nala), Bloemfontein (Mangaung), Reitz (Nketoana), and Virginia (Matjhabeng).

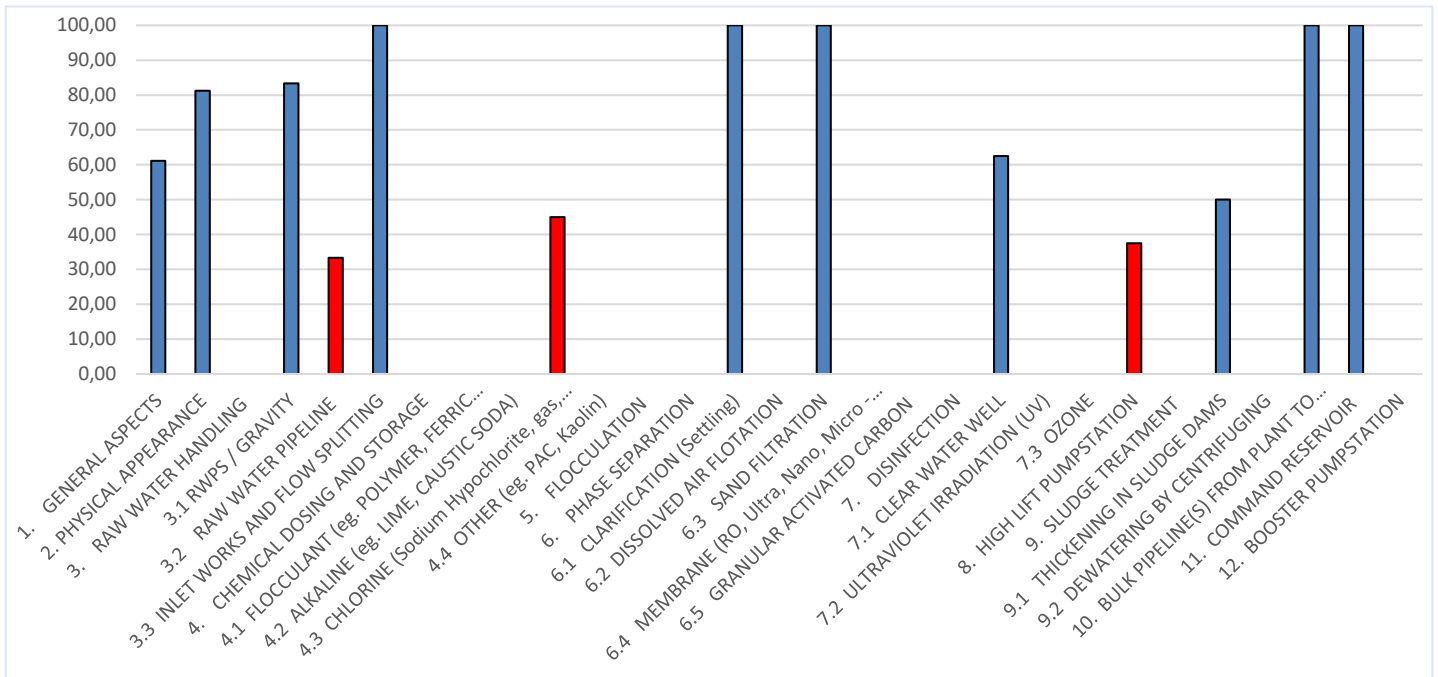
Watch #	Process Unit Assessed	% TSA	Observations
1	General aspects	61.1	Plant Classification certificate is displayed. Logbooks with operational monitoring results and various shift entries, O&M manual, and emergency contact numbers available.

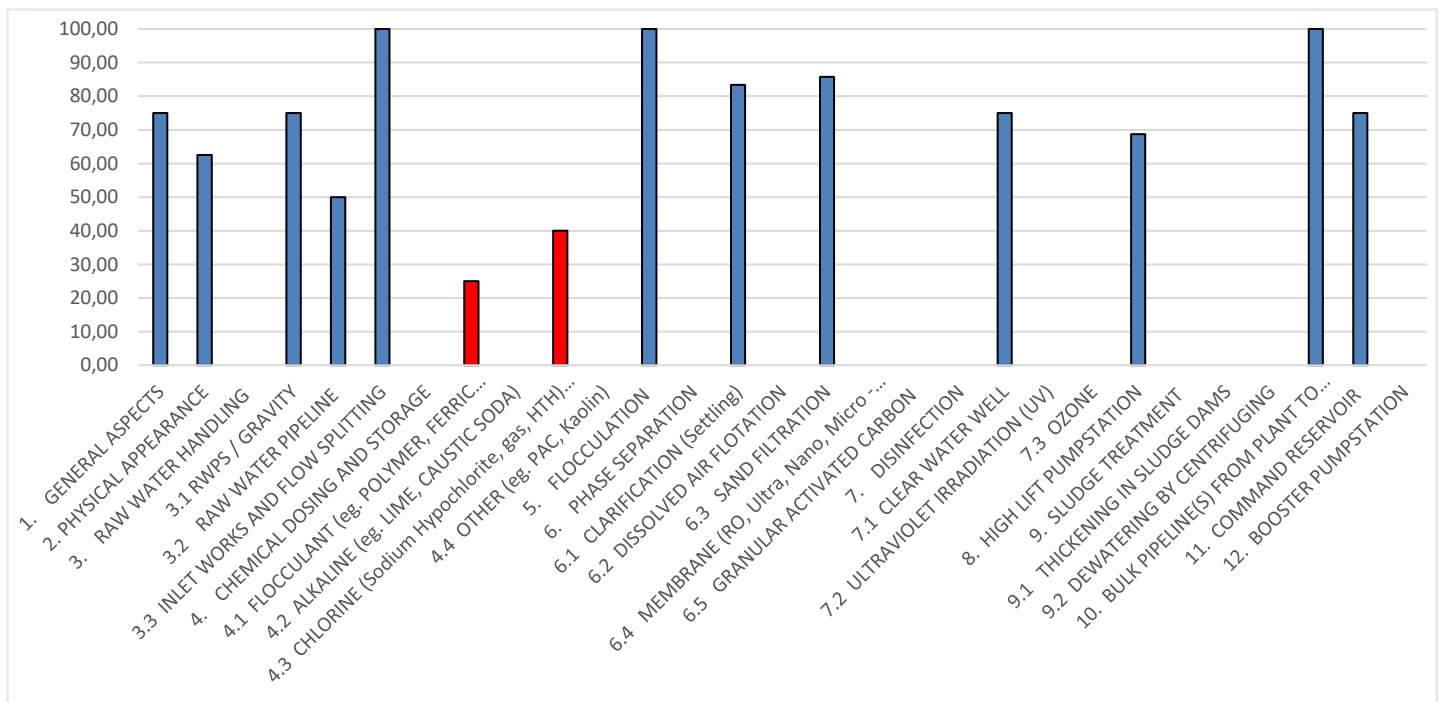
Performance Profile

The following process units were inspected and rated according to the % score on the y-axis. Process units that score <50% are marked in red and needs urgent intervention.

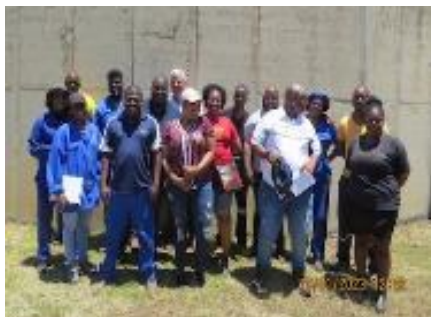
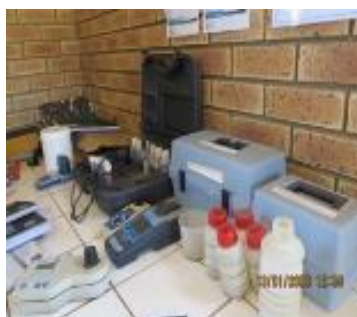
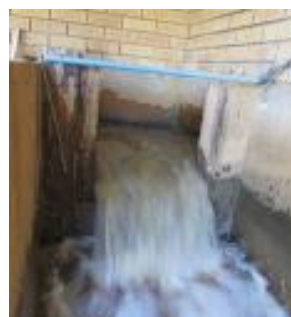
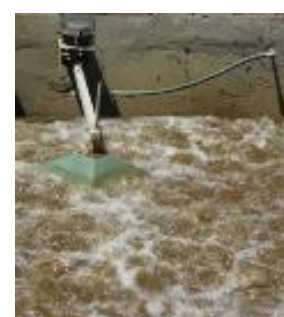
1. Raw water pipe network should be upgraded to ensure uninterrupted supply to the Fouriesburg communities
2. Chemical storage tanks must be bunded
3. The chlorine dosing facility is not conforming with the required regulations and should be upgraded
4. The sedimentation tank weir, scraper, and desludge valves should be refurbished.
5. Filter nozzles to be replaced.
