BLUE DROP

Watch Report

BLUE DROP WATCH REPORT 2023: TECHNICAL ASSESSMENT OF THE CONDITION OF MUNICIPAL DRINKING WATER TREATMENT AND DISTRIBUTION SYSTEMS IN SOUTH AFRICA

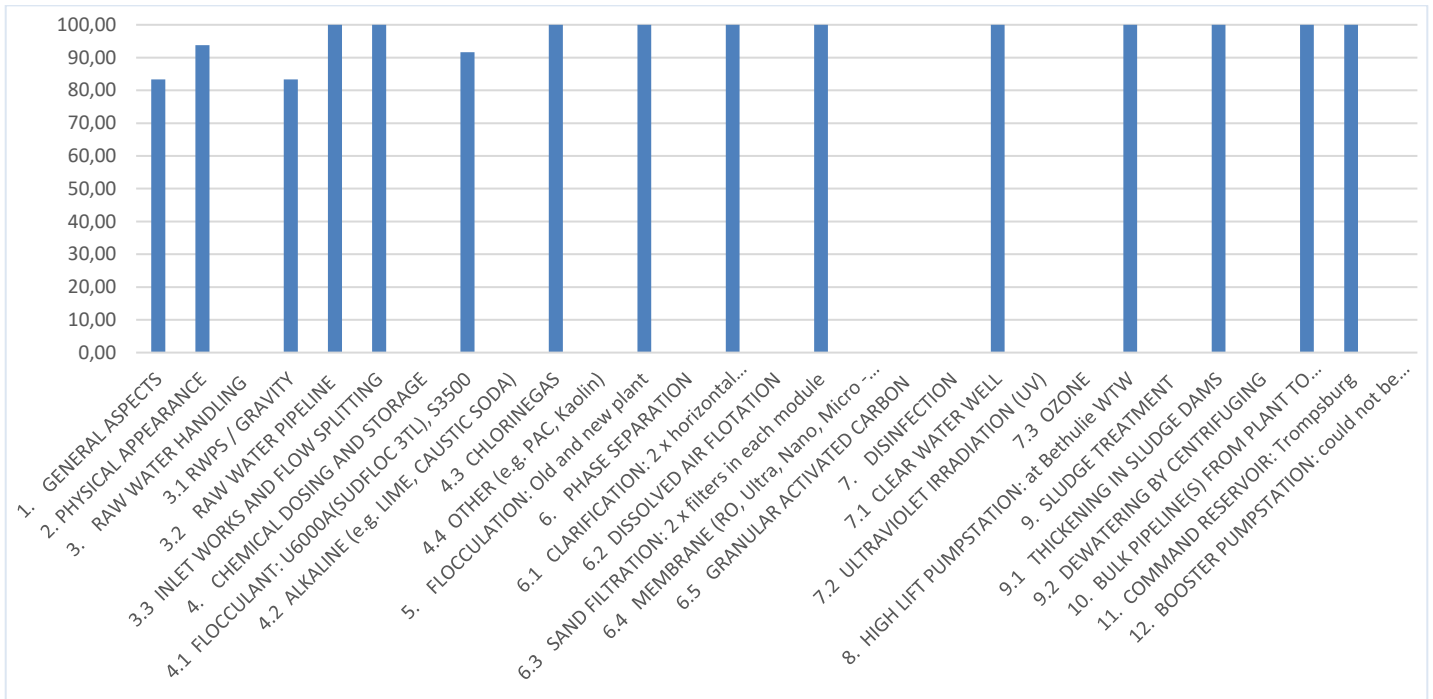
Performance Profile

The following process units were inspected and rated according to the % score on the y-axis. Process units that score <50% are marked in red and need urgent intervention.

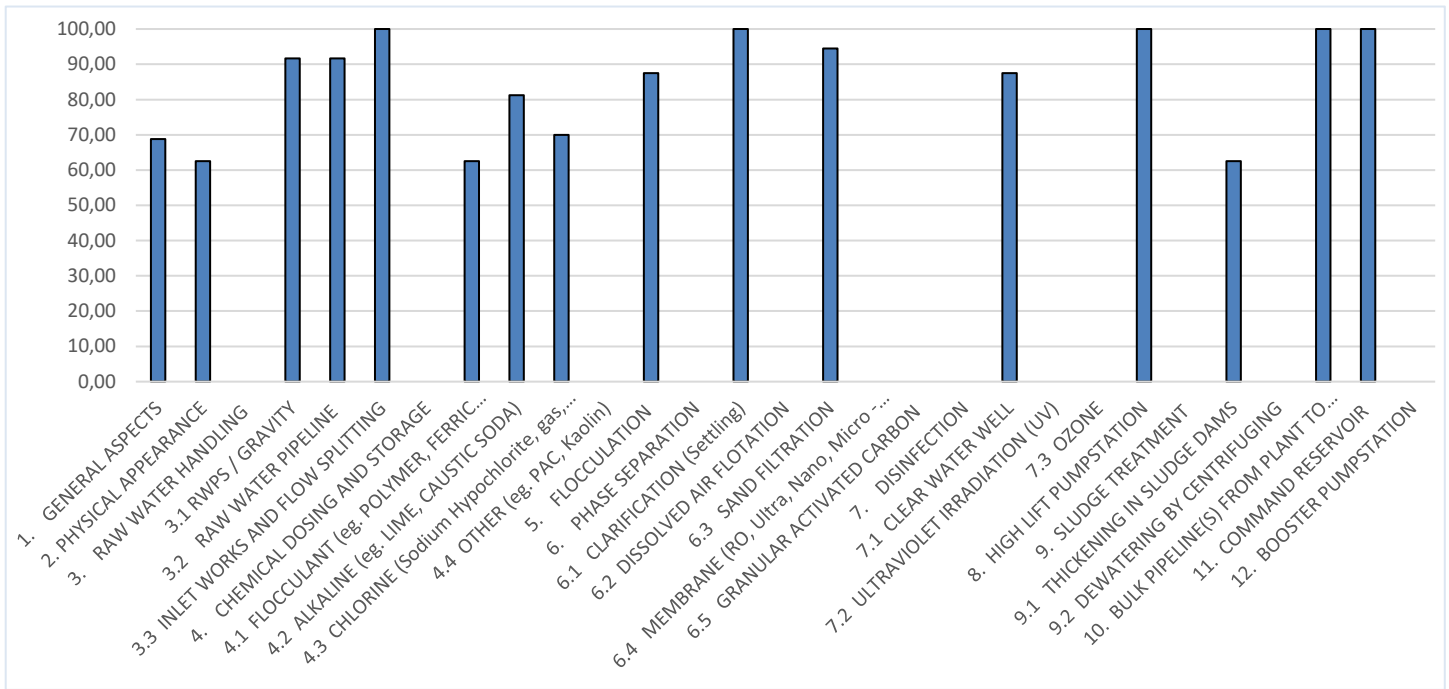
Performance Profile

The following process units were inspected and rated according to the % score on the y-axis. Process units that score <50% are marked in red and needs urgent intervention.

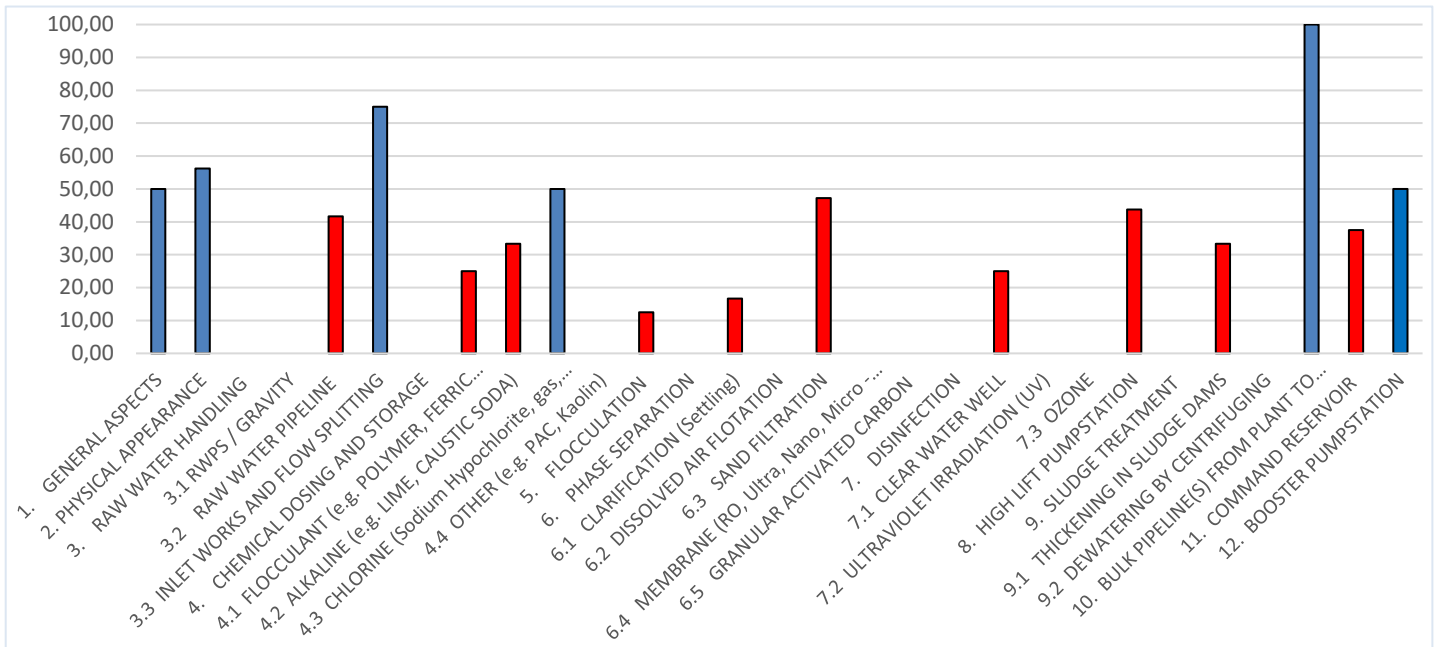
Performance Profile

The following process units were inspected and rated according to the % score on the y-axis. Process units that score <50% are marked in red and needs urgent intervention.

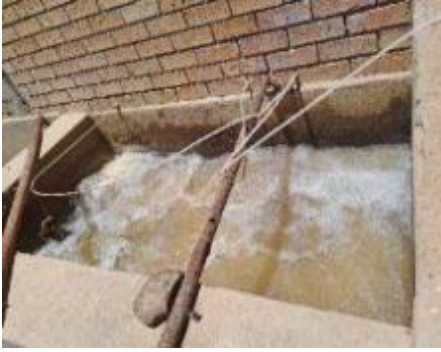
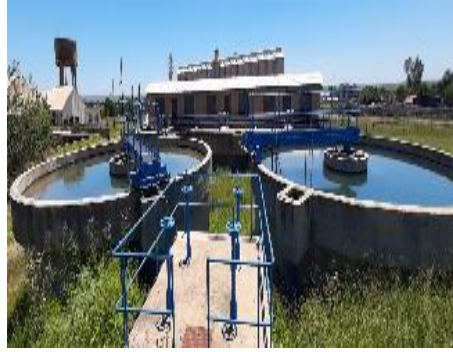
1. Repair, refurbishment of the intake works chemical buildings, inclusive of bunding walls for all chemical holding containers
2. The flocculation unit needs a major refurbishment on the civil works
3. The problem of the clarifiers / settling units needs investigation and rectification
4. The sand filtration units although fairly new, have to have the filter beds investigated and rectification into sand volume
5. Blower pressure and backwash pumps flow to get the filter working efficiently and effectively
6. A more effective means of disinfection needs investigation.

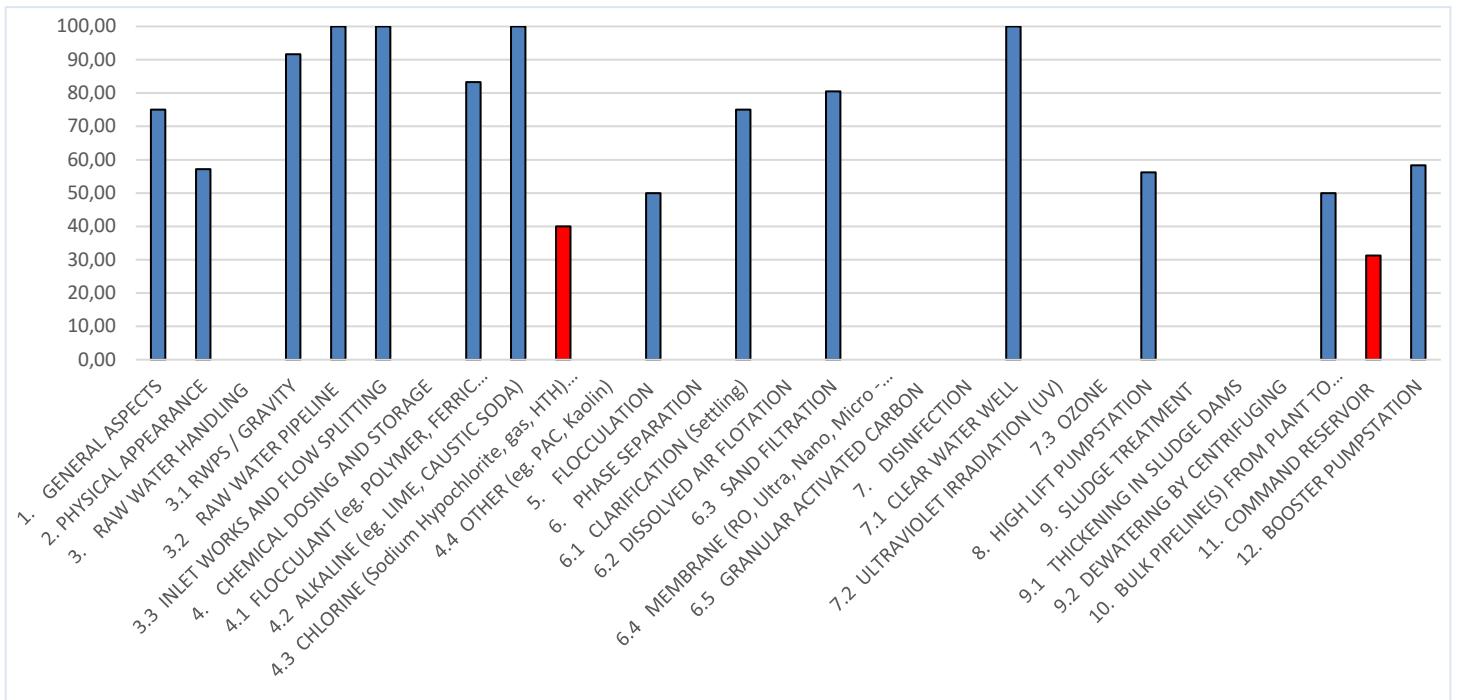
Performance Profile

The following process units were inspected and rated according to the % score on the y-axis. Process units that score <50% are marked in red and needs urgent intervention.

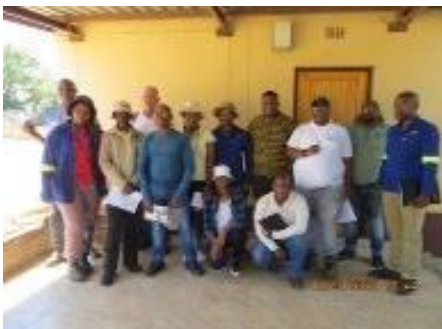
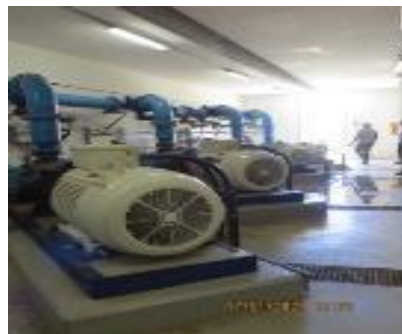
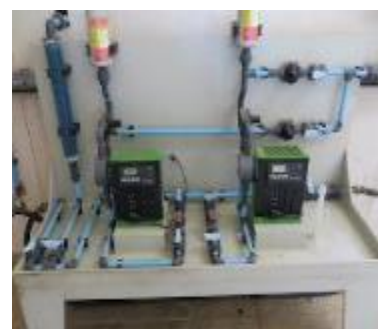
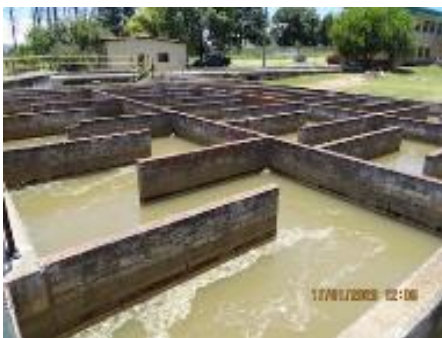
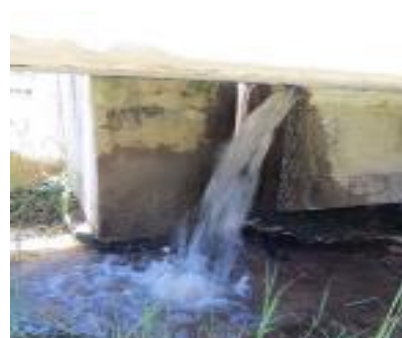
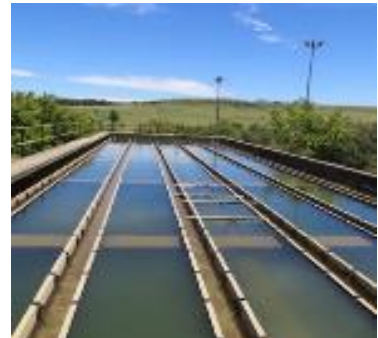
1. The plant is operated at >150% of the design capacity
2. Excessive leaks were observed and must be attended to urgently
3. No risk management in place
4. Monitoring programmes aligned with SANS 241 must be implemented immediately
5. Outflow meters must be repaired. Standby pumps at the booster pump stations must be repaired / replaced
6. Safety at the chlorine dosing facility needs urgent attention. Scales must be repaired.

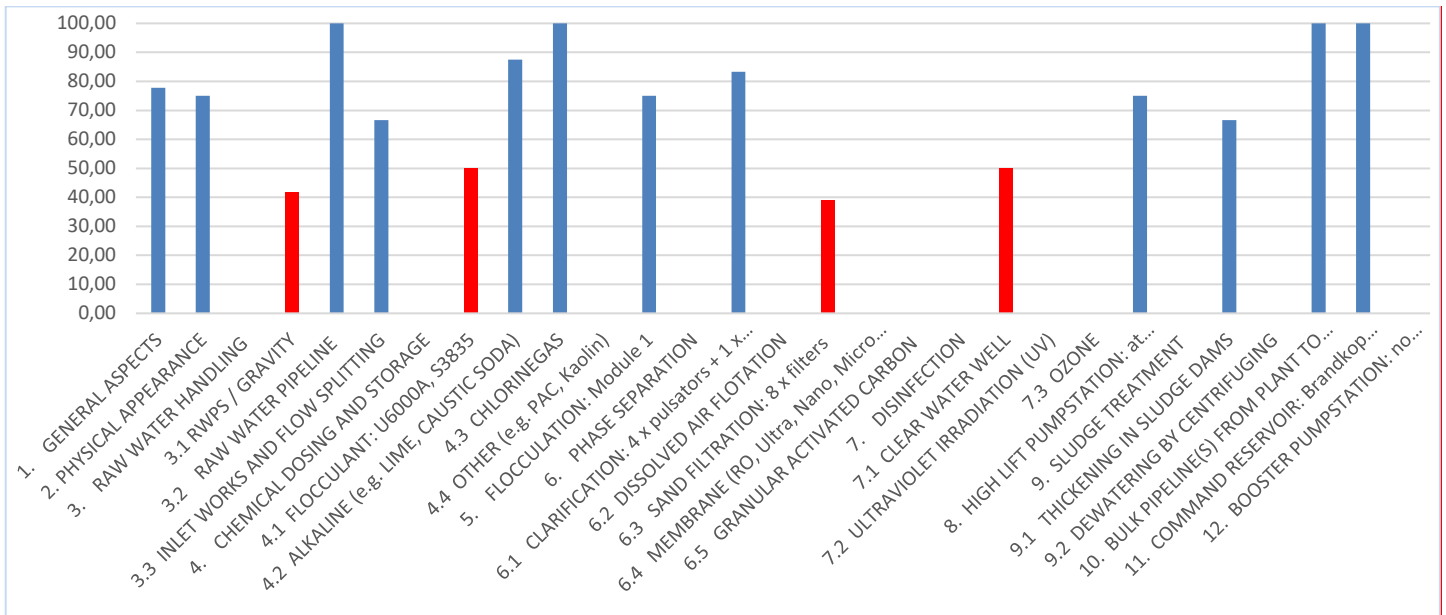
Performance Profile

The following process units were inspected and rated according to the % score on the y-axis. Process units that score <50% are marked in red and need urgent intervention.

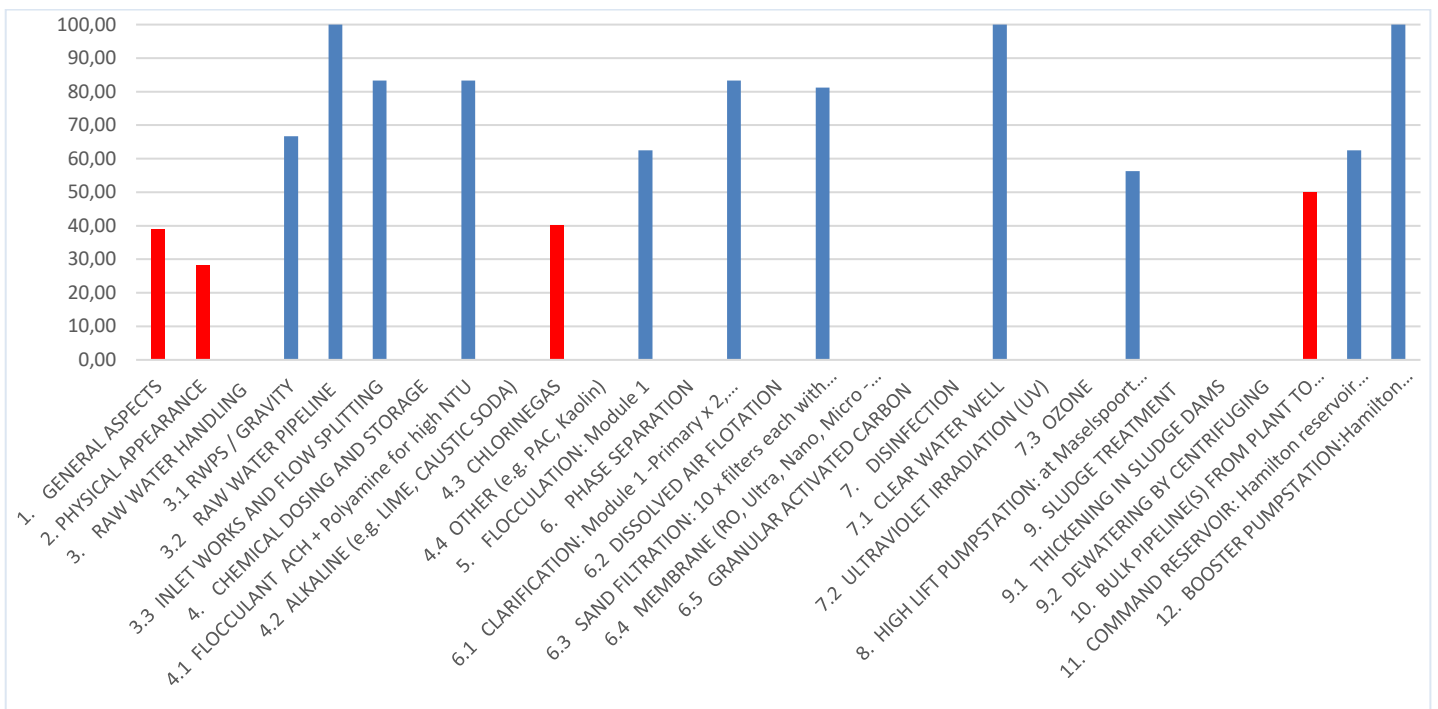
Performance Profile

The following process units were inspected and rated according to the % score on the y-axis. Process units that score <50% are marked in red and need urgent intervention.

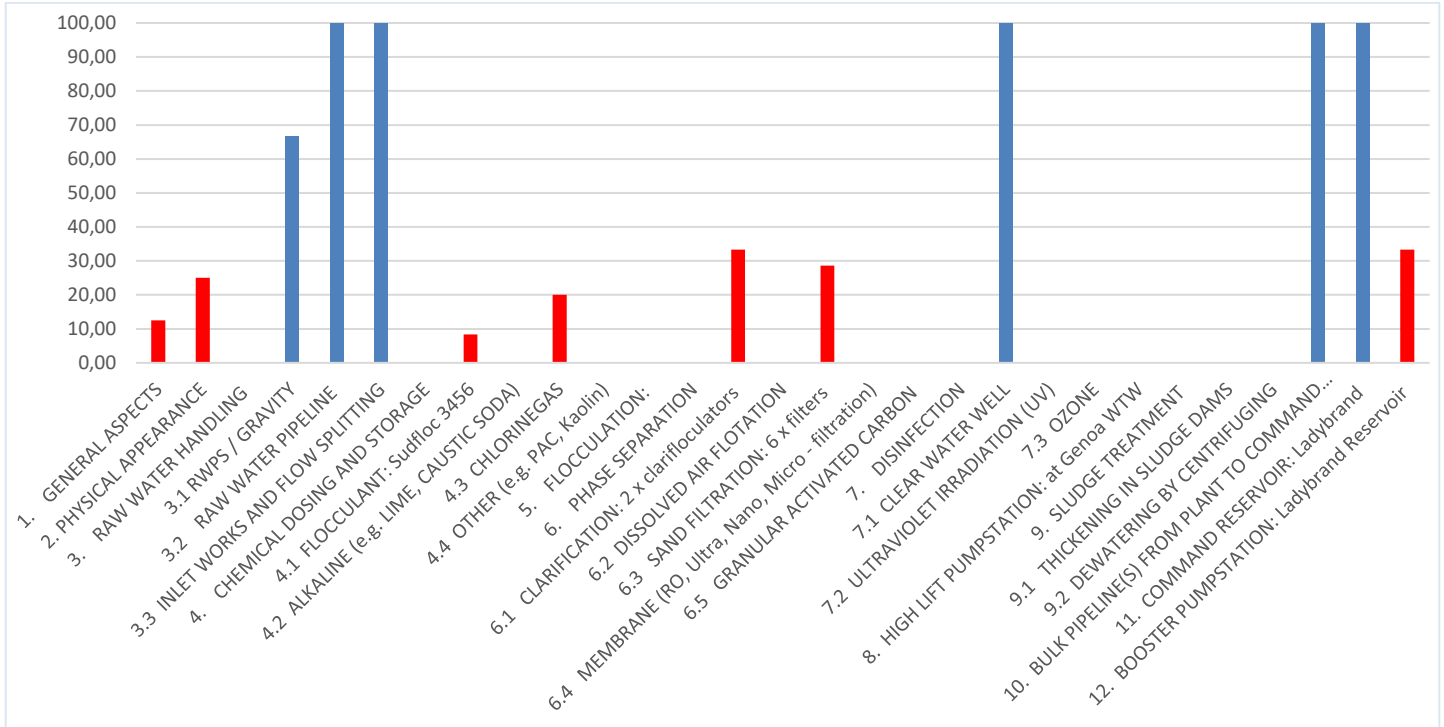
Performance Profile

The following process units were inspected and rated according to the % score on the y-axis. Process units that score <50% are marked in red and need urgent intervention.

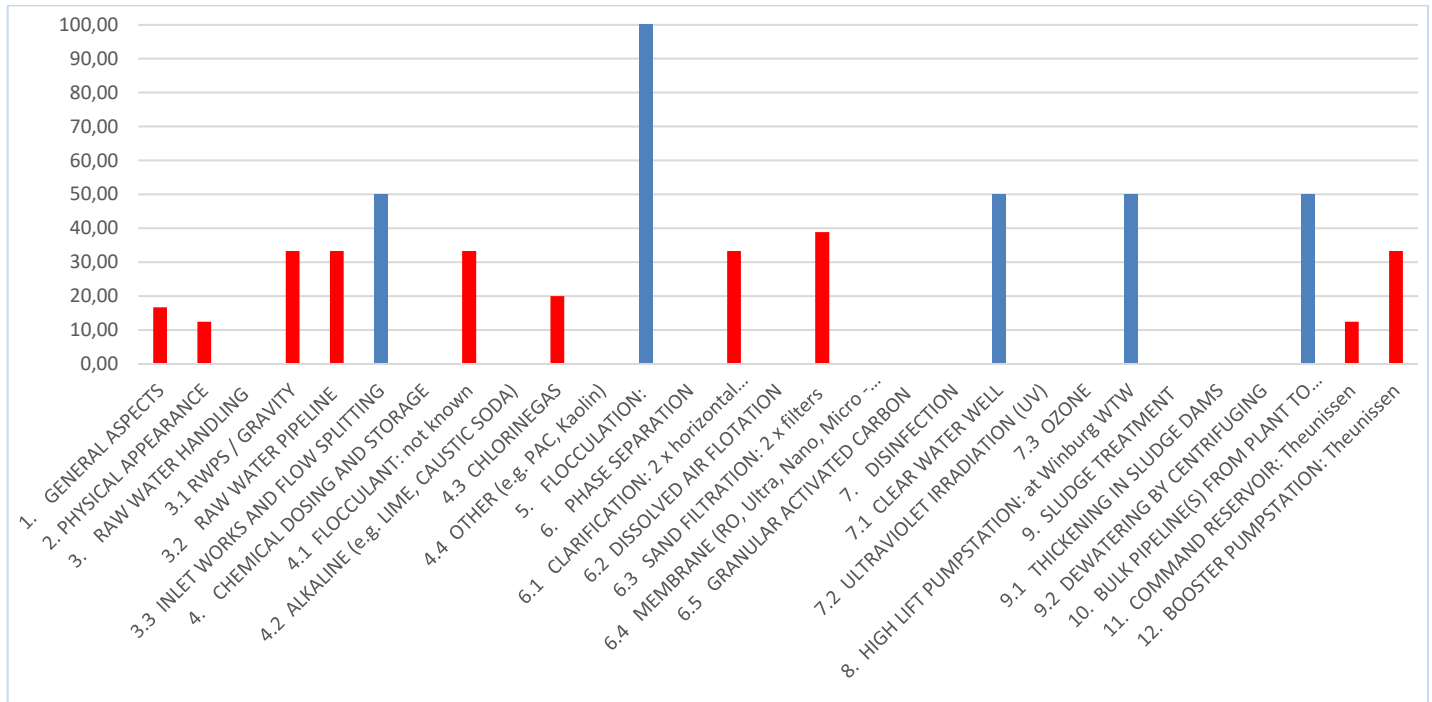
The following process units were inspected and rated according to the % score on the y-axis. Process units that score <50% are marked in red and need urgent intervention.

Watch #	Process Unit Assessed	% TSA	Observations
1.	General aspects	16.6	Lack of documents: certificate, O&M manual, maintenance records, Process flow diagram, emergency contact details. Ph meter, Turbidity meter and chlorine meter on site, No proof of calibration. Jar test conducted but no proof of results

2.	Physical appearance	12.5	The site and garden are extremely bad: overgrown with vegetation, large holes, building rubble, old equipment and pipes, empty chemical containers, litter. No safety signs or safety equipment. Worker's facilities are in an extremely bad condition: one toilet and shower that is flooded, no lights.

3.	Raw water handling		
	Rwps / gravity	33.3	No screens in place, lack of standby submersible pump, lack of inflow meter, dosing not taking place at highest turbulence.
	Raw water pipeline	33.3	
	Inlet works and flow splitting	50.0	
4	Chemical dosing and storage		
	Flocculant (polymer)	33.3	New chemical dosing unit not been commissioned. Old chemical dosing house in extremely bad condition: only 1 dosing pump, day tank not covered, filled with empty chemical containers, building rubble, broken equipment, no bunded walls, no emergency eye wash.
	Chlorine gas	20.0	The chlorine facility is in total disrepair: broken windows, walls covered with mould, building foundation is cracking, only 1 chlorinator, no safety signs, no balance scales, no chlorine gas on site and using sodium hypochlorite dosed directly from drum.
5	Flocculation	100.0	Good floc formation observed, and second flocculation channel was drained for cleaning.

6	Phase separation		
	Clarification	33.3	"New Clari-flocculator" stripped for refurbishment. Old sedimentation tanks show floc carryover, algal growth on weir plates, and high sludge blanket.
	Sand filtration:	38.8	Filter/chlorination building in extremely bad state: mould covered walls, filled with old rusty equipment and many empty chemical dosing drums. Filter media cracked and uneven bubble distribution
7	Disinfection		
	Clear water well	50.0	Clear water well is in room adjacent to the filter gallery. Walls are covered in mould; room is filled with empty chemical containers and rusted equipment. Clear water well is left open; there is very high risk of contamination of water!
8	High lift pumpstation: at WTW	50.0	Duty standby pumps, no flow meter.
9	Sludge treatment		
	Thickening in sludge dams	0.0	No wash water recycling, sludge lagoons have never been cleaned.
10	Bulk pipeline(s) from plant to command reservoir	50.0	Pipeline in adequate condition, no inspections of valve chambers

11	Command reservoir: Theunissen	12.5	No security. Fence is broken and there have been incidents of theft and vandalism, all telemetry components stolen, no flow meters, one reservoir is not in use due to leaking. Lids in place. High lift tower no longer in use.
12	Booster pumpstation: Theunissen	33.3	Only 1 pump. Building was locked, no signage in place.
	Total	30%

1. New filter gallery to be built, current building is structurally not sound
2. New Chemical dosing facility to be completed and commissioned
3. Chlorine dosing facility to be built, current facility is totally broken
4. Sedimentation tank to be refurbished; currently using old sedimentation tanks
5. Inlet work to be upgraded with hydraulic jump and flocculation channels.

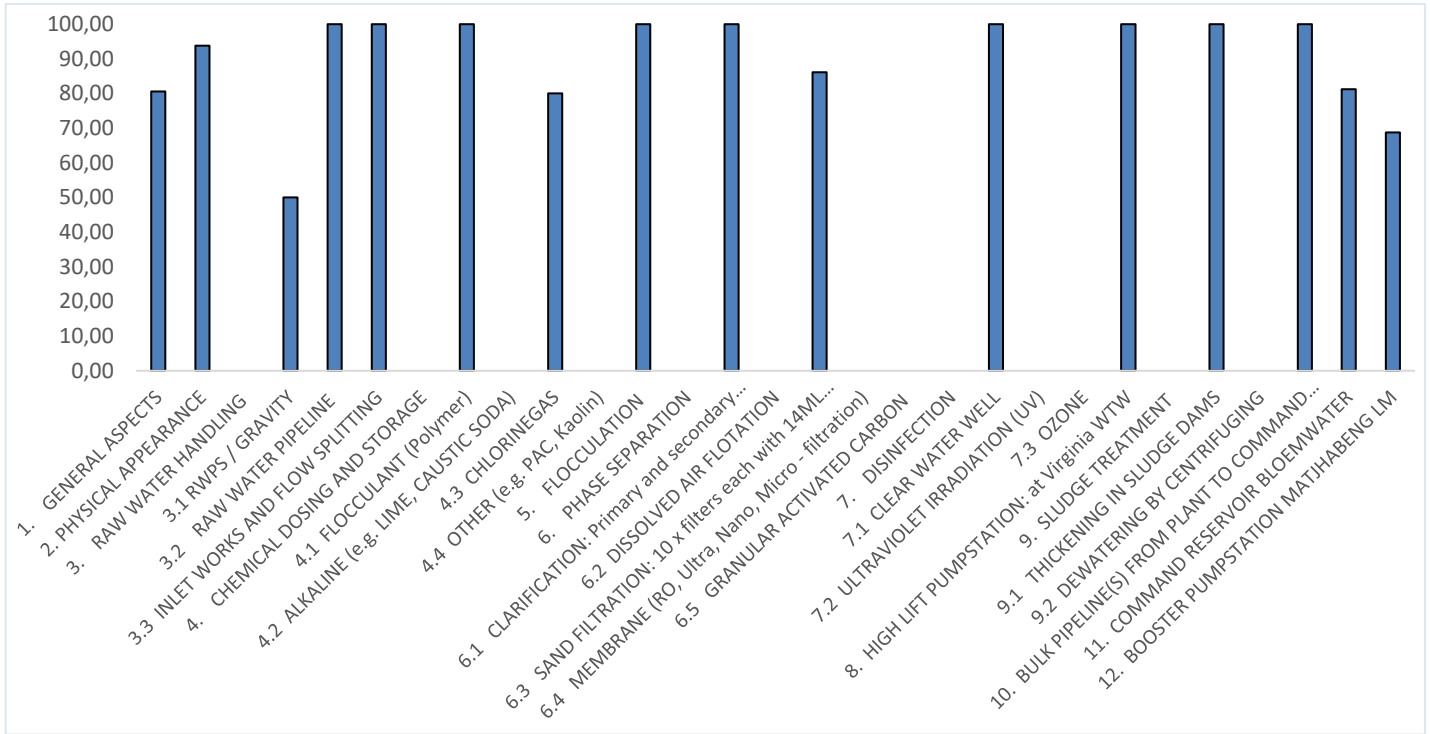
The following process units were inspected and rated according to the % score on the y-axis. Process units that score <50% are marked in red and need urgent intervention.

Watch #	Process Unit Assessed	% TSA	Observations
1.	General aspects	80.9	Class A plant, Excellent telemetry system for whole plant with detailed log sheets for flowmeters, stock levels, reservoir levels, pumps, etc, operational monitoring in place. Process flow diagram not displayed

Sand filtration: 10 x filters x 14ML capacity each	86.1	50% backup for backwash pumps, 100% backup for blowers, regular backwashing in response to turbidity, even bubble distribution, sand in good condition, filter gallery in excellent condition, routine disinfection of filters. 4/10 filters are not working.
7	Disinfection		
	Clear water well	100.0	Sufficient contact time in reservoir, final sample collected before distribution
8	HIGH LIFT PUMPSTATION: at Virginia WTW	100.0	Duty standby pumps, final water flow meters and telemetry system to control pumps.
9	Sludge treatment		
	Thickening in sludge dams	100.0	4 sludge dams, use two at a time, duty standby sludge pumps to return supernatant to head of works
10	Bulk pipeline(s) from plant to command reservoir(s): Bloemwater	100.0	Pipeline in good condition, routine maintenance plan for pipe network, valve chambers and reservoirs.
11	Command reservoir Bloemwater	81.2	24 hr security, fenced, good condition with lids, no visible cracks or leaks, flow meters in place, Telemetry system to monitor reservoir levels, control pumps. Requires grass cutting, cannot access reservoir.

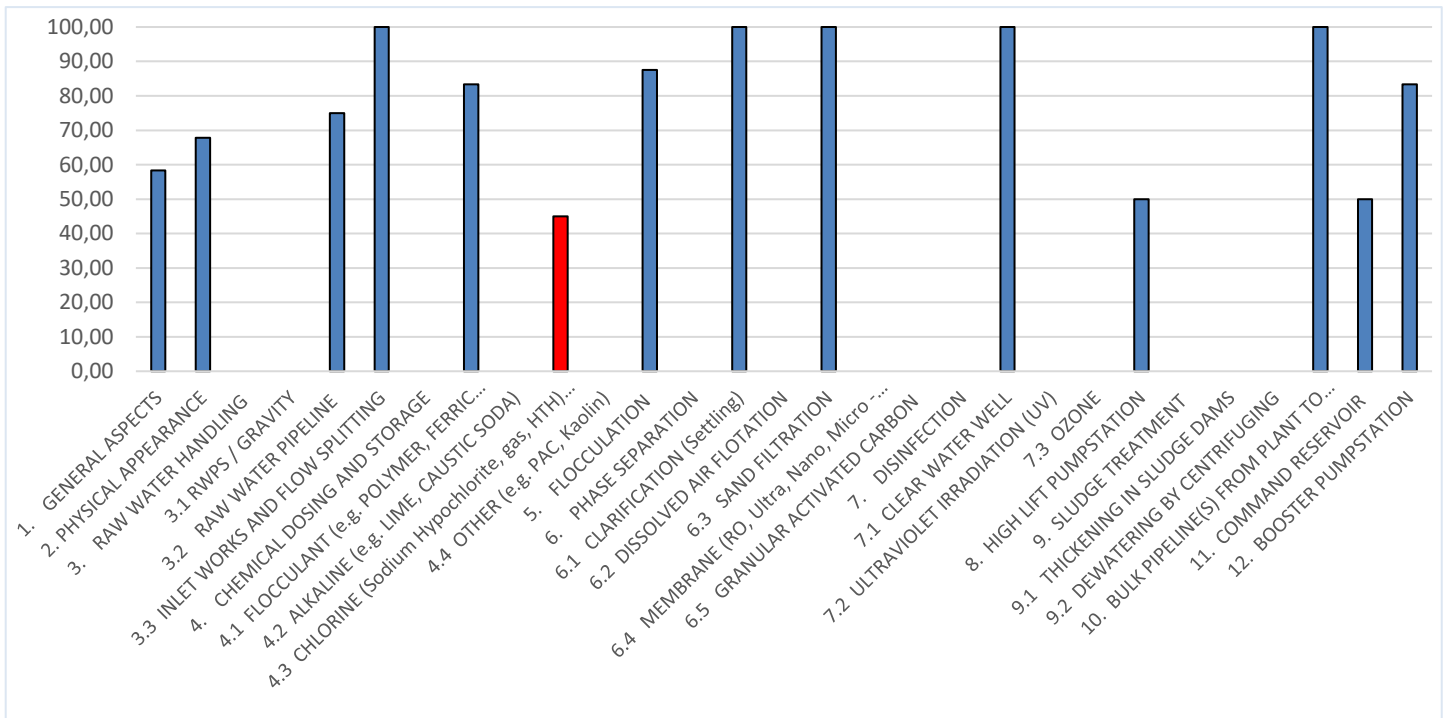
The following process units were inspected and rated according to the % score on the y-axis. Process units that score <50% are marked in red and needs urgent intervention.

Watch #	Process Unit Assessed	% TSA	Observations
1	General aspects	58.3	Class C plant. No drawings of the plant available. O&M manual and IMP available. Operational logbook with recent entries. No Maintenance and Repairs logbook. Turbidity and Chlorine meters on site, Jar tester at main laboratory.
2	Physical appearance of plant	67.9	Access to the plant is restricted. All roads are paved. Site is fairly clean, but grass should be cut. Grass growing on pavement to be removed. Only a few safety signs are visible at relevant areas on the plant.
3	Raw water handling		
	Raw water pumpstation/ gravity feed	NA	The raw water pump is at the Vaal Dam and managed by DWS.
	Raw water pipeline	75.0	The pipe is underground, but no faults / leaks were reported. Both flow meters functional, but not calibrated. Flow rate is recorded daily but not converted and interpreted or used for process control purposes.
	Inlet works	100.0	No splitting at the inlet work. Valves are opened when new packaged plant is used during times of high demand. Hydraulic jump where flow enters the works – sufficient turbulence at the contact point. Visual dripping of flocculant could be seen at the hydraulic jump.

4	Chemical dosing and storage		
	Flocculant	83.3	Only one dosing pump is used and in a working condition. Feeding tube to be replaced. A standby dosing pump is available on site. The area is neat, clean and any spillages are cleaned by hand should they occur. Bunded area available. Storage facility of 15 tons sufficient for 8 to 10 weeks. An emergency wash is situated outside the storage and dosing facility.
	Chlorine	45.3	Sodium Hypochlorite. Order a new delivery as soon as previous order is delivered. Dosing pump installed in a working order, dose granular HTH at filter outlets as standby measure. Only standard PPE available, closest shower available at main building.
5	Flocculation	87.5	Good floc formation with little scum at the wall of the flocculation unit.
6	Phase Separation		
	Clarification (settling)	100.0	No floc carry-over during the site visit. Desludging of the units are done daily, with sludge removal once per month. The weirs are in a good condition with even overflow.

Sand filtration	100.0	The filters and filter media are in good condition - all handrails in place. Backwashing frequency of every morning, more often with high turbidity. Backwash was performed during the site visit with even bubble distribution. Backwash pumps and air blowers are installed and in working condition with a 100% standby available.
7	Disinfection		
	Clear water well	100.0	At 9,9 MI/d should the package plant is used to capacity, the contact time for the 4 MI reservoir is 9 hours. Chlorine is dosed at entry of filtered water into CWW. Flows through reservoir and then measured at an outside tap.
8	High lift pumpstation	50.0	Six pumps installed, 2 not functional. Water is pumped to two reservoirs, with only 2 pumps available for each line. Standby pumps not available. Flow meter operational but not calibrated, flow records captured daily but not used.
9	Sludge treatment		
	Thickening in sludge dams	0.0	Sludge pond downstream of the Vaal Dam wall, overflowed and drains into the river.

10	Bulk pipeline from plant to command reservoir	100.0	Pipe network reported to be in a good condition.
11	Command reservoir	50.0	Water is pumped directly to two reservoirs in the distribution system. Reservoirs visited secure. No telemetry, level indicator of older reservoir not working. Level indicated by water leaking from the reservoir. Flow meter in place but almost impossible to read.
12	Booster pumpstation	83.3	The pumpstation is situated at the reservoirs, fenced and with security. Three pumps installed, two was running at time of the visit. Leaks visible at both pumps. A 50% standby available.
	Total	72.0

- Liquid chlorine dosing facility not working at all
- Two of the six high lift pumps not operational restricting pumping capacity during high demand
- No sludge handling - sludge ponds downstream of the Vaal Dam wall overflows directly into the river
- Major water leakages at pumpstation visited, some at the pumps and others in the valve box
- No maintenance logging procedure to inform the maintenance team of breakdowns, deficiencies, etc.
- No telemetry at reservoir and level indicator of old reservoir not working. Flow meter at the outflow of the reservoir not accessible.

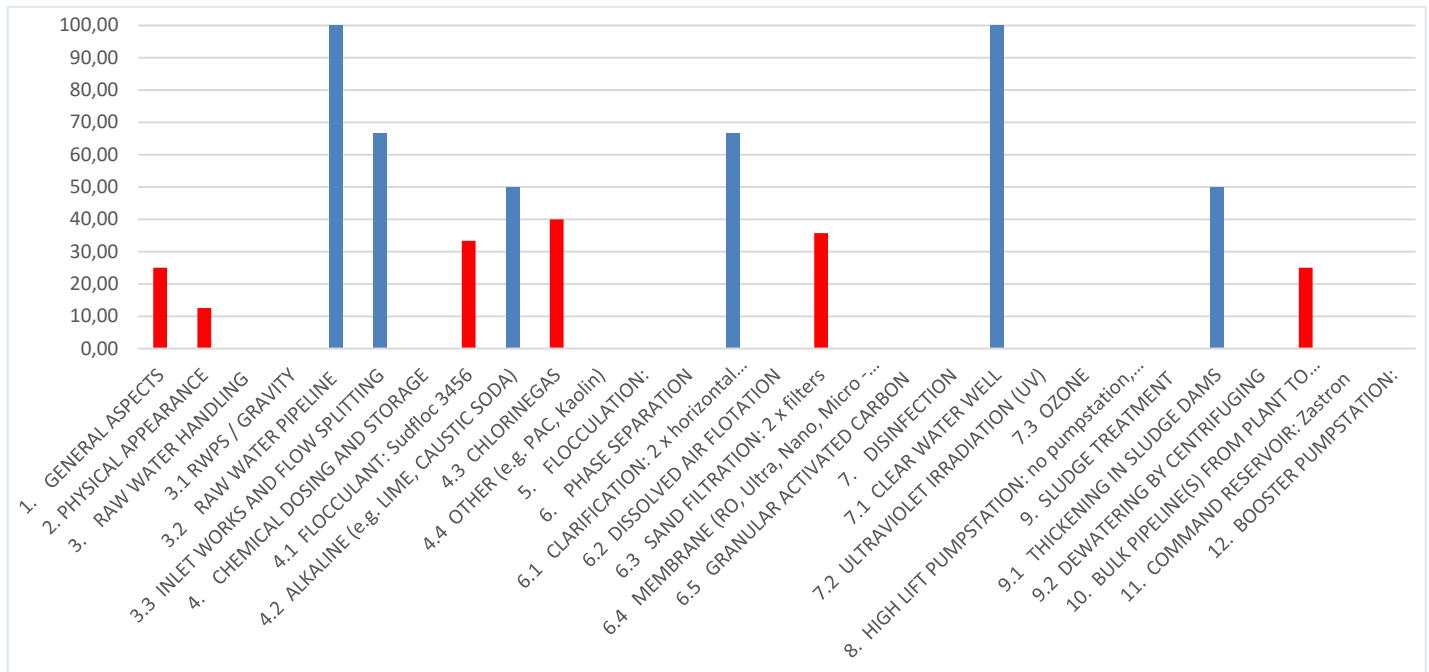
The following process units were inspected and rated according to the % score on the y-axis. Process units that score <50% are marked in red and need urgent intervention.

Watch #	Process Unit Assessed	% TSA	Observations
1.	General aspects	25.0	Certificate and O&M Manual provided. Lack of following documents: maintenance records, Process flow diagram, emergency contact details. Only one log sheet on site, Turbidity and Free Chlorine meter working, Colour/EC/PH meter not working, no record of calibration, no Jar Tests.

2.	Physical appearance	12.5	The site and garden in poor condition, no general workers so grass is not cut, old equipment lying around, heaps No security, gate is always open, and cows grazing on site. Worker's facilities are in very poor condition: one toilet with no door, office. No bathrooms, kitchen, place to eat. There is no drinking water on site!

6	Phase separation		
	Clarification	66.7	Clari-flocculator in good working condition with clear overflow. Clarifier 2 is filled with sludge and clear signs of floc carryover: automatic desludge not working, process controllers indicated manual desludge not working but was found to be operational.
	Sand filtration:	35.7	Lack of backup blower, uneven bubble distribution, uneven flow splitting, filter media is cracked and has mounds. Bags of silica sand lying around on site but not used to replace filter sand.
7	Disinfection		
	Clear water well	100.0	3 x 900kl reservoir on site with lids; require upgrade to repair civil structure.
8	High lift pumpstation: at WTW	0.0	Gravity feed to network, no flow meters in place to verify plant production.
9	Sludge treatment		
	Thickening in sludge dams	50.0	Two wash water basins filled with sludge, drying beds filled with sludge and weeds.
10	Bulk pipeline(s) from plant to command reservoir	25.0	Pipeline in adequate condition, no inspections of valve chambers

1. Chemical dosing pumps to be repaired
2. Automatic desludge on sedimentation tank to be repaired and routine desludging to resume in response to turbidity
3. Chlorination unit must be upgraded: install balance scales, standby chlorinators, automatic switchover, safety signs and equipment
4. Filters to be refurbished: repair/replace broken nozzles, replace sand, install backup for blowers
5. Build staff facilities: toilet, bathroom with supply of water, kitchen, change rooms.

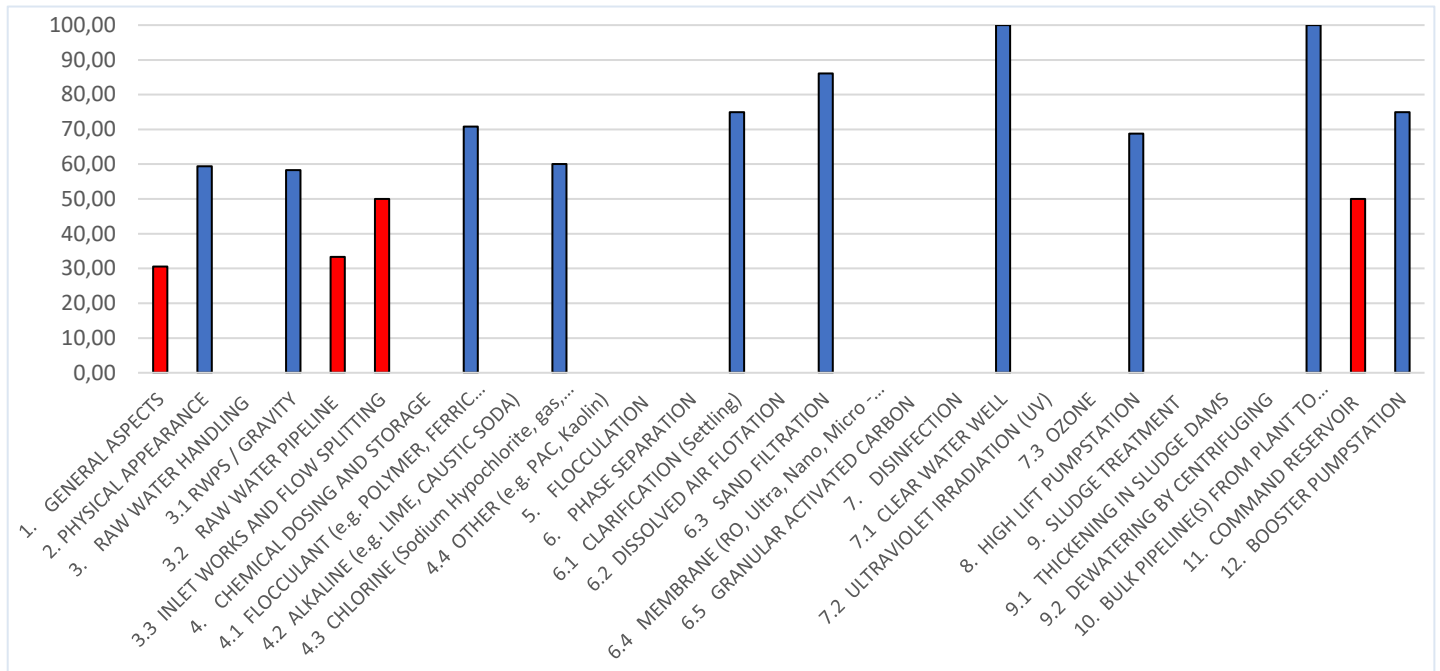
The following process units were inspected and rated according to the % score on the y-axis. Process units that score <50% are marked in red and needs urgent intervention.

Watch #	Process Unit Assessed	% TSA	Observations
1	General aspects	30.5	Class C plant, repairs logbook not available, Operational logbook is available, The O&M manual and process flow diagram are not available onsite. The emergency contact list was displayed onsite. The monitoring equipment are available and operational, not calibrated. Jar testing is not done onsite. Electricity meter is not available as this belongs to Eskom
2	Physical appearance of plant	59.3	The state and tidiness of the garden and terrain is in good condition. There were no serious OHS contraventions in the past year. The plant is fenced. Safety signs are displayed mainly around the Chlorine room.
3	Raw water handling		
	Raw water pumpstation/gravity feed	58.3	There are screens at the pumpstation but partially underwater. One pump at the pumpstation is operational.
	Raw water pipeline	33.3	The Raw water pipeline is in good condition. Two inflow meters and are not in operation. The inflow volumes are not recorded.

Inlet works	50.0	The flow is splitting evenly, and it was observed onsite, into vertical pipe that goes to each of the clari-flocculators and old settling tank. Flash mixing is not effective. Flocculent was observed but seemed too high with a continuous flow and not dripping
4	Chemical dosing and storage		
	Flocculant	70.8	There are four dosing pumps however only one pump is used at time. The dosing area was neat. The storage volume can last up to 30 days. Dosing with Polymer. The emergency shower is closer to the chlorine dosing area
	Chlorine	60.0	All the dosing units are in operation. Redundant equipment needs to be removed. The two pumps placed on top of each other need proper installation. e scale is not in operation, no auto changeover. There is no alarm or detector, extractor fan is installed but not operational. A mask is available but not in a good condition and filter missing. No BA equipment. Sufficient for 30 days. Chlorine gas is used for dosing. They also have an alternative disinfection system with the use of HTH chips. This installation is over a clear well and not acceptable

6	Phase Separation		
	Clarification (settling)	75.0	There was minimal floc observed at weirs to all three units. Desludging is done automatic, except for the old settling tank. The weirs are in good condition (level) and there is some scum and algal growth observed.
	Sand filtration	86.1	There is one backwash pump and in operation. There are two blowers installed and working, however the one blower does not have its air filter installed. Even flow splitting was observed into all filter beds. Backwashing is dependent on the Raw water turbidity, but generally done daily here are no cracks however there are small impressions left on the surface after backwashing. This could be caused but the blower flow and or pressure and or the backwash pump volume or pressure being too high.
7	Disinfection		
	Clear water well	100.0	Contact time in on-site reservoir is more than 30 minutes. The free chlorine is measured from the pipeline and used as final sample point of works

8	High lift pumpstation	68.7	There are a total of four pumps. The combination is two smaller pumps and two larger pumps, the configuration is one duty and one standby. One of the larger pumps have been removed and therefore non-operational. Final flow meter is operational. The flow volume is recorded but no interpretation.
10	Bulk pipeline from plant to command reservoir	100.0	The Raw water pipe network are in good condition.
11	Command reservoir	50.0	The reservoir is in a fenced secure area with security guard. Telemetry is not in place. No final meter at the reservoir. There are no cracks on the structure.
12	Booster pumpstation	75.0	The pump configuration is two duty and one standby. There was loadshedding at the time therefore running condition undetermined, hearsay. The building is secure, signage in place, and adequately fenced with sufficient ventilation. The MCC is in good condition.

1. Raw water abstraction needs upgrading to secure water supply to the plant therefore the community
2. The clear (final) water reservoir leak needs urgent attention as plant cannot run at full capacity.

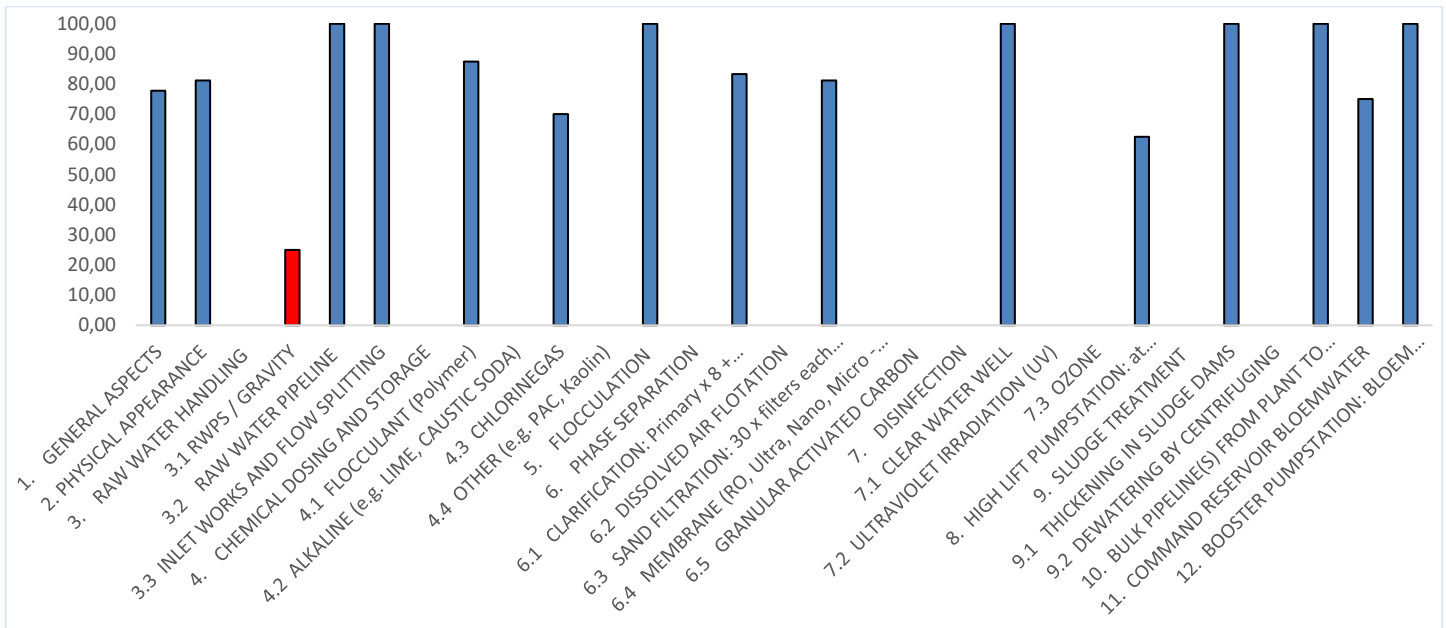
The following process units were inspected and rated according to the % score on the y-axis. Process units that score <50% are marked in red and need urgent intervention.

Watch #	Process Unit Assessed	% TSA	Observations
1.	General aspects	77.8	Class A plant, Excellent telemetry system for whole plant with detailed log sheets for flowmeters, stock levels, reservoir levels, pumps, etc, operational monitoring in place. Process flow diagram not displayed

Sand filtration: 30 x filters x 14ML capacity each	81.2	50% backup for backwash pumps and blowers, regular backwashing in response to turbidity, even bubble distribution, sand in good condition, filter gallery in excellent condition, routine disinfection of filters. 6/30 filters are not working.
7	Disinfection		
	Clear water well	100.0	Sufficient contact time in reservoir, final sample collected before distribution
8	High lift pumpstation: at Balkfontein WTW	62.5	Insufficient backup as 3 pumps not working, final water flow meters and telemetry system in place to control pumps.
9	Sludge treatment		
	Thickening in sludge dams	100.0	4 sludge dams, use two at a time, duty standby sludge pumps to return supernatant to head of works
10	Bulk pipeline(s) from plant to command reservoir(s): Bloem water	100.0	Pipeline in good condition, routine maintenance plan for pipe network, valve chambers and reservoirs.

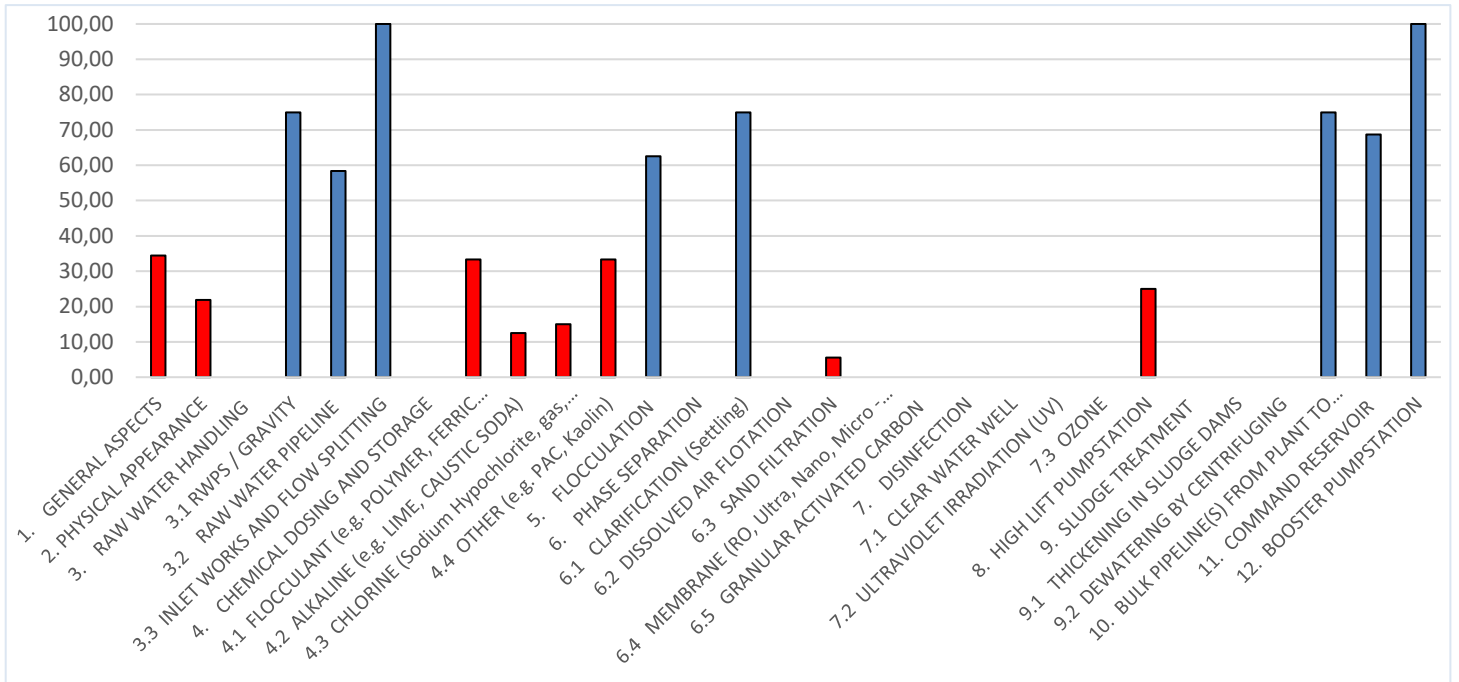
The following process units were inspected and rated according to the % score on the y-axis. Process units that score <50% are marked in red and needs urgent intervention.

Watch #	Process Unit Assessed	% TSA	Observations
1	General aspects	34.4	Class B plant. Operational logbook available with recent entries. O&M manual, IMP, and PFD not available. Some monitoring instruments functional, no proof of calibration. A newly build laboratory equipped with new instruments and reagents on site, but not in use.
2	Physical appearance of plant	21.9	Fence needs maintenance, but site is not accessible to public or stray animals. Refurbishment of the plant not completed, contractor left the site and processes not optimal, causing frustration under staff. The site is not maintained although equipment is available.
3	Raw water handling		
	Raw water pumpstation/ gravity feed	75.0	Screen needs to be replaced, cleaned daily, hyacinth growth evident after screens. Pump in working condition but not in use currently (gravity fed), with 100% standby available.
	Raw water pipeline	58.3	Pipeline in a good condition. No flow meter, measure the height of the water. Results are recorded and converted daily, but no indication that the flow data is interpreted and used to adjust processes.

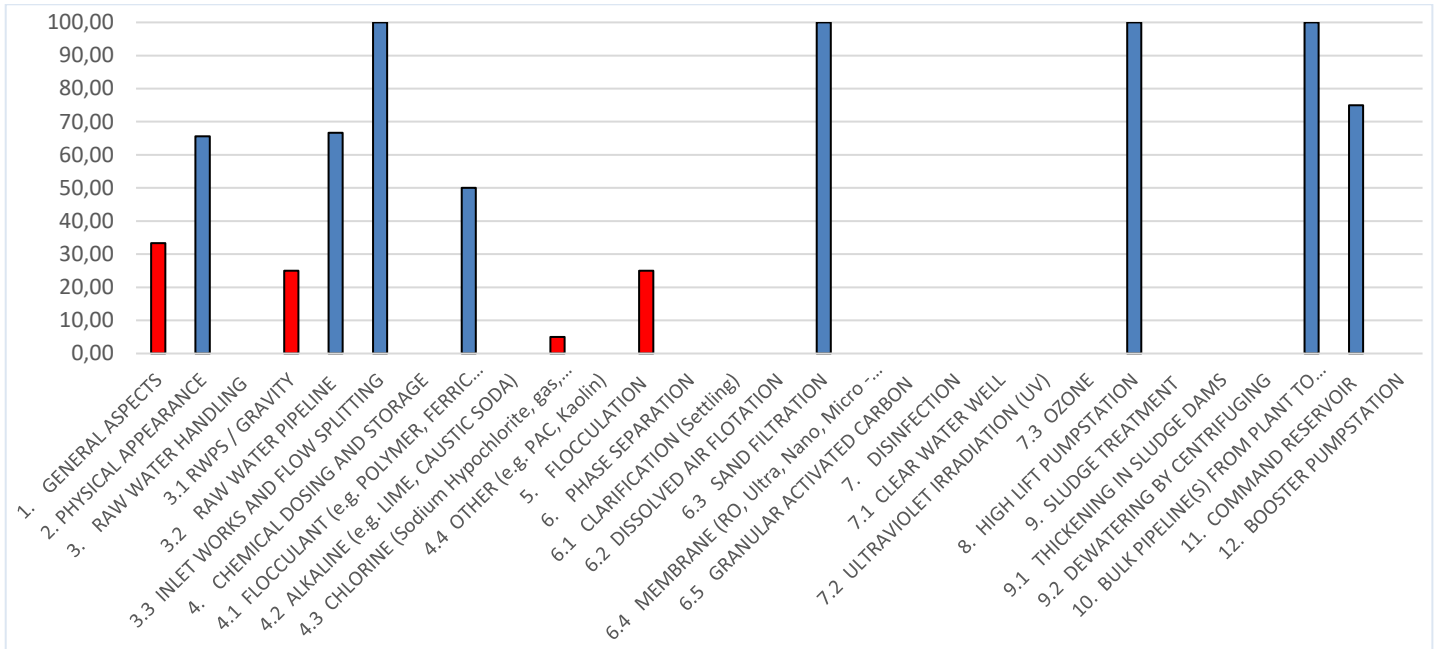
The following process units were inspected and rated according to the % score on the y-axis. Process units that score <50% are marked in red and need urgent intervention.

Watch #	Process Unit Assessed	% TSA	Observations
1	General aspects	33.3	Class C plant, operational logbooks in place but no signage at entrance.
2	Physical appearance of plant	65.6	The state of the garden and terrain is not good. Only certain areas where they normally have to have access is kept clean & tidy otherwise the area within the plant is unkept.
3	Raw water handling		The main pump station is in very poor state with paint peeling off the walls. Only one pump set of two pump sets installed is working. The raw water pipeline is new therefore there are no leakages.
	Raw water pumpstation / gravity feed	25.0	
	Raw water pipeline	66.6	
	Inlet works	100.0	
4	Chemical dosing and storage		The dosing area is not neat and there are signs of spillages and lime powder.
	Flocculant	50.0	
	Chlorine	5.00	
5	Flocculation	25.0	M70 POLY is used. The flocculation unit has some algae growth and sludge settling is taking place.

6	Phase Separation		The settling tank is battling and at risk. It is overloaded with sludge build-up scum formation, lamella plated totally overloaded with sludge. There is an original alternative clari-flocculator and settling unit that is not being use and believe this needs to be reinstated and assist with the current ineffective process unit and can run in parallel.
	Clarification (settling)	58.3	Backwashing is done twice per shift
	Sand filtration	8.3	Two backwash pumps in good working condition, One in operation, one on standby.
7	Disinfection		Not assessed
	Clear water well	-	
8	High lift Pumpstation	100.0	All pumps are in good working condition and the outflow meter is operational
9	Sludge Treatment	0.0	Dewatering is taking place in a small sump next to the filter building. This unit is unkept and overgrown with gras
10	Bulk pipeline from plant to command reservoir	-	The raw water pipeline has no leakages, this is within the plant area

11	Command reservoir	75.0	The reservoir is fenced as part of the treatment plant. The final flow meter is available and working. There are no leakages on the structure
11	Booster pumpstation	-	Not assessed
Total		55%
