BLUE DROP

Watch Report

BLUE DROP WATCH REPORT 2023: TECHNICAL ASSESSMENT OF THE CONDITION OF MUNICIPAL DRINKING WATER TREATMENT AND DISTRIBUTION SYSTEMS IN SOUTH AFRICA

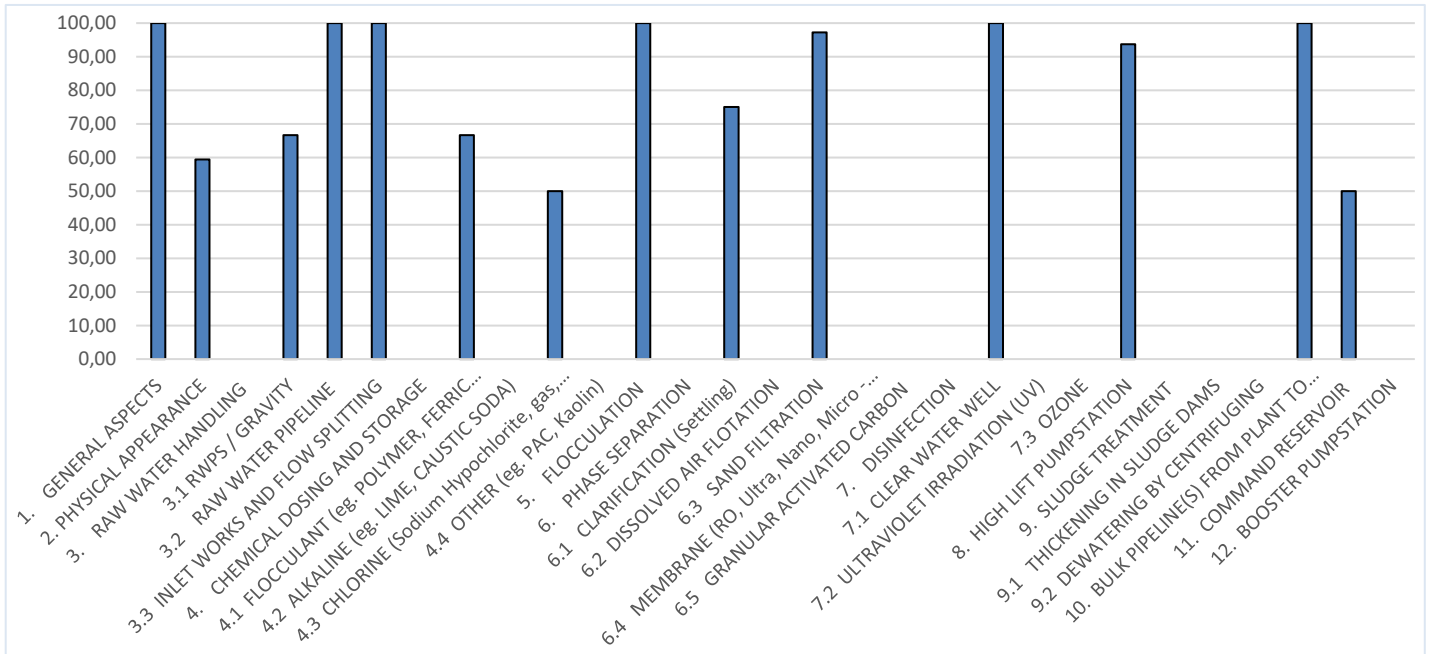
The following process units were inspected and rated according to the % score on the y-axis. Process units that score <50% are marked in red and needs urgent intervention.

Watch #	Process Unit Assessed	% TSA	Observations
1	General aspects	100.0	The recordkeeping at the plant is commendable. All logbook entries were up to date, information systematically filed and quarterly reports available. The plant classification certificate, IMP with contact numbers and PFD all displayed. Laboratory equipment is available, calibrated and results recorded. Jar tests are conducted, and results reported.
2	Physical appearance of plant	59.4	The access road to the plant poses challenges during rainy season. The plant is fenced with access control. No institutional information is provided at the entrance. Safety signage at the plant is not sufficient. Bathrooms and lunch facilities were clean and tidy, except for items stored on top of lockers. Maintenance of the site needs improvement.
3	Raw water handling		
	Raw water pumpstation/ gravity feed	66.7	Screens are installed at both abstraction points. Standby arrangements are in place at both the Caledon and Meulspruit pump stations. At the Caledon pump station two pumps have been out of service for an extended period. These pumps need to be repaired urgently.

Raw water pipeline	100.0	Raw water pipe network reported to be in good condition. Abstraction is measured and recorded. No evidence is available for calibration / verification of the meters.
	Inlet works	100.0	The outlets from the two on-site raw water reservoirs merge into a single inlet to the plant. Chemical dosing is done in line. Dosing pump delivery is verified.
4	Chemical dosing and storage		
	Flocculant	66.7	Two different coagulants are kept on site due to variations in raw water turbidity. Each system is fitted with a dosing pump, which is inter-changeable. The dosing area was clean and tidy with no evidence of spillage. Adequate stock was available on site. The area is not bunded. An emergency shower must be provided close to the dosing area.
	Chlorine	50.0	Gaseous chlorine is dosed. Only one cylinder was connected, and no standby equipment is available. The scale is in working condition and the mass is recorded daily. Safety equipment is installed and in working condition. The door of the chlorine room must be kept locked.

5	Flocculation	100.0	Clari-flocculators are used. Floc formation is monitored at the splitter box to clari-flocculators, by doing a beaker test. Good floc formation was observed.
6	Phase Separation		
	Clarification (settling)	75.0	Stirrers and automatic de-sludging are not in working condition. Erosion caused by sand in raw water source is experienced at gate valves, nuts, and shafts. Weirs are in good condition and cleaned according to a routine maintenance schedule. No floc carry-over was observed.
	Sand filtration	97.2	One Moore filter has been out of operation for a long time due to a crack in the structure. Duty and standby backwash equipment are installed and in working condition. Filters are backwashed once every 24 hours. Even bubble distribution was observed during backwash, no cracks were observed, and the media surface appeared even. A schedule is in place for cleaning.
7	Disinfection

Clear water well	100.0	The estimated contact time at design capacity is 42 minutes. Free chlorine is measured at a tap after the contact tanks.
8	High lift pumpstation	93.8	All pumps installed are in working condition with a standby arrangement. The three pumps on the line to the Northern Reservoirs are in very poor condition. Construction of a new line has commenced in October 2022 and pumps and motors are on order, expecting delivery within 3 months. Flow meters installed on the two lines are functional and flow readings are recorded. No proof of calibration / verification was available.
9	Sludge treatment	NA	Sludge and Filter backwash water are discharged into the Caledon River. No alternative option has ever been provided.
10	Bulk pipeline from plant to command reservoir	100.0	The main bulk line feeding the command reservoir is in a good condition.
11	Command reservoir	50.0	The reservoirs are fenced and structurally in good condition. All inspection manholes are properly closed. Telemetry was vandalised at the Northern Reservoirs and out of order at the Meqheleng reservoir. Overflows are experienced at the Meqheleng reservoir.

1. Raw water abstraction pumps at the Caledon River must be repaired
2. Storage area to be bunded
3. Telemetry must be repaired (water losses from overflowing reservoir)
4. Pave the access road to the plant
5. Stirrers and automatic de-sludging to be repaired
6. Alternative arrangements for discharge of sludge and filter backwash water to be investigated.

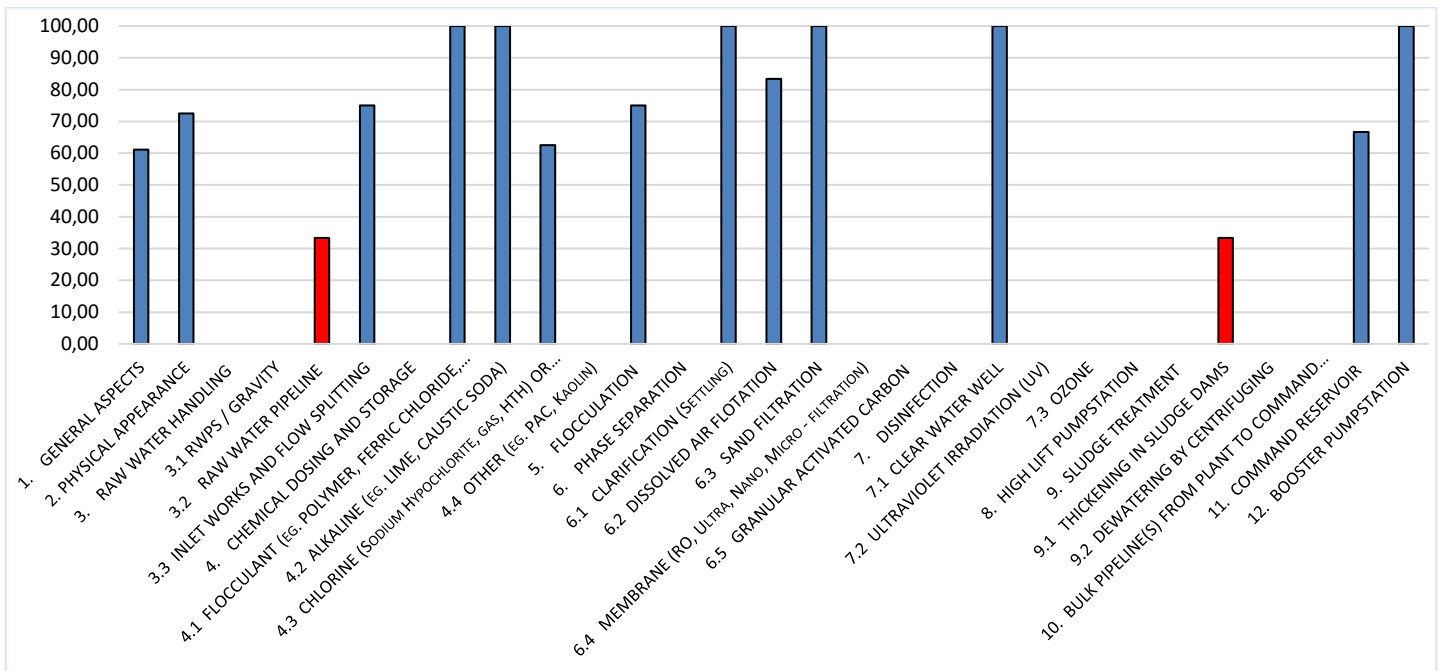
The following process units were inspected and rated according to the % score on the y-axis. Process units that score <50% are marked in red and need urgent intervention.

Watch #	Process Unit Assessed	% TSA	Observations
1	General aspects	61.0	This is a Class C plant. Of the general aspects inspected, process monitoring that should assist the operation of the plant was noted to be the main challenge. The fact that monitoring equipment (e.g., water quality monitoring equipment and jar test) is available but not utilised, is worrying. The ability of the process controller is not a question because the process controller on duty was trained in how to use the equipment and interpret the data. In addition, the aspect of operational monitoring is a regulated one in terms of SANS 241 specification and each water treatment plant is required to do operational monitoring.
2	Physical appearance of plant	72.0	Of the items inspected under Physical appearance: Key items that did not comply to Blue Drop standards is the signage at the entrance. Some parts of the plant have the grass cut and neat whilst some are overgrown with grass and untidy. The road to the plant is tarred, however, continuous heavy rains could easily change the situation.

3	Raw water handling		The raw water handling is generally good. Raw water is stored in a holding dam on site. Raw water pipes are still new as the plant was constructed in 2014. An inlet flow meter is installed though it was not operational on the day of assessment. It was noted that it has not been functioning for about a week. Flows are not recorded though there is an inlet flow meter. Flocculant dosing is conducted manually due to the dosing pumps that are not functioning. The manual dosing is via buckets with holes drilled at the bottom. Monitoring of this process is poor because is not based on the amount of water coming in or the quality of the water.
	Raw water pipeline	33.0	
	Inlet works	75.0	
4	Chemical dosing and storage		Lime dosing is only practiced when there is a need e.g., after heavy rains. Pre-chlorination is conducted manually using HTH granules solution that are mixed in 25L buckets. The solution is dosed via dripping through drilled buckets at the bottom.

Flocculant	63.0	
	Alkaline e.g., Lime	100.0	
	Chlorine	83.0	
5	Flocculation	75.0	Sudfloc 3465 is used. Floc dosing pumps are not functioning, therefore dose manually. Very small flocs were observed. Flocculation channels are cleaned every 3 months.
6	Phase Separation		All the necessary equipment e.g., recycle pumps, compressors, exists with backups, and they are all functional. It is only the saturator that is not functional. It has never been serviced such that the pressure gauge was not working during assessments. There are four filter beds, of which one of them was not operational. The filter bed cannot backwash, therefore was isolated for maintenance. An urgent maintenance of the filter should be carried out to be able to meet the demand.
	Clarification (settling)	100.0	
	Dissolved Air Flotation	83.0	
	Sand filtration	100.0	
7	Disinfection		Chlorine gas is used for post chlorination. Chlorine properly stored in a room with an extractor fan and always sufficient. Do have appropriate PPE on site. The size of the on-site clear water reservoir is 3ML. A 30minutes contact time is estimated to be achieved. However, the assessors were satisfied that disinfectant residual operational test is done via the on-line equipment and results recorded on the log book.

11	Booster pumpstation	100.0	There are four pumps in total - 2 on duty and 2 standbys. All the pumps were in a working condition.
	Total	75%

2. Chemicals such as coagulant and HTH granules for pre-chlorination are dosed manually via dripping method. There are no measured adjustments on the amount dosed because the jar test is not conducted. There is, however, jar test equipment onsite that is not utilised. It is recommended that a jar test is conducted to work out the amount of chemicals to be added.

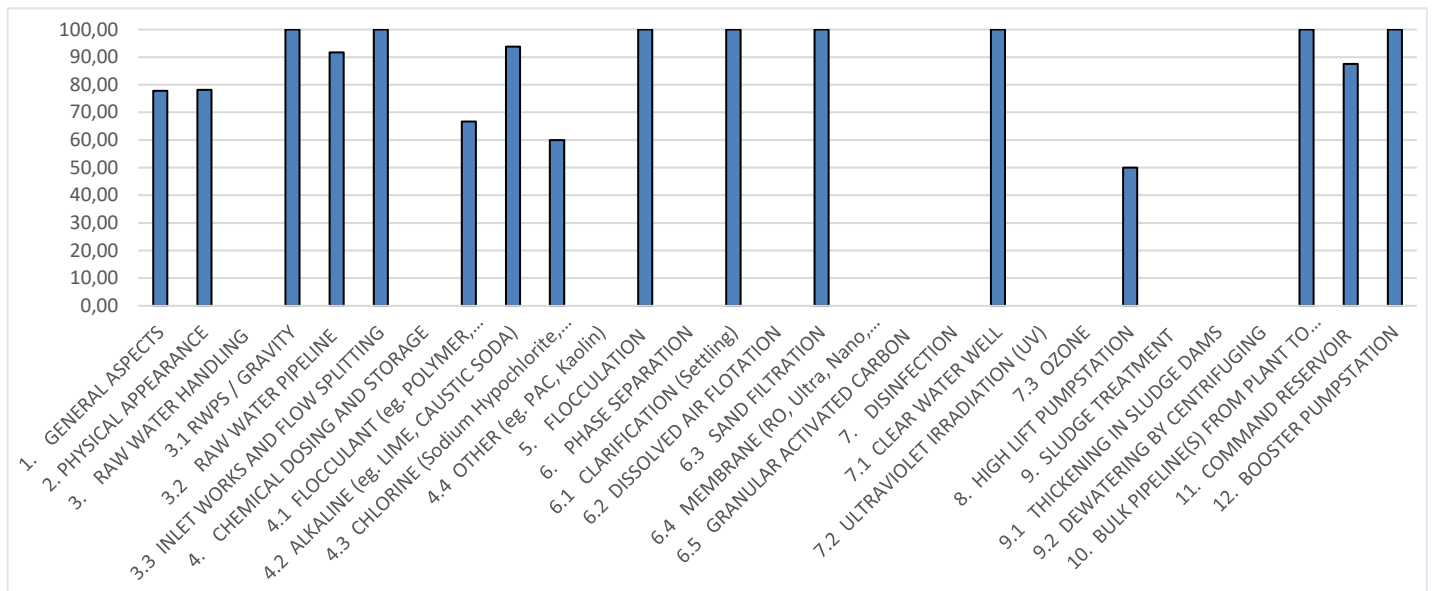
The following process units were inspected and rated according to the % score on the y-axis. Process units that score <50% are marked in red and needs urgent intervention.

Watch #	Process Unit Assessed	% TSA	Observations
1	General aspects	77.8	Certificates and IMPs were all displayed. Excellent recordkeeping is in place. Operational monitoring has been implemented, however lacking quality control as standards have expired and instruments have not been calibrated recently.
2	Physical appearance of plant	78.1	The Process Controllers are satisfied with working conditions, and it was evident that a good working relationship exists. Safety signage was visible throughout the plant. The entrance is not signposted. The boundary fence is in a good condition with the gate slightly damaged.
3	Raw water handling		
	Raw water pumpstation/ gravity feed	100.0	No screens, but self-cleaning sieves. Two 45kw submersible pumps are installed and in working condition.
	Raw water pipeline	91.7	The 200mm asbestos line was replaced four years ago. Process Controllers walk the line once every three months. The flow meter is in working condition and readings are recorded.

Inlet works	100.0	Sudfloc 3465 is dosed at the hydraulic jump at the start of the inlet chamber. Dripping of coagulant was observed. Equipment for measuring the flow rate is installed and used by Process Controllers.
4	Chemical dosing and storage		
	Flocculant	66.7	Three dosing pumps are installed, all functional. The area was clean and neat. All stock tanks are clearly marked, and adequate storage volume is available. The area is however not bunded. An emergency wash area will be provided.
	Alkaline	93.8	There is one dry lime dosing unit installed but not in operation at the time of the inspection. Adequate stock was available. The bags must be stored on pellets.
	Chlorine	60.0	Dosing equipment was in working condition. Only one cylinder was connected. Adequate stock was available on site. A scale has been delivered and will be installed. Safety measures need urgent attention. No safety equipment is installed, and the cartridge of gas mask has expired in Sept 2020.

5	Flocculation	100.0	Settling tests are performed to observe the settling ability, ensuring immediate corrective action. Good floc formation was observed.
6	Phase Separation		
	Clarification (settling)	100.0	1 x lamellae settling tank with two sections and one circular tank installed. Even overflow and no growth or floc carry-over present.
	Sand filtration	100.0	Moore airlift filters installed, two compressors and two blowers available. Filters are backwashed every 12 hours. Even bubble distribution was observed during backwash. Filter media was replaced in January 2022. HTH is used to deep clean the filters. Good housekeeping in place.
7	Disinfection		
	Clear water well	100.0	Chlorine is dosed where water is entering the clear water well. Adequate contact time provided.
8	High lift pumpstation	50.0	Duty and standby pump sets installed. One motor was out on repairs and confirmed that it was installed the following week. The outflow meter is not functional. The meter at the Tikwane line is in operation. The replacement of flow meters is included in the current refurbishment project

9	Sludge treatment		
	Thickening in sludge dams	0.0	There is a sludge dam next to the plant but overgrown with weeds. Sludge and filter backwash water mostly discharge into the veld.
10	Bulk pipeline from plant to command reservoir	100.0	The 250 mm PVC line to Hoopstad is a new line. The 250mm PVC line to Tikwane is in good condition. A network inspection was done, and the information is also captured in the report.
11	Command reservoir	87.5	Busy with construction work on site and the reservoirs were not inspected. Information was provided by consultant and information also obtained from network inspection report. The two reservoirs balance out and the level of one reservoir is displayed at the plant. Flow measurement is only on the Tikwane line.
12	Booster pumpstation	100.0	Information as obtained from consultant: Two booster pump stations with two newly installed pump sets each.
	Total	82%

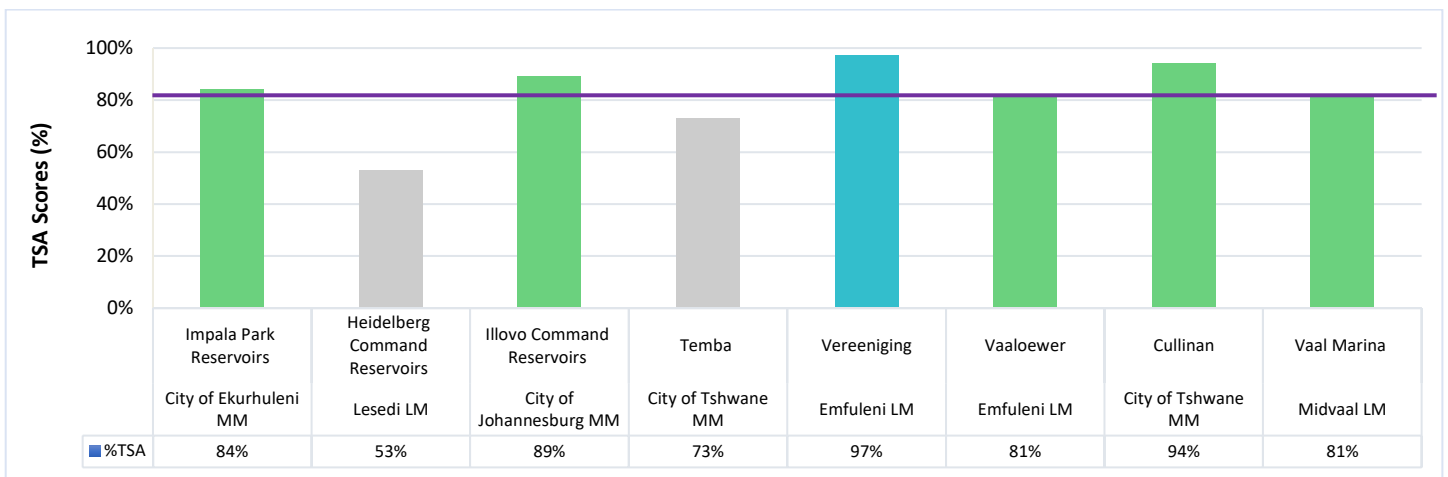
Figure 18 - GP TSA scores for all the BD Systems

An average of 82% was achieved for the 8 systems assessed, which means that infrastructure and processes are partially functional with a good to average performance. The best overall performance was found for Emfuleni Rand Water, followed by City of Tshwane Magalies Water, and City of Johannesburg. The water boards provided the top two best performing systems. The lowest performance was observed for the Heidelberg Command Reservoirs managed by Rand Water.

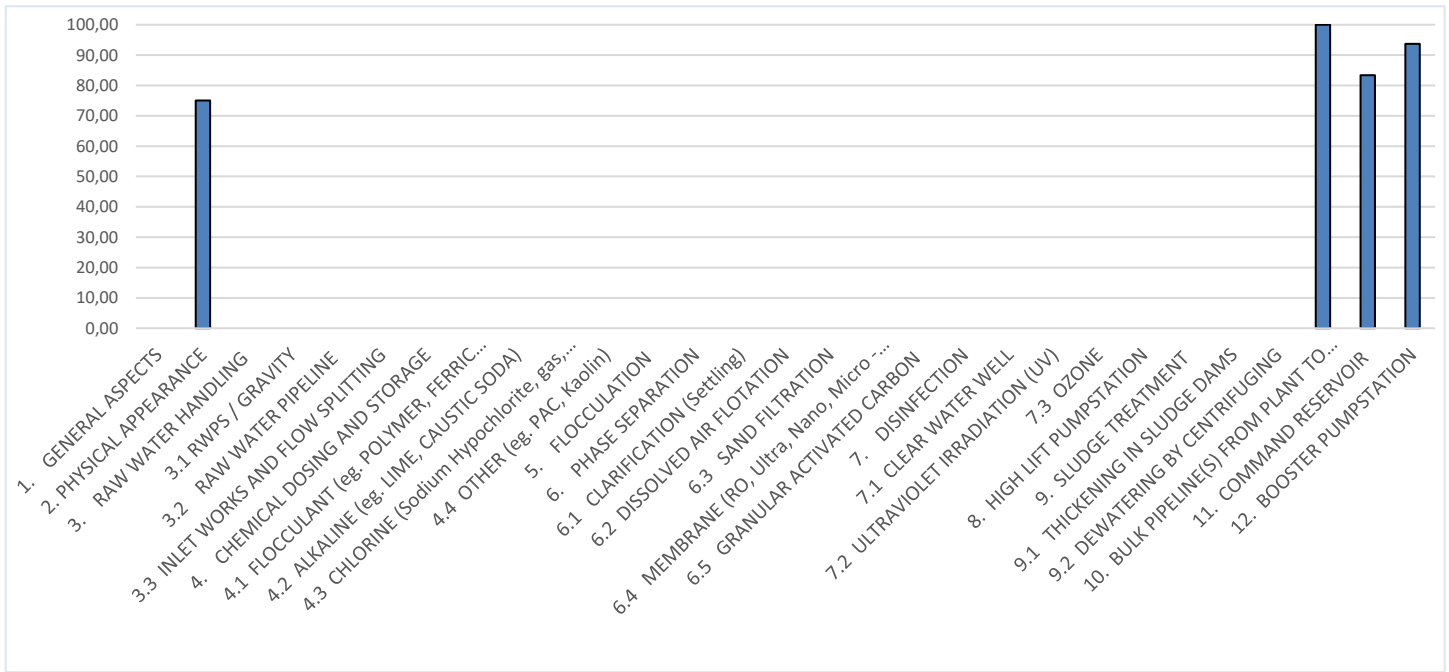
The following process units were inspected and rated according to the % score on the y-axis. Process units that score <50% are marked in red and needs urgent intervention.

Watch #	Process Unit Assessed	% TSA	Observations
2	Physical Appearance	75.0	Old paving requires maintenance/weed control. Pump House requires good cleaning schedule. Sump Pump is not maintaining water removal from pump station and requires repair / replacement. Telemetry is not operational due to contract expiry in 2020.
10	Bulk pipeline from plant to command reservoir	100.0	One on site valve chamber cover requires repair/replacement. Does not hold a water quality risk.
11	Command reservoir	83.3	Weed control required around reservoirs to prevent damage to reservoir aprons and drainage channels.

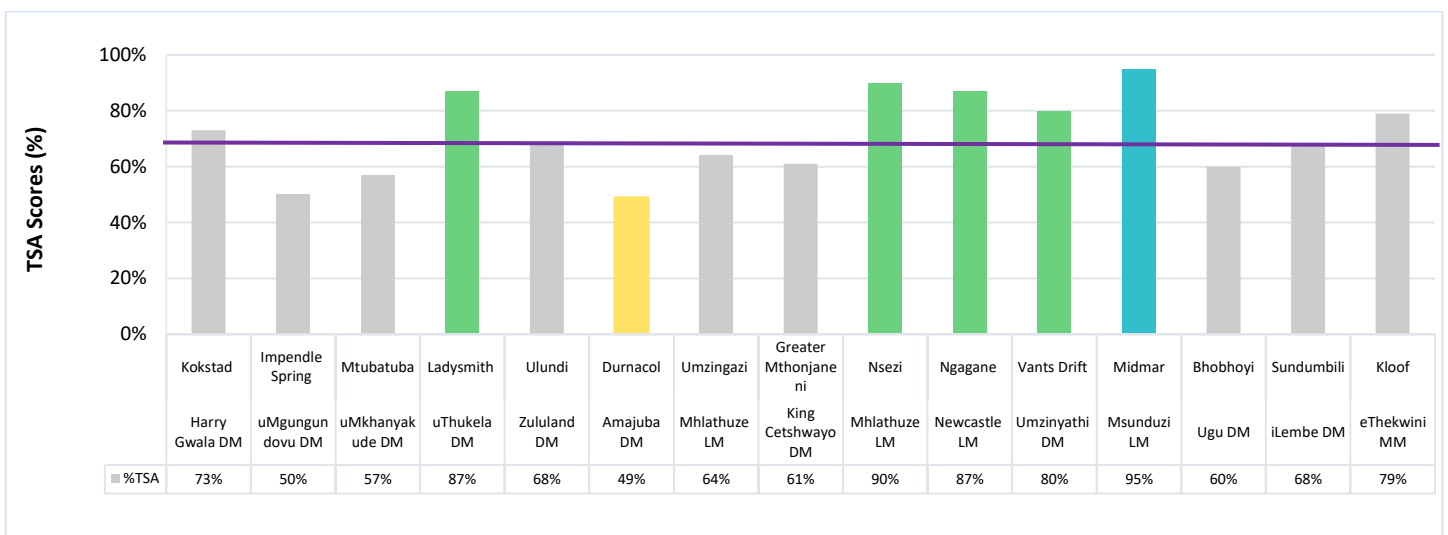
Figure 22 - KZN TSA scores for all the BD Systems

An average of 71% was achieved for the 15 systems assessed, which means that infrastructure and processes are partially functional with an average performance. The best overall performance was found for Msunduzi Umgeni Water, followed by Mhlathuze, uThukela and Newcastle uThukela Water. The WSP/WBs provided three of the best performing systems. The lowest performance was observed for Durnacol and Impendle Spring Protection.

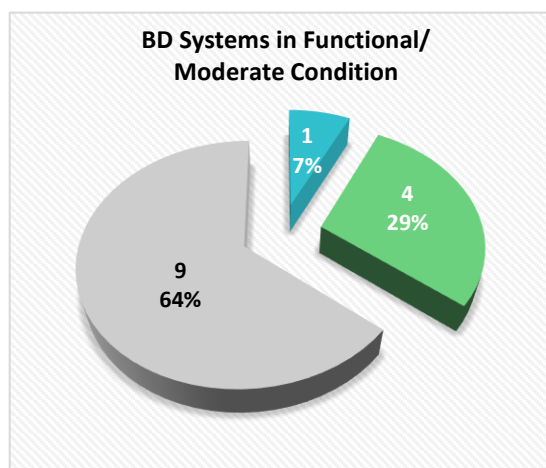
Figure 23 - No. BD Systems in Functional/ Moderate Condition

Of the 14 systems in the excellent to average performance categories it was found that:

- 1 system (7%) was in excellent good condition
- 4 systems (29%) were in good condition
- 9 systems (64%) were in average condition.

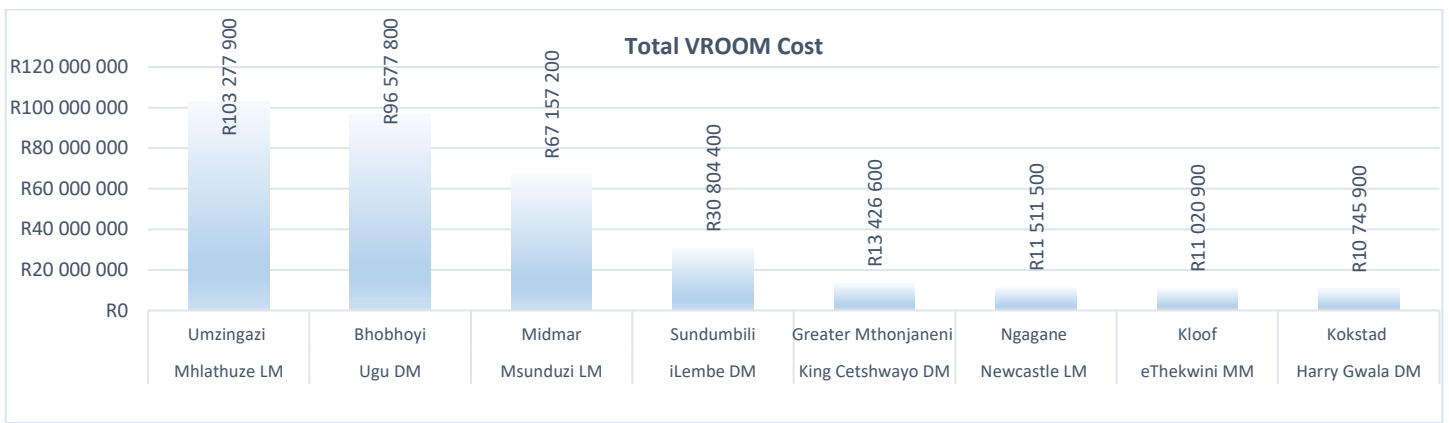
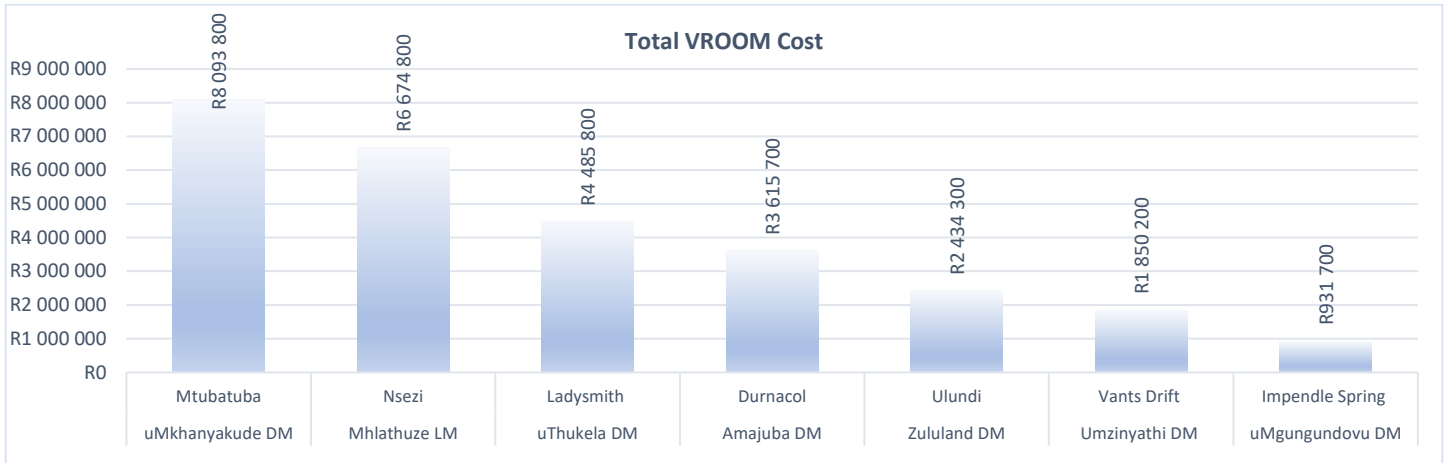
Figure 24 - Total VROOM Cost for the BD Systems Assessed

The associated VROOM costs for the 15 water supply systems assessed amounts to R372.6 million, with the bulk of investment needed for Umzingazi (Mhlathuze), Bhobhoyi (Ugu) and Midmar (Umgeni Water).

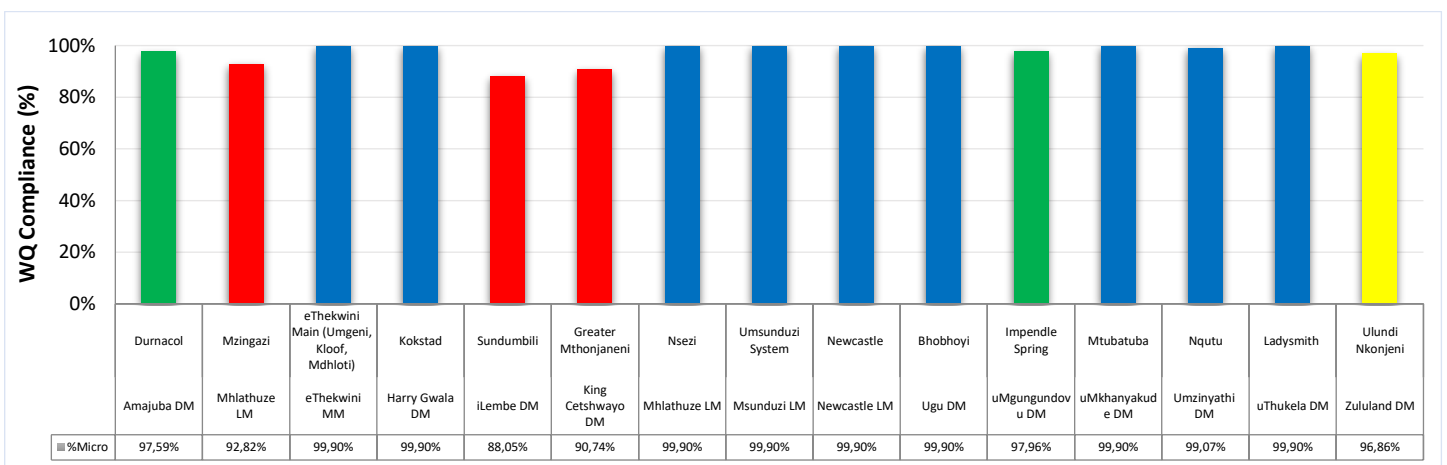
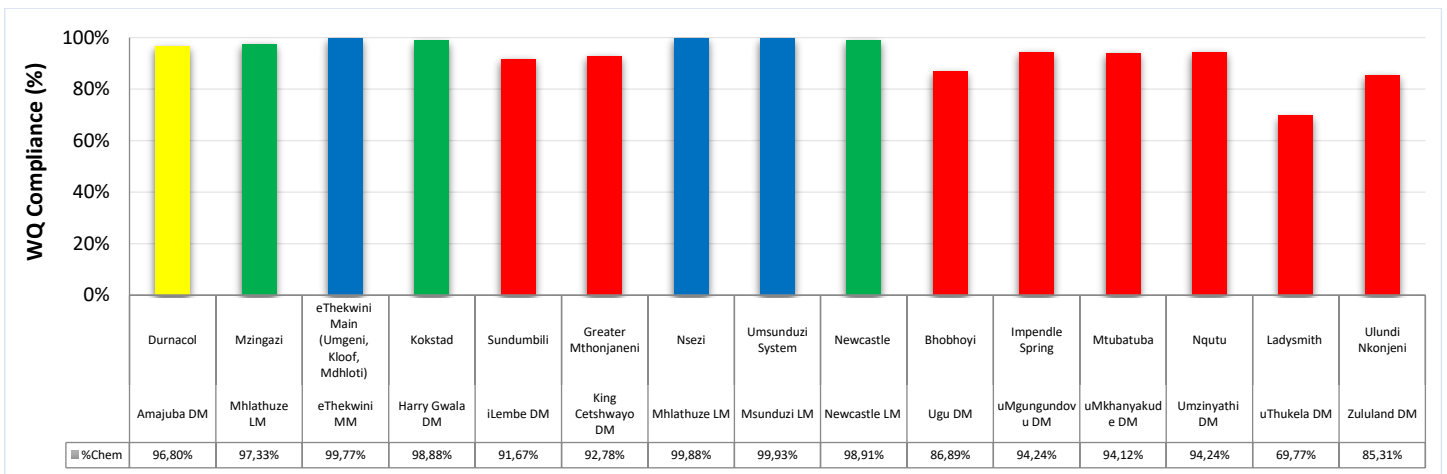
Figure 25 - KZN Drinking Water Quality Status of all the TSA Water Supply Systems

The TSA and water quality results depict a different picture. The TSA shows 14 of the 15 water supply systems to be in the *excellent to average performance category*, and the water quality compliance shows that 27-60% of the systems *fail to produce compliant final water quality*.

Out of 15 treatment plants, 9 (66%) and 2 (13%) of systems achieve excellent and good microbiological quality. A total of 1 (7%) system has poor microbiological quality and 3 (20%) systems have bad microbiological water quality status. The water in these systems poses a serious acute health risk to the community. WSAs with poor microbiological water quality status must be assessed to confirm status in all systems to ensure rectification measures are comprehensive to safeguard communities. The direct cause of microbiological failures can be linked to the TSA sub-watch Area 7, which has a low contribution to the overall TSA score. The failure to produce water that meets E. coli standards can be linked back to poor operations, defective infrastructure, dosing rates, absence of disinfection chemicals, lack of monitoring, or lack of operating and chemistry knowledge. WSIs that are not monitoring the final water quality at the outlet of the treatment plant or at specific end use points must develop a monitoring programme and resume with compliance monitoring as a matter of urgency.

Chemical compliance shows that 3 (20%) and 3 (20%) have excellent and good water quality, whilst the majority of systems fail to achieve chemical compliance. A total of 1 (7%) and 8 (53%) systems have a poor and bad chemical water quality status.

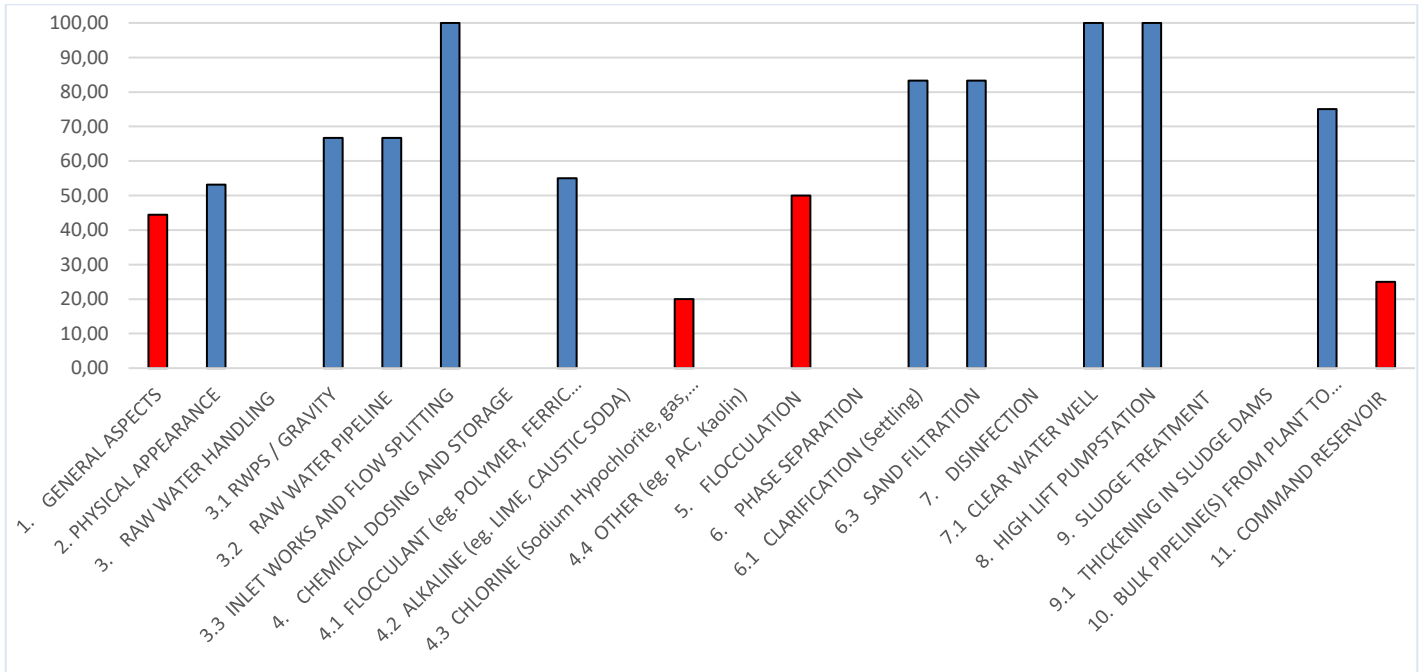
The following process units were inspected and rated according to the % score on the y-axis. Process units that score <50% are marked in red and need urgent intervention.

Watch #	Process Unit Assessed	% TSA	Observations
1	General aspects	44.4	The works classification and process flow diagram are not displayed, maintenance and repairs logbook are not on-site. No records of electricity consumption. Attention is required on administrative requirements.
2	Physical appearance of plant	53.1	The entrance is sign posted; however, safety signs are not sufficient in most process units. Electrical cable should be isolated, and general tidiness needs to be improved. The road in the plant premises should be paved or tarred, chemicals such as poly should be properly stored with safety precautions to avoid incidents.
3	Raw water handling		
	Raw water pumpstation / gravity feed	66.6	Inlet pumps appears to be in good working condition. The Process controller indicated that part of raw water lines requires attention as its prone to breakages, inflow meters require calibration and flow rate is recorded.

Raw water pipeline	66.6	
	Inlet works	100.0	
4	Chemical dosing and storage		
	Flocculant	55.0	2nd dosing pump to be fixed as it is non-operational. Bund for poly storage is required.
	Alkaline (Lime)	0.0	Lime dosing not taking place, the system needs to be re-instated, two 25kg half full dehydrated lime bags were observed.
	Chlorine	20.0	Although the works is not old - a lot of housekeeping and general maintenance and fixing of the unit is required at the chlorine dosing area. None of the equipment was working adequately at the chlorine room.
	Other (e.g., pac, kaolin)	0.0	The works is equipped with activated carbon, and it is not functional and general maintenance and fixing of the equipment is required to put the system in operation again.
5	Flocculation	50.0	2 out of the 5 flash floc stirrers were non-operational due to mechanical breakdown. It was explained that 4 were not operational due to the faulty bridge that they were connected to. All Mechanical and Electrical components need to be attended to and the two stirrers should be brought back into correct operation.

6	Phase separation		
	Clarification (settling)	83.3	No floc carry-over observed, clear water, only general maintenance and cleaning required.
	Sand Filtration	83.3	Two pumps for backwashing and all pumps in good working condition. Only one blower installed no standby/backup.
7	Disinfection		
	Clear water well	100.0	Final water samples are taken at a final tap and analysed for free chlorine; analysis records demonstrated onsite.
8	High lift pump station	100.0	The high lift pumpstations were in good condition. The latest (and biggest) pumpstation was commissioned in 2022 and is very impressive.
9	Sludge treatment		
	Thickening in sludge dams	0.0	Sludge dams not maintained, sludge thickening dams with overgrown weeds and not being operated.
10	Bulk pipeline from plant to command reservoir	75.0	There was no evidence of cathodic protection or maintenance done.
11	Command reservoir	25.0	The command reservoir is inside premises, telemetry not working and no flow measurements from command reservoir to distribution.

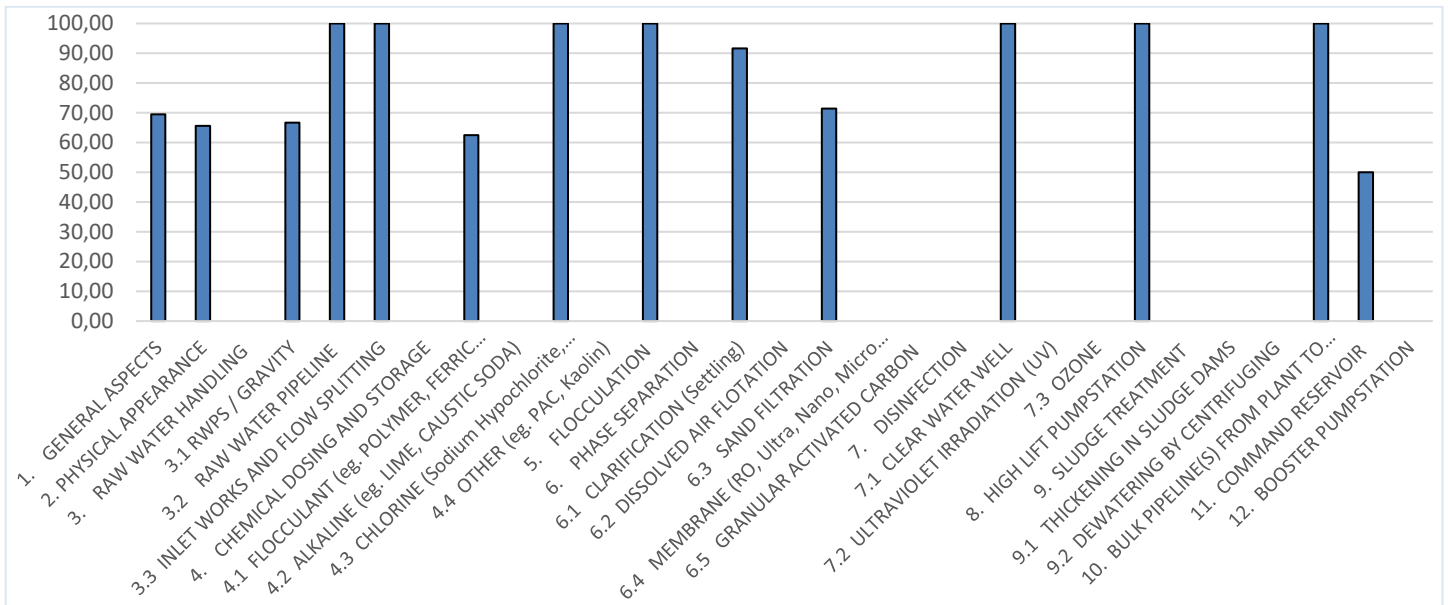
The following process units were inspected and rated according to the % score on the y-axis. Process units that score <50% are marked in red and need urgent intervention.

Watch #	Process Unit Assessed	% TSA	Observations
1	General aspects	69.4	Class C plant, logbooks in place, no PFD displayed, and O&M manuals are not complete.
2	Physical appearance of plant	59.4	Fenced and signposted. Infrastructure is showing its age. Safety signage is generally missing.
3	Raw water handling		Raw water is abstracted from the Kranskloof Dam via high-lift pumps. One pump is removed for repair which is a risk as there is only one duty pump available at the time of the audit. Raw water pipeline and inlet infrastructure are functional with sufficient mixing.
	Raw water pumpstation / gravity feed	66.7	
	Raw water pipeline	100.0	
	Inlet works	100.0	
4	Chemical dosing and storage		Sufficient flocculant storage (6 months), but no bunding. Duty and standby dosing equipment functional.
	Flocculant	70.8	
	Chlorine	100.0	Disinfection is through onsite sodium hypochlorite generation by means of electrolysis of salt. This is an excellent technology for this site and there are no raw material shortages.

5	Flocculation	100.0	The flocculation channel may be too small, and the concrete is ageing.
6	Phase Separation		
	Clarification (settling)	91.7	Water from clarifiers was very clear. Desludging occurs once a week. The concrete is corroded but there is no sign of growth on the surface.
	Sand Filtration	81.2	Filters are backwashed daily using a feed line from high-lift pumps. Only one blower is operational.
7	Disinfection		Contact time is estimated at 45 minutes.
	Clear water well	100.0	
8	High Lift Pumpstation	100.0	Both duty and standby pumps are in operation.
10	Bulk pipeline from plant to command reservoir	75.0	The main pipeline to the command reservoir had reported no breakages. However, it does not have cathodic protection.
11	Command reservoir	62.5	Fenced and gated with 24-hour security, telemetry fitted and reporting to head office. Manholes are not locked and could allow ingress if the roof is flooded. There are no visible leaks.

1. Raw water pumps need an overhaul, and the one pump needs to be re-installed.
2. An additional filter blower is required as currently there is no standby.
3. Concrete on the clarifier is badly corroded.
4. Most of the civil and building infrastructure is in need to a major refurbishment.
5. The road on the site needs to be repaired and resurfaced.

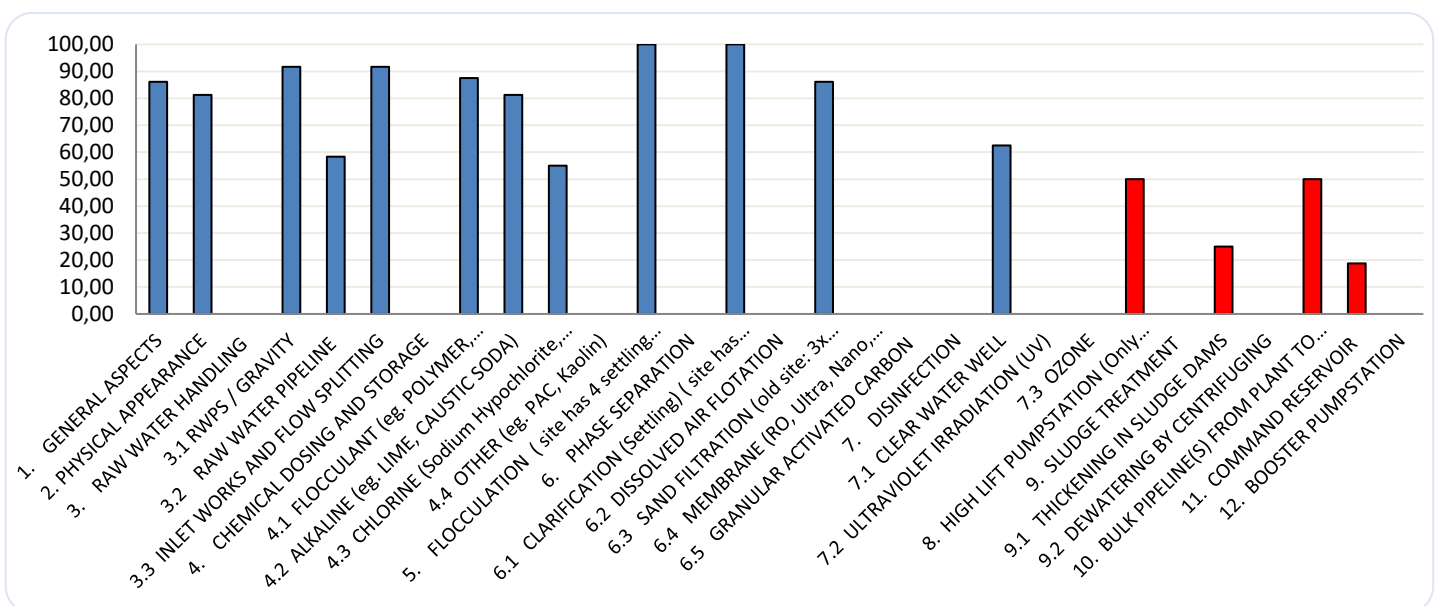
The following process units were inspected and rated according to the % score on the y-axis. Process units that score <50% are marked in red and need urgent intervention.

Watch #	Process Unit Assessed	% TSA	Observations
1	General aspects	86.1	Class C plant, logbooks in place. IMP in place with contact numbers of staff. Electrical meter area needs cleaning and generator needs major servicing or replacement due to frequent breakages
2	Physical appearance of plant	81.2	Fenced, neat terrain, good housekeeping, high workplace satisfaction in the new building sections, except for resident staff's kitchen (ill-used). Civil refurbishment of the old plant buildings etc is required and may need substantial work, ito ceilings, plaster work, tiles, sealing and painting.
3	Raw water handling		
	Raw water pumpstation / gravity feed	91.6	2 sources: Mzintlava PS, major refurbishment being completed. Will need replace current small generator with adequately sized generator. Flow meter is on site but not yet installed, part of existing refurb contract. Flow meter is on site but not yet installed, part of existing refurb contract. Crystal Springs Dam gravity feed (mainly winter or dry season source)

Raw water pipeline	58.3	Rising main Galv Steel, and Gravity main AC (will need replacing). Pipe conditions fair. Each pipe line has its own flow meter, flows are not recorded or captured on logbook, recommend reinstating non-functioning SCADA
	Inlet works	91.6	HoW and dosing in same building. Even flow splitting and effective flash mixing observed. Basic & preventative mech maintenance required on pipe and valves, likewise for civil maintenance on doors, outside roof.
4	Chemical dosing and storage		
	Flocculant	87.5	Duty and standby pump set in good condition, Area partially banded. Dosage / room need some civil maintenance (, day tank standing on wooden pallet, rusting pipe work needs attention)
	Alkaline (Lime)	81.2	Two dry lime dosing units installed (1 duty & 1 standby) needs some preventative maintenance. Bag area dry, raised off floor. Area wet and little bit lime spillages on the floor. Sufficient storage for 30 days and lime is not daily in use.

Chlorine	55.0	1 chlorinator, New section's Chlorine dosing installation must be completed, still waiting for appointment of service provider. Old Emergency wash area (shower) not well maintained, new emergency shower excellent condition.
5	Flocculation	100.0	Floc Blanket Pulsators - Less flocs were visible (some very small floc/ turbidity), but mostly settled at bottom. Good condition of flocculation units as no scum were not accumulating, normal settlement on walls.
6	Phase Separation		
	Clarification (settling)	100.0	4 Settling tanks, Limited Floc/scum carry over only where weir needs adjusting (raising). Civil - Condition - basins starting to show age, some remedial concrete work required (cracked sections); no visible leaks, safety barriers good to fair condition; Visual WQ looks excellent in launders
	Sand Filtration	86.1	Old site: 3x Rapid gravity filters & new site: 3x Rapid gravity filters. Backwash pumps and air blowers in good condition. Even overflow at outlet boxes, media, and filter galleries in good condition. Old building boxes need cleaning and some preventative maintenance.

10	Bulk pipeline from plant to command reservoir	50.0	Distribution and reticulation pipes are galv steel, AC & PVC, mostly AC. Many leaks experienced on Galv Steel and AC line. Recommend replacing Galv Steel and AC with PVC where possible.
11	Command reservoirs	18.7	Gated (secure) and sign posted. Site has Reservoir, pump room, security room. Substantial theft of palisade fencing by community leading to community having full access to premises (major risk). Poor ground keeping and telemetry and flow meter not functional. Reservoir structure in fair condition, but drainage / scouring problematic.
	Total	73%

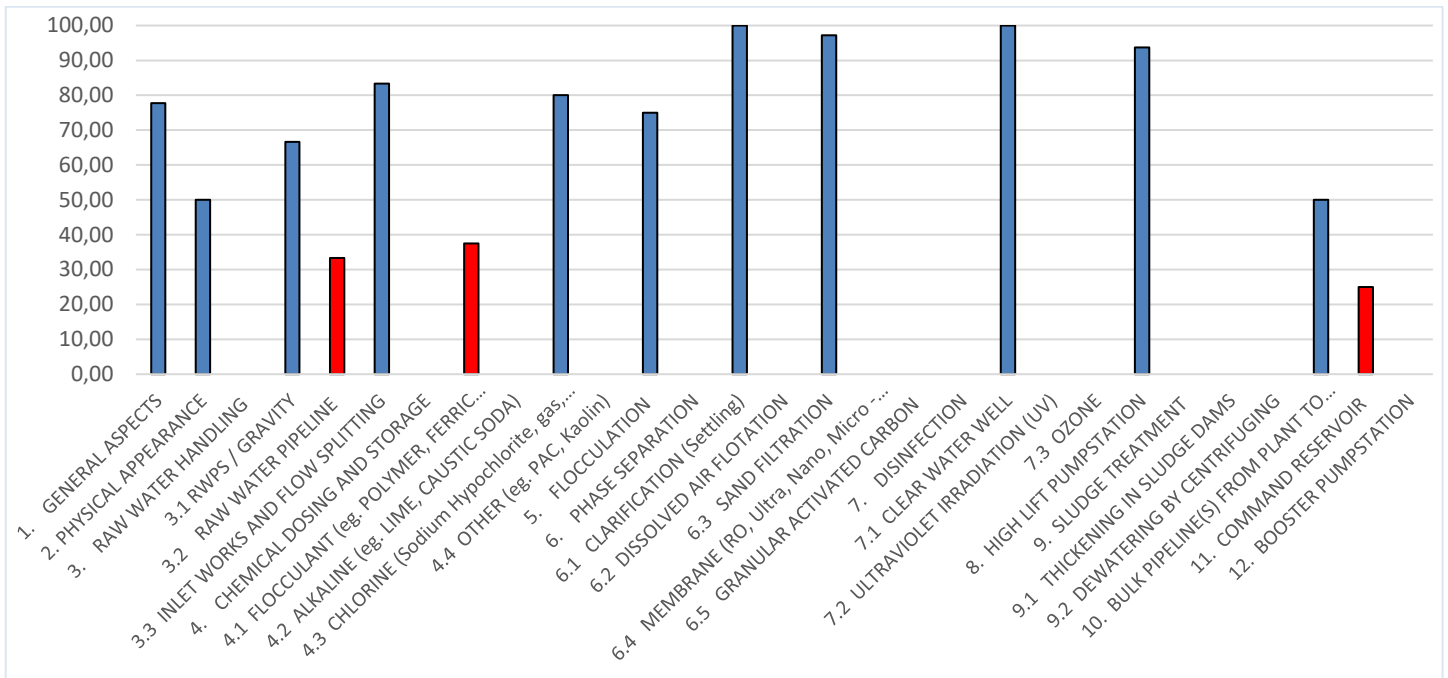
The following process units were inspected and rated according to the % score on the y-axis. Process units that score <50% are marked in red and need urgent intervention.

Watch #	Process Unit Assessed	% TSA	Observations
1	General aspects	77.7	Class A plant. The 2018 certificate is displayed. All logbooks, maintenance schedules, IMP, PFD, and monitoring equipment plus calibration is in place. The original O&M manuals are on site but need to be updated.
2	Physical appearance of plant	43.7	The entrance is clearly marked with a sign. The garden and terrain are not well kept, and the buildings and roads is also in a state of disrepair, with many water leaks around the site. The bathroom facilities are not in a good state. The safety rails on the tower walkway are missing.
3	Raw water handling		There are no screens at the pump station, but debris hasn't caused any pump failures because the draw-off level can be adjusted. Two out of three pumps are functioning. When this pump is operational, there is a 50% standby capacity. The main supply flow meter is not operational, but the supply pipeline is in good condition. Flow splitting is not taking place evenly as there is too much turbulence at the splitter box causing an overflow.

7	Disinfection		There is approximately 45 minutes of contact time on site.
	Clear water well	100.0	
8	High Lift Pumpstation	93.7	There are 2 duty and one standby high lift pump in operation. Flow measurement is operational.
10	Bulk pipeline from plant to command reservoir	87.5	No leaks were reported, and the valve chamber inspected was in adequate condition.
11	Command reservoir	25.0	There is poor security at the command reservoir, and the telemetry and flow meter to the next reservoir is not working. Some seepage leaks can be seen on the reservoir structure.
Total		68%

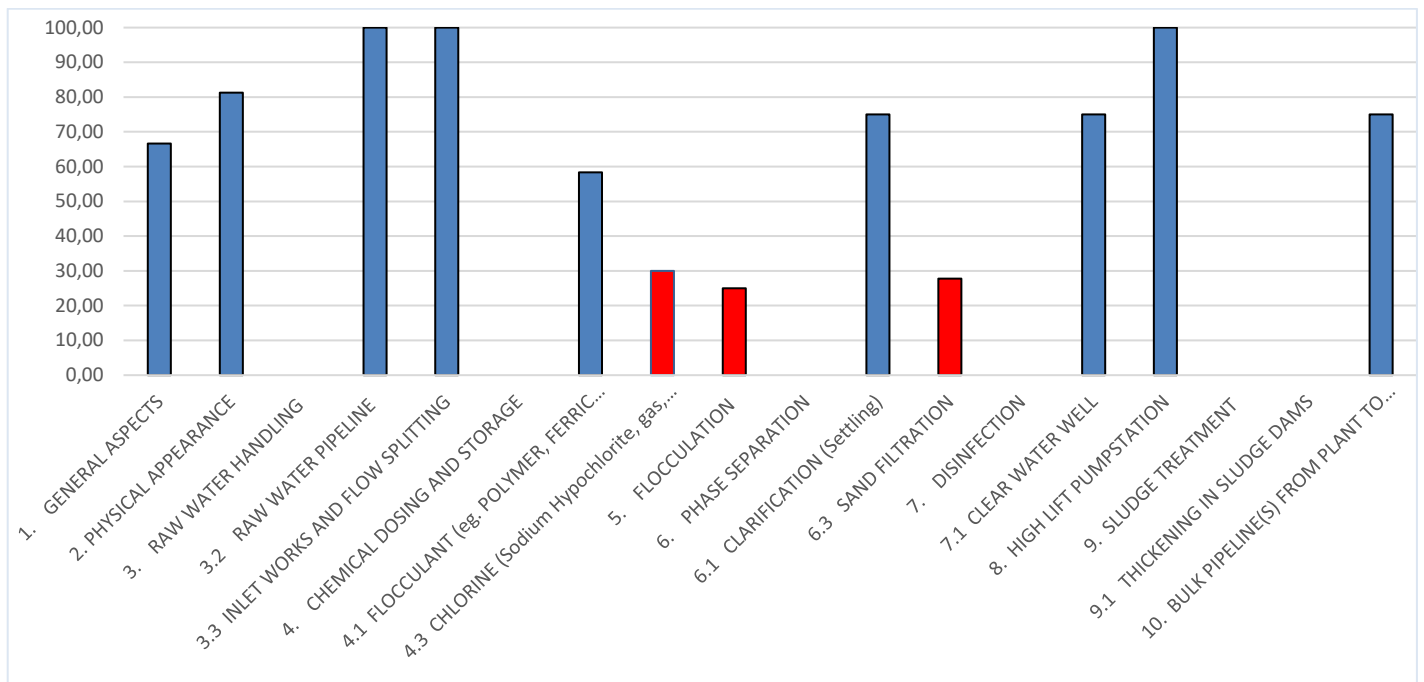
The following process units were inspected and rated according to the % score on the y-axis. Process units that score <50% are marked in red and need urgent intervention.

Watch #	Process Unit Assessed	% TSA	Observations
1	General aspects	66.6	Class B plant, logbooks in place, SOP manuals are available for each of the process units. However, there is no maintenance manual. There was no process flow diagram at the WTW (provisional PDF has been created for this report).
2	Physical appearance of plant	81.2	The entrance is sign posted. Facility is fenced and access at entry points is controlled by security personnel. Sufficient safety signs are visible at all relevant areas on the plant. The housekeeping in the chlorine area was poor.
3	Raw water handling		
	Raw water pumpstation / gravity feed	na	Raw water pipeline is a gravity feed from the dam. Where the pipe was visible it appeared in good condition. Flow rates recorded every 2 hours in operational monitoring logbook. Flash mixing taking place at dosing point due to high turbulence.
	Raw water pipeline	100.0	
	Inlet works	100.0

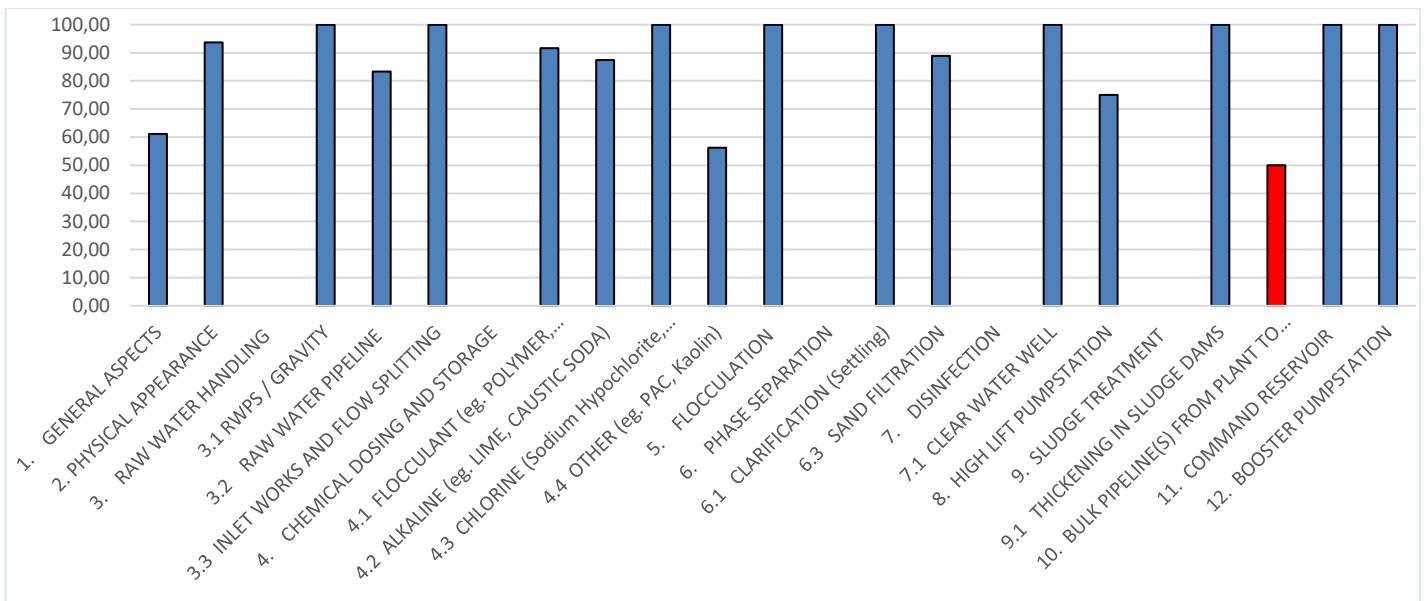
The following process units were inspected and rated according to the % score on the y-axis. Process units that score <50% are marked in red and need urgent intervention.

Watch #	Process Unit Assessed	% TSA	Observations
1	General aspects	61.1	Class A plant, logbooks in place, SOP manuals are available for each of the process units. Logbooks in place and updated. Excellent demonstration of daily shift entries clearly indicated on site.
2	Physical appearance of plant	93.7	Garden needs to be attended to and general weeding and upkeep required. Sufficient safety signs are visible at all relevant areas on the plant.
3	Raw water handling		Three pumps have been installed at the Ngagane river pump station. One of the pumps had been dismantled for maintenance while the other two were in good working condition. Cathodic protection of raw water line available. Inlet works in good functional condition.
	Raw water pumpstation / gravity feed	100.0	
	Raw water pipeline	83.3	
	Inlet works	100.0	
4	Chemical dosing and storage		Each module has two dosing pumps, one standby and one duty dosing pump. The dosing area was found to be in a good condition, clean and without spillage.
