BLUE DROP

Watch Report

BLUE DROP WATCH REPORT 2023: TECHNICAL ASSESSMENT OF THE CONDITION OF MUNICIPAL DRINKING WATER TREATMENT AND DISTRIBUTION SYSTEMS IN SOUTH AFRICA

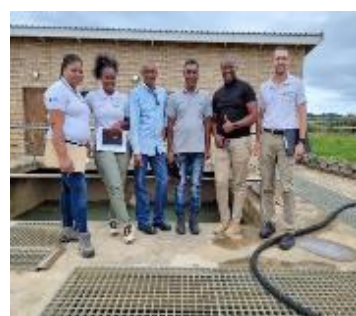
Impendle Spring Protection TSA Score: 50%

Watch #	Process Unit Assessed	% TSA	Observations
1	General aspects	56.2	No O&M Manual provided, but Logbook, Class of Works and PC Certificates and IMP with full contact details - Provided and kept in site bakkie with PC. Shared Container storage yard with full ablutions is fenced and secure. Containers need refurbishment. The walking route to the protection and actual spring protection box needs some form of safety railings and steps, specifically in wet weather
2	Technical

2.1	Spring Protection and delivery line to reservoir	51.2	The system consists of galv steel pipes from the protection site to Reservoir site. Recommend protecting exposed pipe sections from damage by human and animal foot traffic. Inflow meter is required.

2.2	Disinfection	56.2	Old HoW vandalised. New HoW needed with effective dosing mechanism, also consider utilising a sodium hypochlorite dosing systems rather than HTH tablets for more manageable/ controlled dosing. Would also recommend PC training regarding dosing and dosing management

2.3	On-site reservoir	37.5	The Command Reservoirs and disinfection unit are within a fenced area, but the entrance gate is broken. (RES1 -oldest & not functional - in urgent need of refurbishment or replacement; RES2 also needs some refurbishment, mainly around valve chambers, valves, etc, (showing signs of damage due to vandalism and age). Bulk flow meters at reservoir outlets and reservoir level meters recommended. Telemetry (solar powered) could be advantageous.
Total		50%

1. Flow metering at inlet and outlets
2. New HoW & dosing system
3. Refurbish/ rebuild 2nd reservoir (smaller older reservoir) and repair gate.

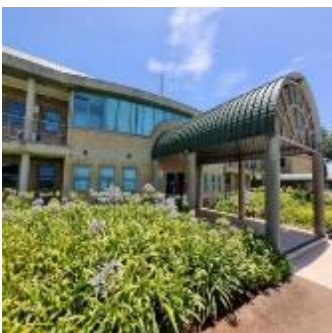
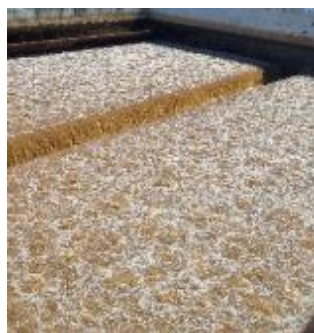
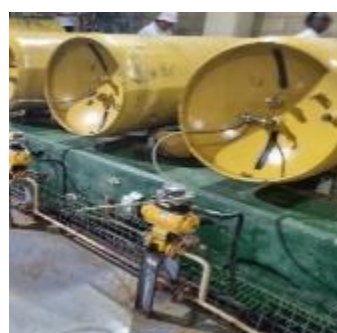
8.10 City of uMhlatuze Local Municipality

Watch #	Process Unit Assessed	% TSA	Observations
1	General aspects	69.4	Class A plant, logbooks in place, no display area noted for PFD, but SCADA displays the PFD on site. No O & M manuals on site, but operational procedures posted on the wall.
2	Physical appearance of plant	93.7	The entrance is clearly marked with a signpost. Site has a controlled gate, fence in good condition and security during the night and over weekends. There are sufficient safety signs visible at all relevant areas on the plant.
3	Raw water handling		2 duty pumps & 2 standby. All pumps in working good condition. Pipeline appears to be in good condition - servitude in place with concrete vents and manholes. Even cathodic protection analysis was being undertaken. A large flow splitting tower with 'cascade' to each clarifier with even flow splitting.
	Raw water pumpstation / gravity feed	100.0	
	Raw water pipeline	100.0	
	Inlet works	100.0

4	Chemical dosing and storage		The dosing pumps are configured to be used as backup for each other there is sufficient standby. The area is neat, clean and any spillages are contained and managed adequately. Caustic dosing for pH correction - Very neat - all operational. Duty + Standby pumps. All dosing units operational and standby 100%. Two systems - motive pumps and injectors both fully operational. 100% standby dosing unit. Chlorine gas (bulk) used - there was sufficient storage for approx. 2-3 months. Repair broken scales and an addition of one chlorinator for backup is necessary.
	Flocculant	100.0	
	Alkaline (Lime)	100.0	
	Chlorine	100.0	
	Other (e.g., pac, kaolin)	na	
5	Flocculation	75.0	Good floc formation both at clarifiers as well as before DAF, however, floc mixers before DAF need re-design and replacement. Some scum build-up before DAF was noticed during the site visit.
6	Phase separation

Clarification (settling)	83.3	The one clarifier was overloaded due to plant capacity issues; however, current expansion of the plant is expected to resolve that. Loadshedding is also adding to over-capacity issues in plant (can only pump for certain hours).
	Dissolved air flotation (daf)	92.8	Six recycle pumps are installed and are new and in good condition. Saturator was serviced in the last 12 months; it was noted to be serviced at least every 2 - 3 years nevertheless it is in good working condition.
	Sand filtration (pressure sand filters)	75.0	Three backwash pumps are installed and in working condition. Media will require replacement as well as few touch-ups on pipes and mechanical equipment (slight rust).
7	Disinfection		
	Clear water well	100.0	Chlorine is dosed directly in-line and the contact occurs in the under-ground sump before high-lift PS. Free chlorine residual is measured every hour at the final treated water.

8	High lift pumpstation	87.5	Six pumps are installed - all in working good condition. Online flow metering in place. Flow records captured and plotted at the SCADA.
9	Sludge treatment		
	Thickening in sludge dams	na	Sludge is pumped to Mondi WWTW.
10	Bulk pipeline(s) from plant to command reservoir(s)	100.0	The main bulk feeding Monde reservoirs, valve chambers and WSAs reservoirs were noted to be in good condition.
11	Command reservoir	100.0	The reservoirs were surrounded by a fence and a gated entrance. Telemetry at the command reservoirs is operational and can be observed from the operations room at the WTW. The reservoirs were observed to be leak free.
	Total	90%

1. Media to be replaced.
2. One clarifier was overloaded due to plant capacity issues; however, the current expansion is expected to address it.
3. Loadshedding destructs the pumping (can only pump for certain hours).

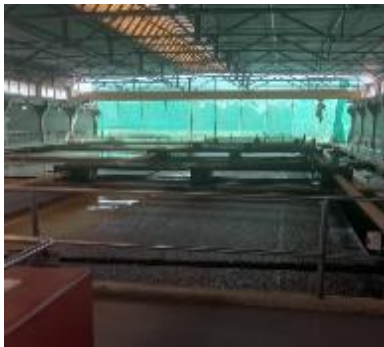
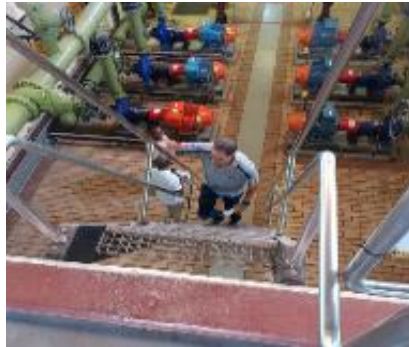
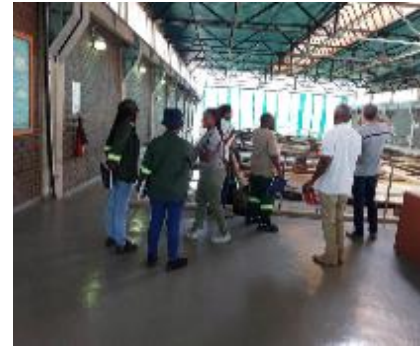
Mzingazi TSA Score: 64%

Watch #	Process Unit Assessed	% TSA	Observations
1	General aspects	69.4	Class B plant, logbooks in place, SOP manuals are available for each of the process units. Logbooks in place and updated. Process flow diagram available in O&M manual but not displayed on the wall. Excellent signage at gate, with contacts.
2	Physical appearance of plant	75.0	The works is old, however functional. Grass was only partly cut in some areas. Many windows or doors broken. Poor condition due to age. Some of the hand railings are loose, external housekeeping such as grass cutting is required, filter media replacement, cracked stairs etc. Refurbishment of the existing units of this plant is necessary.
3	Raw water handling		
	Raw water pumpstation / gravity feed	66.6	No evidence of maintenance. The pipes are old, not painted and some rust on them. No sign of cathodic protection or maintenance. Flowmeter had been struck by lightning and was not working at the time of the site visit, however a new one had been ordered and was on site and needed to be installed. Chemical dosing pumps functional and in good condition.

Other (e.g., PAC, Kaolin)	na	
5	Flocculation	75.0	Flash mixing occurred underground (static mixer) and there were no above ground floc-maturation tanks. There are no sedimentation tanks. However, there was almost no flocs detectable in the water. In general, the raw water quality is of good quality.
6	Phase separation		
	Clarification (settling)	na	
	Sand Filtration	27.7	Only 7 of the 8 filters were operational (one out of service). The filter sand had not been replaced in 50 years (since plant was commissioned) and it is therefore visibly hard and lumpy. According to PC, the filters cannot be backwashed individually - the entire plant needs to be switched off and then all filters need to be backwashed. This only gets done once every 2 weeks and is very unpractical. The backwash that was witnessed by the team was poor (they tried to backwash without shutting down the entire works) - the air was almost not evident, and the media was blocked.

7	Disinfection		
	Clear water well	25.0	There is no contact tank for disinfection. The chlorine is dosed on the line connected to the final tank. Currently free chlorine is measured at the network due to setup of the system. It is recommended to have a dedicated clear well for chlorine contact and measurement.
8	High lift pump station	75.0	There are 2 sets of pumps, one set transports water to Meer-en-see (3 pumps but only 1 is working) and another set of pumps transports water to town and other areas (all 6 pumps working condition). Due to aging of the pump's breakages are occurring more frequently.
9	Sludge treatment		
	Thickening in sludge dams	na	
10	Bulk pipeline from plant to command reservoir	75.0	These lines are underground and difficult to visually inspect. However, at the plant outlet manhole the condition appears as though attention is required as it appears that there has been no maintenance.

11	Command reservoir	100.0	Flowmeter on outlet of plant was operational. The SCADA gave evidence that reservoir levels are determinable. The visible structure of the reservoir appears to be in a good condition.
12	BOOSTER PUMPSTATION	87.5	Four pumps - all operational. The booster pumpstation is in good condition than the WTW. However, there is no signage on the pumpstation.
	Total	64%

2. Electrical equipment replacement
3. Replacement of the filter media
4. Leakage at CWW need to be repaired.

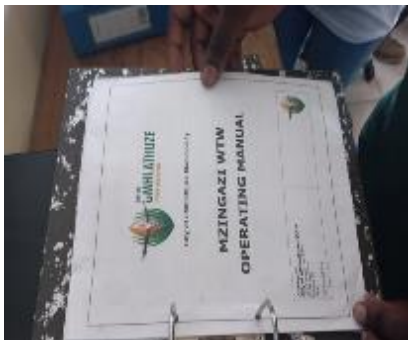
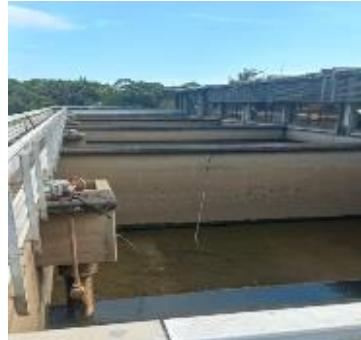
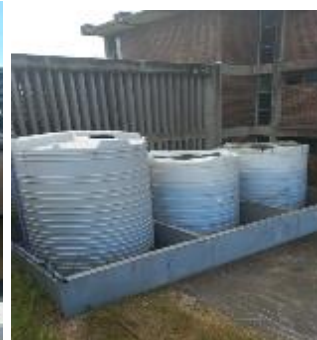
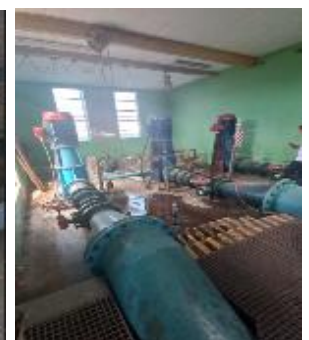
Mtubatuba TSA Score: 57%

Watch #	Process Unit Assessed	% TSA	Observations
1	General aspects	66.7	Class B plant, logbooks in place, old O&M manual with new being developed, PFD available but not displayed on wall, IMP for DWQ and contact list displayed, process monitoring equipment is functional and calibrated except no pH testing for RW & FW, electricity meter is working but locked up and not recorded
2	Physical appearance of plant	71.9	Signage at gate, fenced, the access road and parking areas are not surfaced and hampers the delivery of chemicals, terrain neat but some mechanical & other equipment lying around to be removed/stored, signage predominantly good overall, good housekeeping, good workplace satisfaction, only minor OHS issues, the workers bathroom & shower facility to be renovated
3	Raw water handling		Raw water abstraction from the Wit Mfolozi River, screens submersed and could not be viewed, pumps in working condition and standby is sufficient; no leakages evident, pipe size ok, no cathodic protection, maintenance is done, RW measuring device and flow transmitter not functional; the sand trap is operational and flow splitting is performed by the eye, flow control required as the 4 no. clarifiers have differing diameters

Raw water pumpstation/ gravity feed	91.7	
	Raw water pipeline	25.0	
	Inlet works	75.0	
4	Chemical dosing and storage		Flocculant duty and standby pumps in good condition, dosing area is neat and contained, storage volume is sufficient for 30 days and is banded, no functional emergency wash area nearby; 1 of 2 Chlorine dosing units operational with no standby, the storage volume is not sufficient for 30 days and foresee delivery and storage problems in future, safety equipment available except the extractor fans looked like they were not operational
	Flocculant	79.1	
	Chlorine	35.0	
5	Flocculation	50.0	Flocs visible at the clarifier inlet box, the new floc unit added adjacent to the rapid mix zone is a design issue as insufficiently sized and turbulent conditions evident, the old floc unit does not have a floc channel, improve regularity of jar testing for better floc formation
6	Phase Separation		Desludging takes place every shift or 2 hrs depending on the Turbidity range, 3 of the 4 clarifier automated bridges are functional, automated bridge for clarifier 4 and the stilling basin in good condition, automated bridge for clarifiers 1 and 3 and clarifier 3 stilling basin to be refurbished, concrete outer ring wall structure for clarifiers 1 and 3 to be refurbished, the cracks on the civil overflows to be repaired, clarifier 1 automated bridge has broken scraper arms and should be refurbished/replaced and cleaned out, clarifier 2 automated bridge operates with some noise but is dysfunctional and should be replaced/refurbished, overflow weirs on 2 of the clarifiers to be installed; No backwash pumps installed scour airflow only, gravity filters – 1 of 2 blowers operational with no standby, backwashing 1 per shift, pressure filters – 1 blower operational with no standby, backwashing every 1 or 2 days, design issue with the new gravity filters media to be remedied

Clarification (settling)	66.7	
	Sand filtration	38.9	
7	Disinfection		Old and new reservoirs is 10 MI total, contact time is 20 min and insufficient (< 30 min), Free Cl ₂ measurement is taken from the water basin tap in the main office and ranges between 0.1 to 2 mg/l
	Clear water well	75.0	
8	High lift pumpstation	87.5	All pumps in working condition with sufficient standby, the final flow measuring device is functional for only 1 of the 2-pipe network
9	Sludge treatment		The sludge dam is not functional and has not been emptied only pipe blockages are sorted out, no recycling of the water
	Thickening in sludge dams	0.0	
10	Bulk pipeline from plant to command reservoir	50.0	Old asbestos pipeline has leaks but they are remedied, the new steel pipeline has no leaks, no cathodic protection for both pipe network, maintenance done on both pipe network and are adequately sized, the valve chamber viewed had missing manhole covers, one chambers exhibited rainwater ingress/flooding, no vent pipes mesh to prevent ingress of birds and animals

11	Command reservoir	18.8	Appear to be leak free, predominantly not closed at top as slabs/covers are almost all missing and not replaced to make secure from people and animals/birds, the fence has numerous gaps for easy access onto the site so 24 hr security in place, telemetry system not functional, no final flow measuring device in place
	Total	57.3%

1. No backup generator at the plant
2. Raw water flow meter not functional
3. Flocculation channel design for new (retention time too short) and flocculation channel for the old
4. 2 of 4 clarifiers automated bridges are dysfunctional.
5. New gravity filters media design correction; Replace standby blower; Investigate a backwash pump for bed expansion.

6. Chlorination unit is dysfunctional; Chlorine delivery and storage requires proper roads and access; Supply chain of 70 kg cylinders are soon to be replaced by 1-ton drums.
7. Install cathodic protection on the raw and final water pipe network; Fencing and manhole replacement to secure access and ensure adequate safety at the command reservoirs.

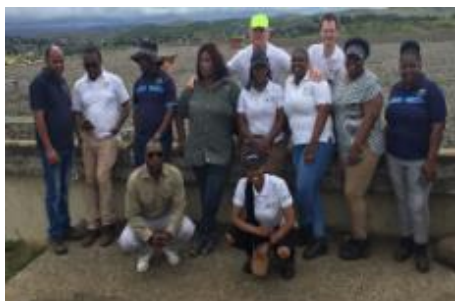
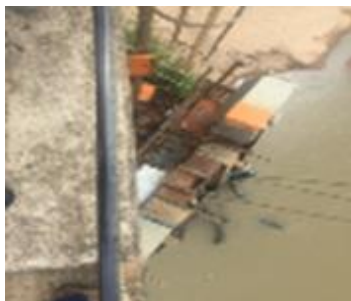
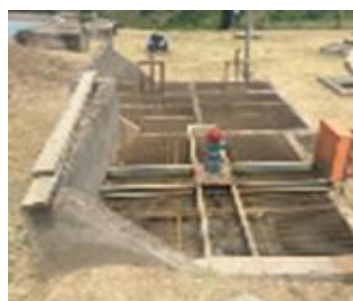
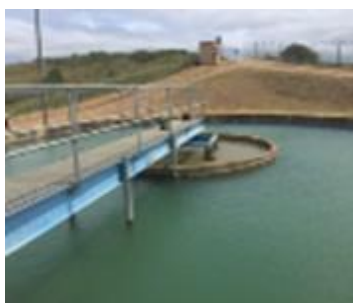
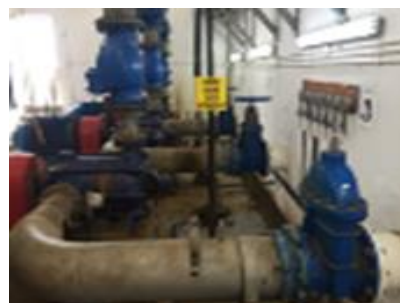
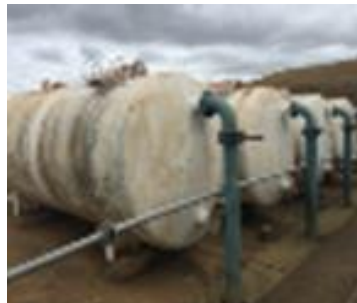
8.12 uMzinyathi District Municipality

Watch #	Process Unit Assessed	% TSA	Observations
1	General aspects	44.4	Works not classified. Maintenance logbook, operational logbook and a basic incident management is displayed with contact numbers. The process monitoring equipment is functional, but not calibrated up to date. Electricity consumption meter is not accessible to the onsite process controllers.
2	Physical appearance of plant	68.7	The entrance is marked with a signpost. A descent ablution facility with change house and eating facilities is required on the site. The roads require refurbishment.
3	Raw water handling		There are 4 deep-well submersible pumps that are all in good working condition. The civils and electrical panel are also in good working condition, and adequate pump set standby is available. The raw water pipeline is in fair condition, this gets maintained and painted timeously however, there is no cathodic protection. Flow is measured and recorded throughout the data is recorded on the operational logbook.

6	Phase separation		There are a series of package lamella settlers which are all clean and in operating condition. There is no floc carryover. Desludging of the units are done regularly.
	Clarification (settling)	100.0	
	Sand Filtration	100.0	There are only 4 sand filters, and they appear to be operating very well. There are no backwash pumps, the system works on hydraulic head flows to create a backwash flow the system is working well. Two air blowers are in good working condition.
7	Disinfection	100.0	Chlorine contact occurs in the final on-site reservoir and there is sufficient contact time. Chlorine is measured at the outlet of the reservoir using online chlorine meter. Additional chlorine dosing stations are present at the bulk reservoirs in case there is no residual chlorine in the system (this is being checked regularly).
	Clear water well	100.0	
8	High lift pump station	87.5	There are 3 high-lift pumps all have/are getting new motors and refurbished. Flows are recorded.

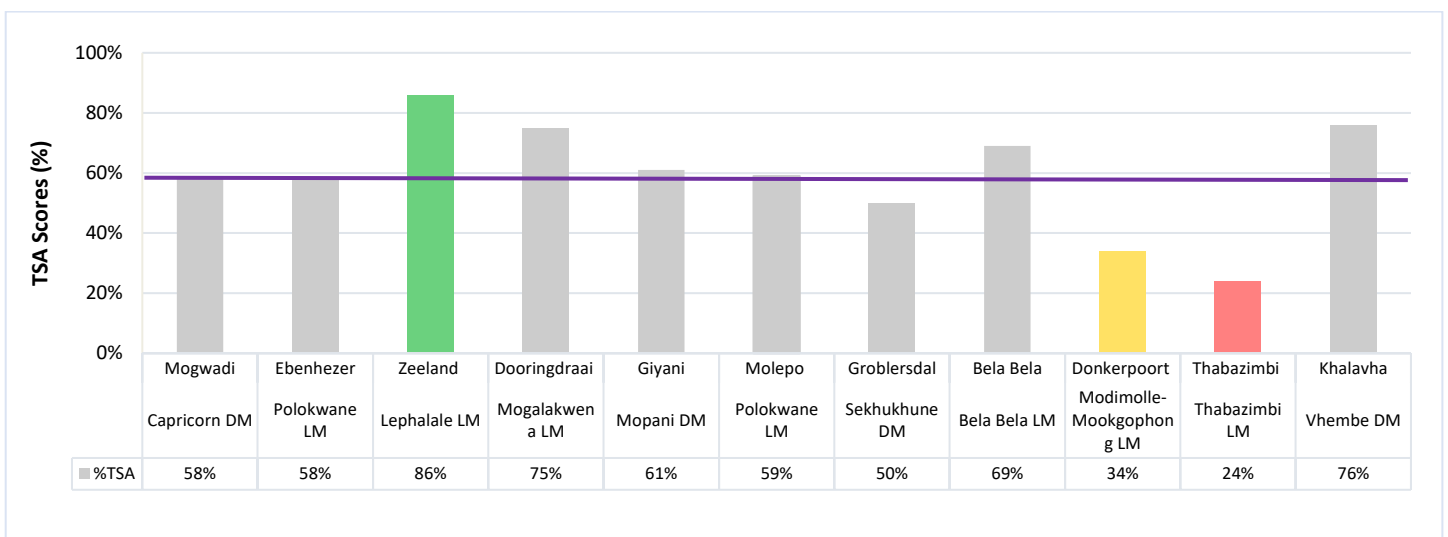
Figure 26 - LP TSA scores for all the BD Systems

An average of 59% was achieved for the 11 systems assessed, which means that infrastructure and processes are partially functional with an average performance. The best overall performance was found for Lephalale EXXARO, followed by Vhembe, and Mogalakwena. The WB/WSPs provided some of the better performing systems. On average, lesser performance was observed for Thabazimbi Chlorination Plant and Donkerpoort.

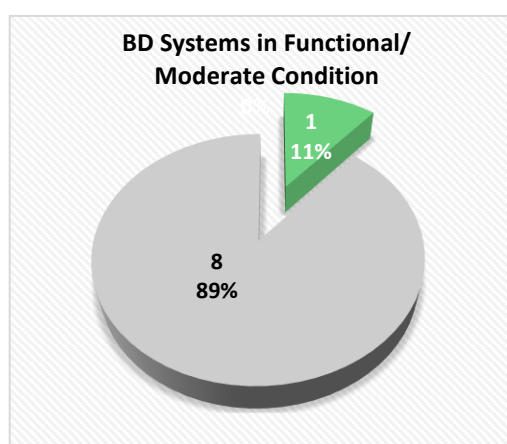
Figure 27 - No. BD Systems in Functional/ Moderate Condition

- 1 system (11%) was in good condition
- 8 systems (89%) were in average condition.

Only one system managed by EXARRO was found to be in good condition.

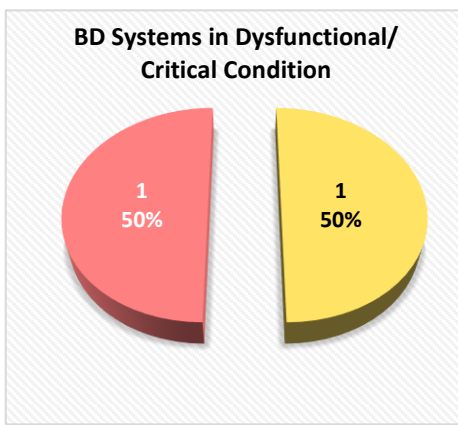
Figure 28 - No. BD Systems in Dysfunctional/ Critical Condition

- 1 system was in poor condition
- 1 system was in critical state.

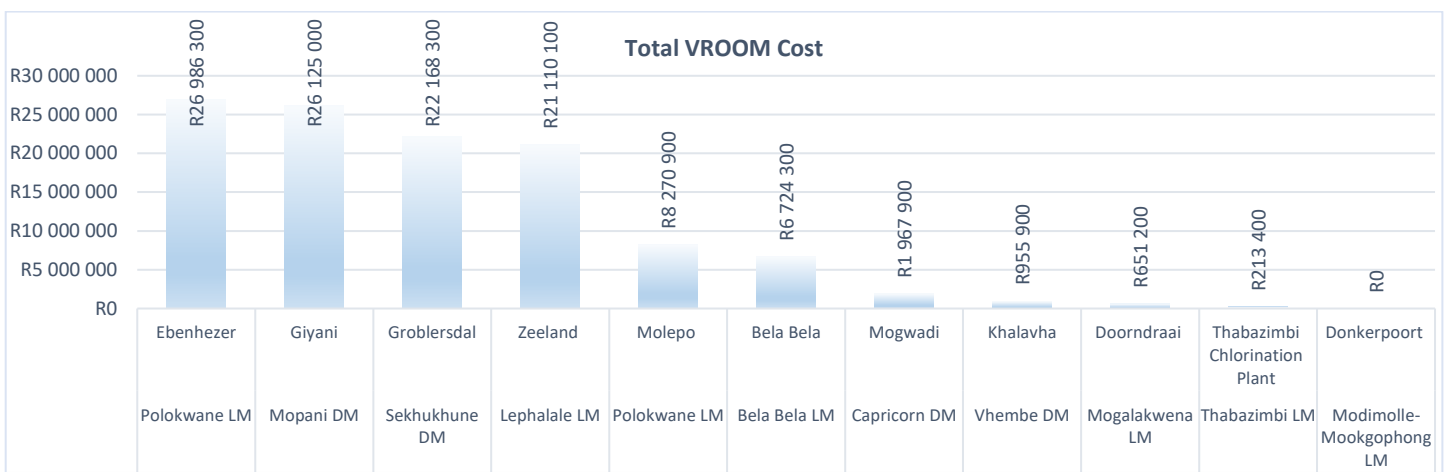
Figure 29 - Total VROOM Cost for the BD Systems Assessed

The associated VROOM costs for the 11 water supply systems assessed amounts to R144.5 million, with the bulk of investment needed for Donkerpoort (Modimolle-Mookgophong), Giyani (Mopani) and Ebenhezer (Polokwane).

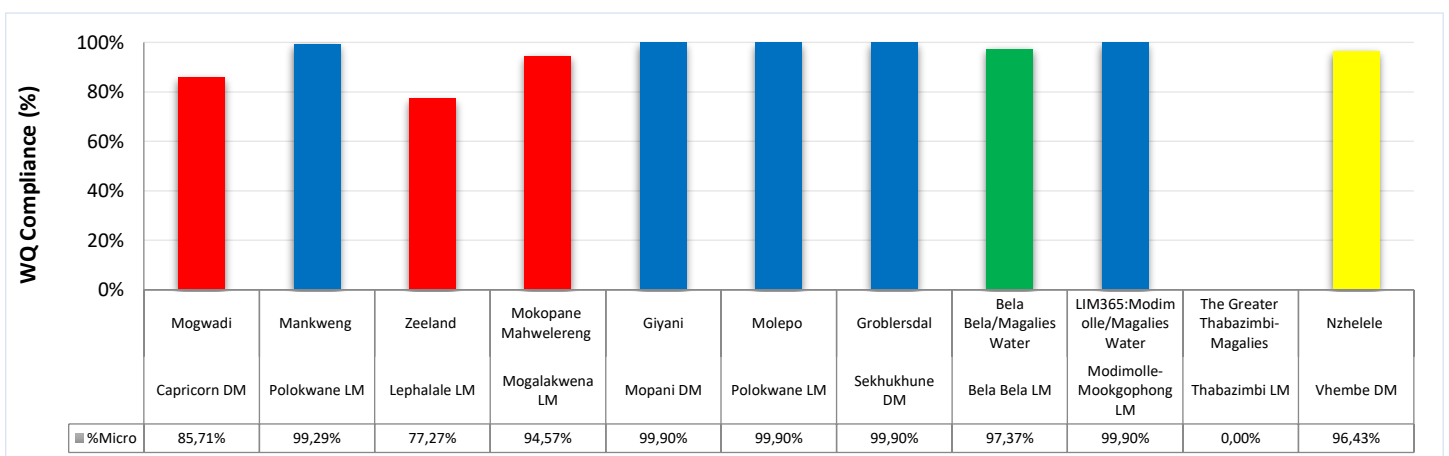
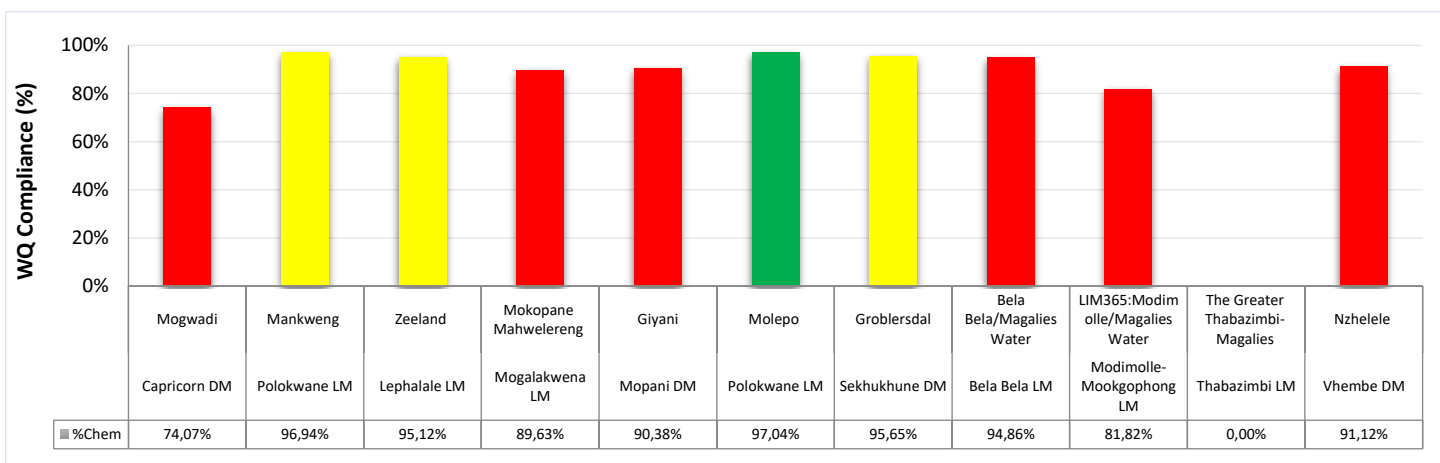
Figure 30 - LP Drinking Water Quality Status of all the TSA Water Supply Systems

The TSA and water quality results depict a vastly different picture. The TSA shows 9 of the 11 water supply systems to be in the *excellent to average performance category*, and the water quality compliance shows that 46-91% of the systems *fail to produce compliant final water quality*.

Out of 11 treatment plants, 5 (45%) and 1 (9%) of systems achieve excellent and good microbiological quality. A total of 1 (9%) system has poor microbiological water quality status and 4 (37%) systems have a bad microbiological water quality status. The water in these systems poses a serious acute health risk to the community. WSAs with poor microbiological water quality status must be assessed to confirm status in all systems to ensure rectification measures are comprehensive to safeguard communities. The direct cause of microbiological failures can be linked to the TSA sub-watch Area 7, which has a low contribution to the overall TSA score. The failure to produce water that meets E. coli standards can be linked back to poor operations, defective infrastructure, dosing rates, absence of disinfection chemicals, lack of monitoring, or lack of operating and chemistry knowledge. WSIs that are not monitoring the final water quality at the outlet of the treatment plant or at specific end use points must develop a monitoring programme and resume with compliance monitoring as a matter of urgency.

Chemical compliance shows that 1 (9%) has good water quality, whilst the majority of systems fail to achieve chemical compliance. A total of 3 (27%) and 7 (64%) systems have a poor and bad chemical water quality status.

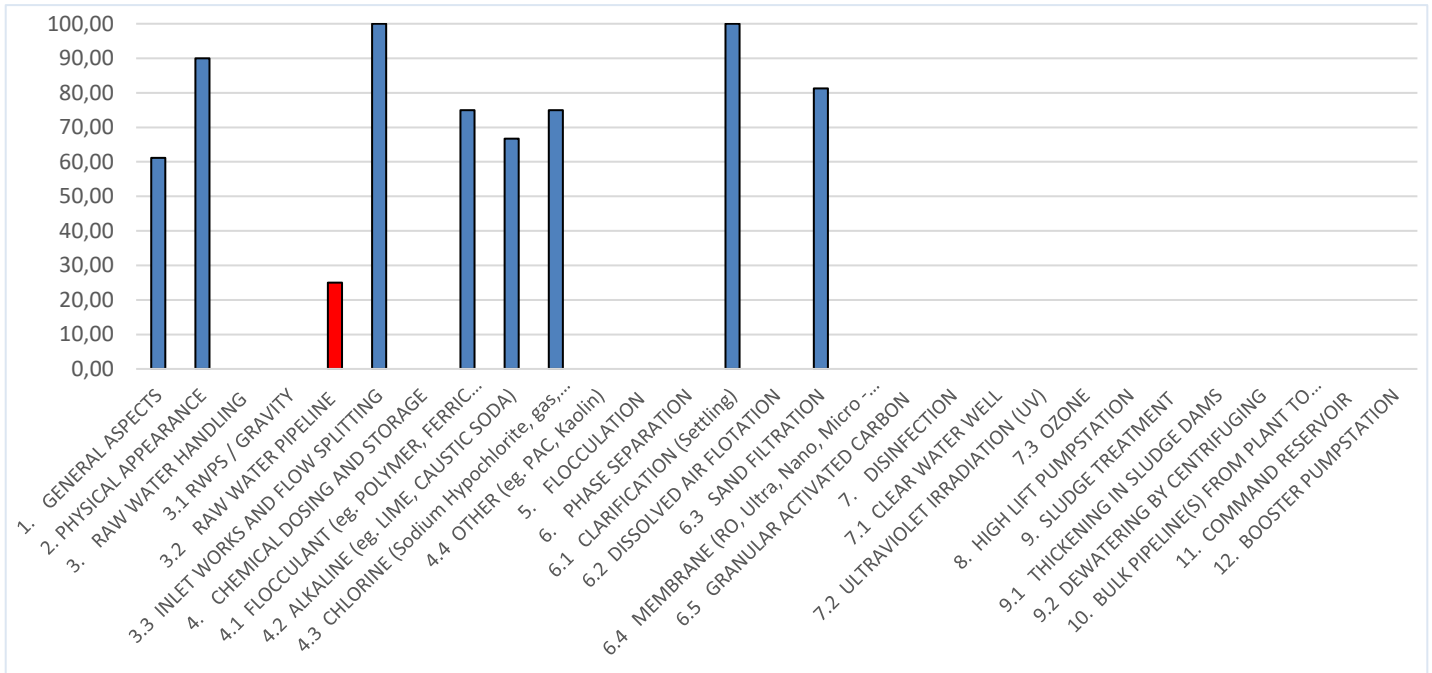
Performance Profile

The following process units were inspected and rated according to the % score on the y-axis. Process units that score <50% are marked in red and needs urgent intervention.

Watch #	Process Unit Assessed	% TSA	Observations
1	General aspects	61.1	The PFD and IMP were not displayed, all other documents available. The equipment is functional, but no proof of calibration was presented. We were informed that a jar test is performed as and when it is required, and not on a regular basis. All the apparatus to do the test is however not present. The audit team was informed that the electricity meter is available and that the use is recorded.
2	Physical appearance of plant	90.0	Facility is well fenced. The roads are in good condition. The facility is tidy however the grass was long and needs to be cut, also there were weeds growing on the pavement. Safety signs in place but is not covering all the areas of operation.
3	Raw water handling		
	Raw water pumpstation/ gravity feed	na	Water gravitates to the plant.
	Raw water pipeline	25.0	Pipeline not assessed, however there was a leakage observed from the valve at the entrance to the plant. There is no replacement valve available. Inflow meter in place but not verified. Just meter reading is taken once per shift, but no interpretation.

5	Flocculation	na	No flocculation facility available.
6	Phase Separation		
	Clarification (settling)	100.0	The water was clear with fish in the clarifier which is a good indication of the water quality. Regular de-sludging taking place. Weir structures are in good condition and free from growth.
	Sand filtration	81.3	Three pumps installed, one pump on standby. Air blowers installed. Filter media could not be assessed due to high turbidity water on the filter and no filter backwash demonstration. Housekeeping can improve.
7	Disinfection		
	Clear water well		Not assessed due to time constraints
8	High lift pumpstation		Not assessed due to time constraints
9	Sludge treatment		Not assessed due to time constraints
10	Bulk pipeline from plant to command reservoir		Not assessed due to time constraints
11	Command reservoir		Not assessed due to time constraints
12	Booster pumpstation		Not assessed due to time constraints

1. No standby lime feeder resulting in the package plant not being used.
2. No standby valves available in the store, resulting in leakages and water losses.
3. Flocculation channels are not provided for in the design of the plant.
4. No diesel is available for the onsite generator.
5. Occupational Health and Safety aspects of the gas chlorination plant needs urgent attention.

- Ensuring that the treatment technology used at Doorndraai Dam is well maintained, timeously repaired, and updated.
- Process Controllers should be encouraged to apply good process control practices and to continuously optimise treatment and distribution processes.
- Water Safety Planning should be the way of doing business and should include all risks in terms of providing a water service.
- Although the microbiological quality of the bilk water provided to the WSA complies to SANS 241, attention needs to be given to chemical water quality and monitoring compliance.

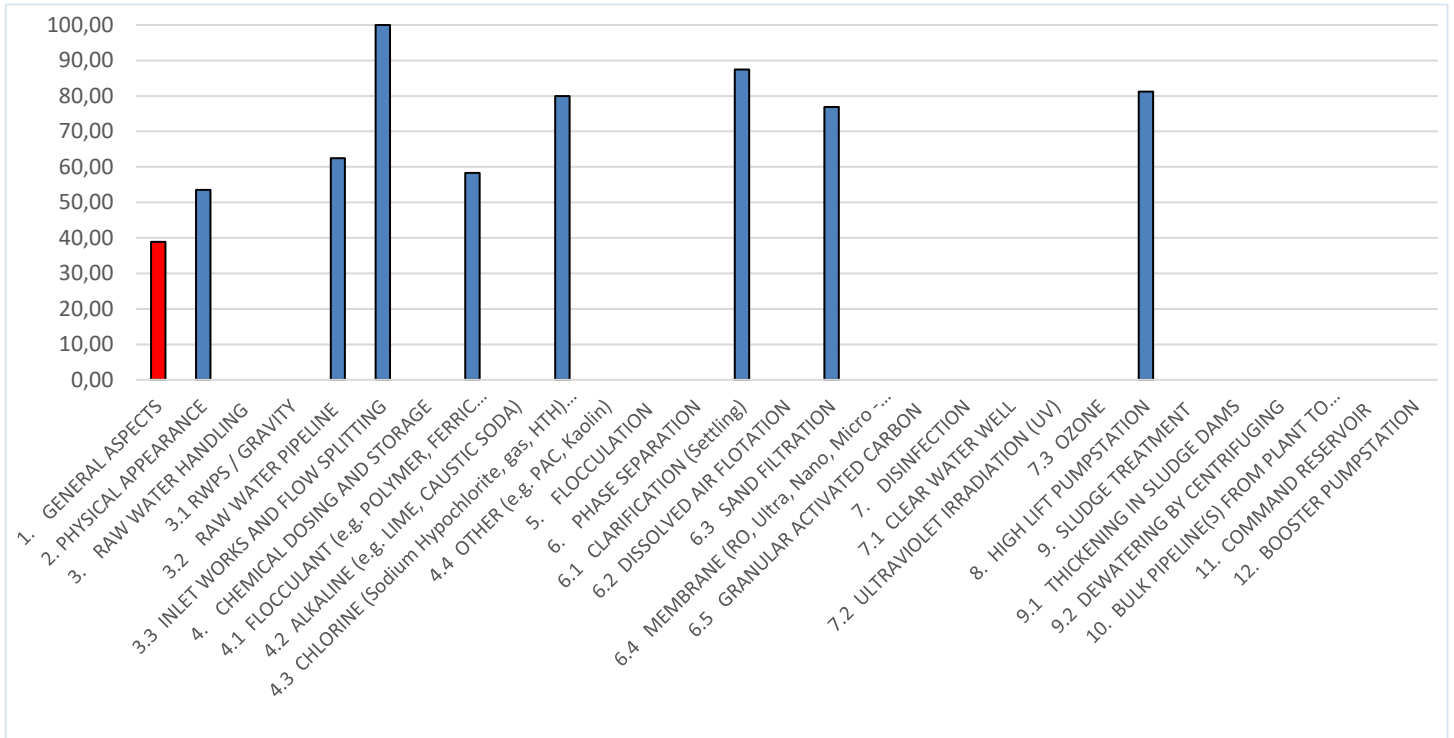
Performance Profile

The following process units were inspected and rated according to the % score on the y-axis. Process units that score <50% are marked in red and needs urgent intervention.

Watch #	Process Unit Assessed	% TSA	Observations
1	General aspects	38.9	The plants is classified as a Class B water treatment works. Operational logs and O&M manual are on site. No maintenance logbook, IMP of PFD are available / displayed. Process monitoring equipment is functional but no proof of calibration. Jar test is said to be done by main laboratory which was not assessed.
2	Physical appearance of plant	53.6	Facility is well fenced and the roads in a good condition. General housekeeping can improve. The interior of the buildings is in a good condition. Several open manholes were observed. The Oxygen Pack for Chlorine room is not secured, and basic Chlorine dosing room safety is not observed. Safety signage should improve significantly.
3	Raw water handling		
	Raw water pumpstation/ gravity feed	na	Pumpstation could not be assessed during loadshedding.
	Raw water pipeline	62.5	Inflow meter in place but not verified. Just meter reading is taken once per shift, but no interpretation.

Inlet works	100.0	Flash mixing is effective. Chemical feed can be monitored. Dropdown facility also available at the dosing pumps.
4	Chemical dosing and storage		
	Flocculant	58.3	Housekeeping in the dosing unit can improve. Present stock, Ultrafloc 3600 for 14 days. 30 Tons on order. No bunding area. Two pumps installed with dropdown testing unit. One pump on standby. Emergency shower not observed during the assessment.
	Alkaline	na	The plant was designed and build with lime dosing facilities which is no longer being used. No proper and scientific definition could be given for it other than that the pH is high enough. No mention was made about the stability of the water.
	Chlorine	80.0	All units are said to be in working condition. One standby chlorinator. Scale is working and switch-over device in place. Safety equipment available but status of it is unknown. Oxygen cylinder and mask in open cupboard outside the building. There is no compliance to occupational safety practices.

5	Flocculation	na	Loadshedding prevented observation regarding flocculation and floc formation in the round clarifiers.
6	Phase Separation		
	Clarification (settling)	87.5	De-sludging valve is said to work every time the bridge pass. It is not known of the valve opens long enough to remove all the sludge. Weir structures are in good condition but covered with biofilm.
	Sand filtration	76.9	Two backwash water pumps are installed but the up-flow capacity is questioned. One pump on standby. Air blower installed. Flow from the 4 clarifiers is evenly split to the sand filters. Good distribution of air during air scouring. Media surface is uneven and covered with thick layer of sludge and signs of cracks. Some filter walls are dirty. At Filter 8, backwashed during assessment, the presence of mudball is evident. This is due to improper backwash procedure and low up flow rate of during backwashing.
7	Disinfection

Clear water well	0.0	No information available on the CWW and Free Chlorine measurement.
8	High lift pumpstation	81.3	Nine pumps installed. Seven in working condition. Final flow meter in place but not verified. Flow records captured.
9	Sludge treatment		
	Thickening in sludge dams	0.0	Sludge dams have not been emptied in the past two years.
10	Bulk pipeline from plant to command reservoir	na	This unit could not be assessed due to time availability
11	Command reservoir	na	This unit could not be assessed due to time availability
12	Booster pumpstation	na	This unit could not be assessed due to time availability
	Total	61%

1. Filter sand contains mudballs.
2. Filter backwash pump capacity needs to be confirmed.
3. Chlorine dosing facilities need to be tested and equipped with safety signs and steps.
4. Replace the Central Columns of clarifiers.
5. Arial photos show a 5th clarifier, that not in service.

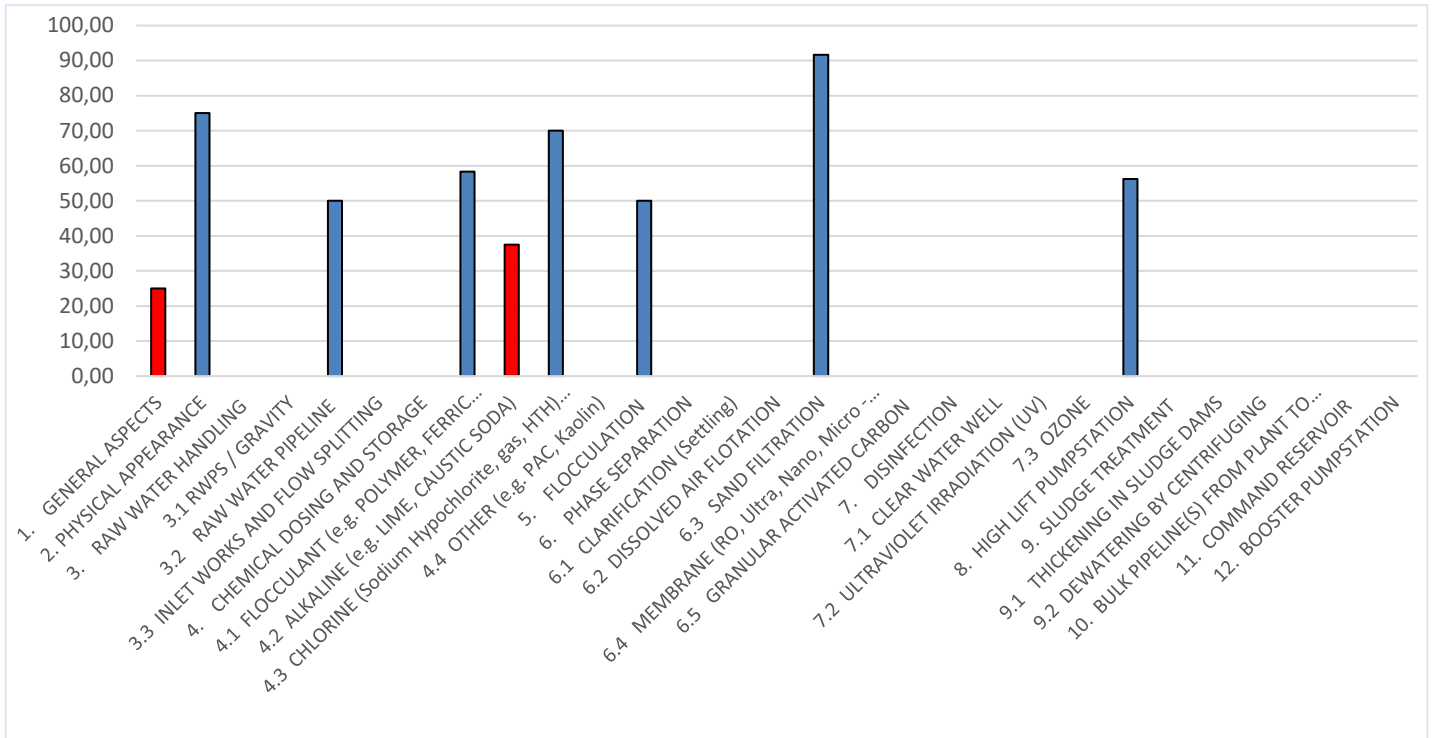
Performance Profile

Ebenhezer Water Treatment Plant TSA Score: 58%

The following process units were inspected and rated according to the % score on the y-axis. Process units that score <50% are marked in red and needs urgent intervention.

Watch #	Process Unit Assessed	% TSA	Observations
1	General aspects	25.0	The plant was designed as a direct filtration plant. No process flow diagram and incident management protocol/ contact numbers are displayed on site. Other critical items for the sustainable operation of the plant are also missing. The electricity meter onsite and read by electrician but readings is not used to improve the efficiency of the plant.
2	Physical appearance of plant	75.0	The facility is fenced, and the roads are in a good condition. Natural grass should be cut inside the fenced area. General housekeeping can improve. At lime dosing facility, the grid corroded and presents a safety hazard. Safety signs are generally missing. Open electrical cables were observed at several places on the plant.
3	Raw water handling		
	Raw water pumpstation/ gravity feed	na	Water is gravity fed from the Ebenezer Dam, but infrastructure could not be assessed.

5	Flocculation	50.0	Poly added as a filtration aid. No micro flocs observed after flocculation period. The flocculation channel is clean.
6	Phase Separation		
	Sand filtration	91.7	Two backwash pumps are installed with one on standby. Air blower installed. Even flow splitting to all filters observed. Good distribution of air during air scouring. Signs of broken nozzles were observed during backwashing. Filter walls dirty, in some cases, weeds are growing in the filters. The only filter used, filter 1, is not washed down during backwashing. General Maintenance required.
7	Disinfection		
	Clear water well	na	Disinfection with chlorine gas is taking place, but the efficiency thereof was not assessed.
8	High lift pumpstation	56.3	Six pumps installed and in working condition with only 30 % on standby. Final flow meter in place but not verified. Flow records captured.
9	Sludge treatment		
	Thickening in sludge dams	na	Not assessed due to time limitation

- ◆ Ensuring that the treatment technology used is well maintained, timeously repaired, and updated.
- ◆ Process Controllers should be encouraged to apply good process control practices and to continuously optimise treatment and distribution processes.
- ◆ Water Safety Planning should be the way of doing business and should include all risks in terms of providing a water service.
- ◆ Although the microbiological quality of the bilk water provided to the WSA complies to SANS 241, attention needs to be given to chemical water quality and monitoring compliance.

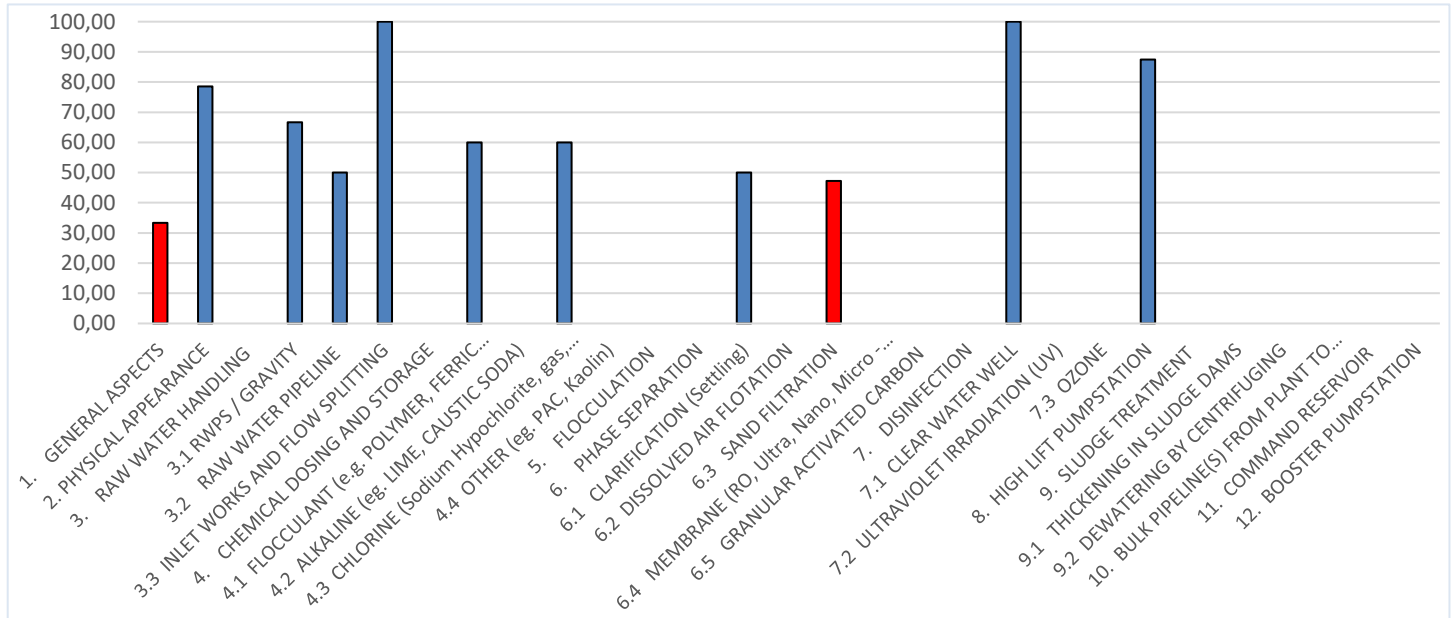
Performance Profile

Molepo TSA Score: 59%

The following process units were inspected and rated according to the % score on the y-axis. Process units that score <50% are marked in red and needs urgent intervention.

Watch #	Process Unit Assessed	% TSA	Observations
1	General aspects	33.3	Class C WTW. Operational logbook on site, but no other documentation available. Turbidity meter and Chlorine meter on site but no proof of calibration. Glassware dirty. Jar tester in the laboratory but glassware to conduct the test with, is not available. No standard operating procedure available. Electricity meter available but not read.
2	Physical appearance of plant	78.6	The facility is well fenced. General housekeeping can improve. Inside of buildings in good condition. Roads in good condition. Open man holes. Oxygen cylinder for Chlorine room found inside the chlorine room and not in the outside container, open manholes. These issues seem not to receive attention. Safety signs in place.
3	Raw water handling		
	Raw water pumpstation/ gravity feed	66.7	Inlet not assessable. Two pumps installed. Both in working condition and are operated alternatively.

Watch #	Process Unit Assessed	% TSA	Observations
	Clarification (settling)	50.0	Due to poor floc formation, the water is not clear at the end of sedimentation with micro-flocs being present. De-sludge only once per week. Weir structures are in good condition but covered with sludge that may prevent even and free flow.
	Sand filtration	47.2	Two backwash pumps installed with 100% standby available. Only one air blower installed. Only one of bed of filter 1 can be backwashed with water. Good distribution of air during air scouring. Media surface is uneven and covered with thick layer of sludge. Filters are backwashed once per week. Filter wall dirty, in some cases, weeds are growing in the filters. The only filter used, filter 1, is not washed down during backwashing.
7	Disinfection		
	Clear water well	100.0	Contact time is 5 Ml reservoir is several hours. Free Cl2 tested at final water sample point.

1. Free ozone reading in water not possible.
2. Lime handling needs to be addressed.
3. Illegal connections need to be removed.
4. Leakage at the reservoirs need to be repaired.
5. Supervisor and Process controllers needs plant-based process management training.

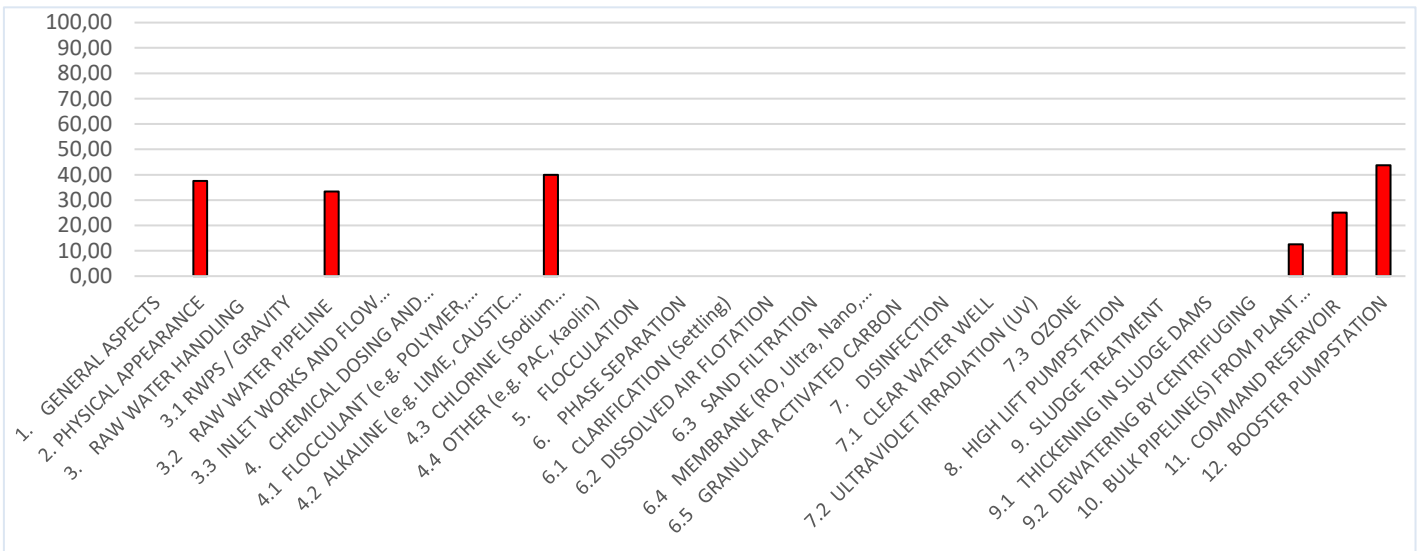
Performance Profile

The following process units were inspected and rated according to the % score on the y-axis. Process units that score <50% are marked in red and needs urgent intervention.

Watch #	Process Unit Assessed	% TSA	Observations
1	General aspects	0.0	Not displayed on the wall and the classification is incomplete. There is no maintenance and repairs logbook at the chlorination plant. There is no operational logbook at the chlorination plant.
2	Physical appearance of plant	37.5	Entrance not signposted. The surrounding is fairly clean. Power cable exposed and near water in the pump station. The facility is fully fenced with lockable gate. There was a security guard on site with proper access control. The safety signs were displayed outside the chlorine room only.
3	Technical

3.1	Borehole pumps and delivery line to reservoir	na	Not assessed as the pumps are in the property of the mine.
		33.3	Raw water pipeline is made of steel and is fairly in good condition. Municipal officials were unable to confirm whether they were leaking or not due to a lack of maintenance plan. Inflow meter for the borehole water is in place and operational.

3.2	Chlorine	40.0	Pumps are in good condition. Although the pumps are in good shape, the pipes are now blocked, and chlorine gas cannot flow freely because they have not been used for the past two years. There is a standby dosing unit which is not operational due to unavailability of chlorine gas. The chlorine gas cylinders were empty and was no available stock for the past 2 years.

3.4	On-site reservoir	0.0	The reservoir is 2m ³ in size and has a contact time of more than 30 minutes. The pipeline from the booster pump to the reservoir is 7 km long. however, chlorine is not dosed.
4	High lift pumpstation	na	The water is pumped to the command reservoir from the chlorination plant, which also serves as a booster pump station.
5	Bulk pipeline from plant to command reservoir	12.5	The bulk pipeline that runs from the booster pumpstation to the reservoirs has been reported to have significant leaks.
6	Command reservoir	25.0	There are two reservoirs in Regorogile: 10 Ml/d each. There is a security guard onsite as well as proper access control. The facility is fully fenced, and gate is lockable however the track rail was detached from the ground. There is no telemetry, and the reservoir are not operational
7	Booster pumpstation	43.7	Four booster pumps installed only two were operational. The standby pumps were not operational. The building is secured and there was sufficient ventilation. The pumpstation was flooded with water from the boreholes. MCC is in good condition.

1. The Thabazimbi LM personnel do not have control over the flow pumped from the mine to the chlorination plant, making it difficult to manage overflows and leaks.
2. The community receives water from water tankers because the two reservoirs don't have any water.
3. There chlorination plant has not been dosing the chlorine gas for the past 2 years due to unavailability of chlorine gas cylinders.
4. There is no regular bulk pipeline maintenance, and the bulk pipeline is said to be leaking and old.
5. There is no planned project/maintenance for the reservoirs to be operational.

Borehole water is pumped from the mine into the municipal reservoir which has a booster pumpstation and then get chlorinated before being distributed to the community. In the reservoir, borehole water blends with Magalies Water. The reservoir volume is estimated to be 2 m³ and is old and has cracks in it and the inlet pipes were deteriorating and rusting.

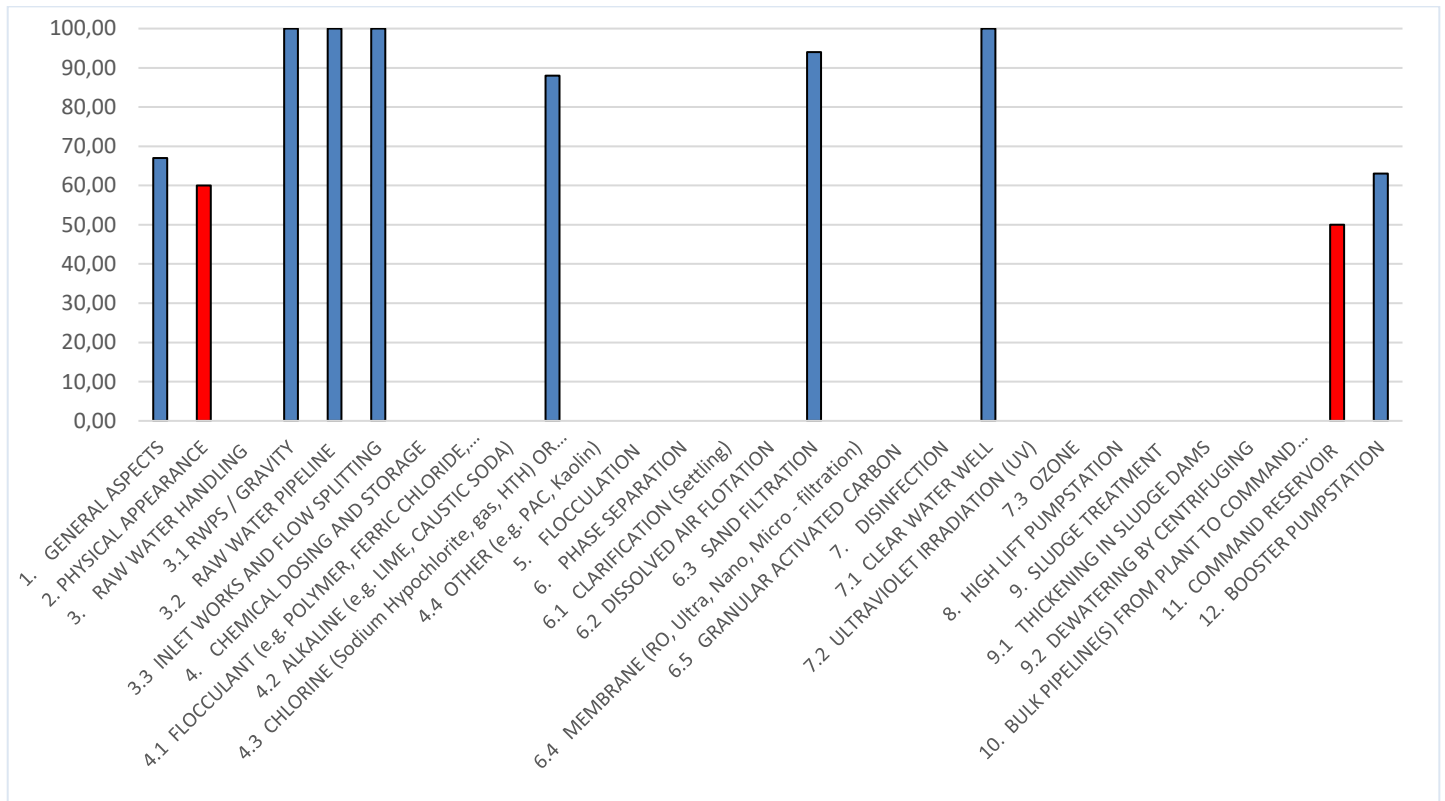
Performance Profile

The following process units were inspected and rated according to the % score on the y-axis. Process units that score <50% are marked in red and need urgent intervention.

Watch #	Process Unit Assessed	% TSA	Observations
1	General aspects	67.0	This is a Class C plant. Of the general aspects inspected, repairs logbook and process monitoring kit and Jar test were the only items which did not get full score of Blue Drop standard.
2	Physical appearance of plant	60.0	Of the items inspected under Physical appearance: Key items that did not comply to Blue Drop standards is the road access to the plant especially when it is raining because of the poor road surface and poor storm water management. This item is quite important for bulk delivery of water treatment chemicals to the plant and access to the staff working in the plant. It could lead to staff unsafety. In addition the two leaking pressure filters caused nuisance wetness and slippery conditions in the plant. Also there is no signage at the entrance of the plant.
3	Raw water handling		The raw water handling is generally good. Source is surface water dam; screens are in place and are cleaned regularly. The 350mm gravity line is steel new and in December 2022 a flow meter was installed and now the plant will record the flows which was not done in the period of assessment July 2021 till June 2022. This item scored less because there are no flow records in the assessment period. The Inlet works splits into two to each train of the pressure filters i.e. no pre-sedimentation here due to low turbidity water and only filtration and disinfection is done.

Raw water pumpstation / gravity feed	100.0	
	Raw water pipeline	100.0	
	Inlet works	100.0	
4	Chemical dosing and storage		The only water treatment chemical used is a solution of HTH granules and water. The make-up tanks for it is 2 x 1000L tanks and each tank has its own stirrer and own dosing pump. However both stirrers are taken out for repairs resulting in staff using a stick to stir the solution make. It is a hazardous matter needing the attention of the Municipality for the stirrers to be fixed and returned back. The score of 100% does not reflect to the (OHS) hazard situation BUT to disinfectant dosage of purified water to community.
	Flocculant	na	
	Chlorine	88.0	
5	Flocculation	na	Not applicable i.e. no water treatment flocculent is added
6	Phase Separation	na	No phase separation
	Clarification (settling)	Na	No settling tanks
	Sand filtration	94.0	There are twelve pressure filters (in two trains of six). The filters were installed in 2018, However two are leaking and causing nuisance water on the floor surface of the warehouse in which the plant is housed. This is water wastage and hazard situation. The leaking two filters need urgent attention i.e. Filter No.5 and 6 in one train. The pressure filters have ONLY two backwash pumps i.e. a 1 x duty and 1 x standby no air blowers. In addition the Head from the raw water dam takes water through the filters to the clean water reservoir i.e. no pumping through the filters.

12	Booster pumpstation	63.0	There are two submersible pumps. Only one is working and the standby is taken out for repairs. It is the only item that is noted and needed the attention of the Municipality at this Booster Pump Station at the time. However, in March 2023 the District Municipality confirmed that the pump is re-installed.
	Total	76%

1. All flow meter the District Municipality must implement the best practice of verification or calibration as well keep records of flow. It is to ensure that the plant is not operated beyond the capacity and also to ensure water balance.
2. Pressure filters No.5 and No.6 that are leaking at gaskets of the "domes" must be fixed. It is causing water wastage and wet nuisance in the plant.
3. The road to the plant is not accessible by vehicles during rainy season. It would result in difficulties for deliveries as well the emergency services to access the plant.
4. All operational monitoring tests e.g. pH, Turbidity and Jar test must be checked regularly and as required by the Operation and Maintenance Manual of the plant and Blue Drop requirements.
