BLUE DROP

Watch Report

BLUE DROP WATCH REPORT 2023: TECHNICAL ASSESSMENT OF THE CONDITION OF MUNICIPAL DRINKING WATER TREATMENT AND DISTRIBUTION SYSTEMS IN SOUTH AFRICA

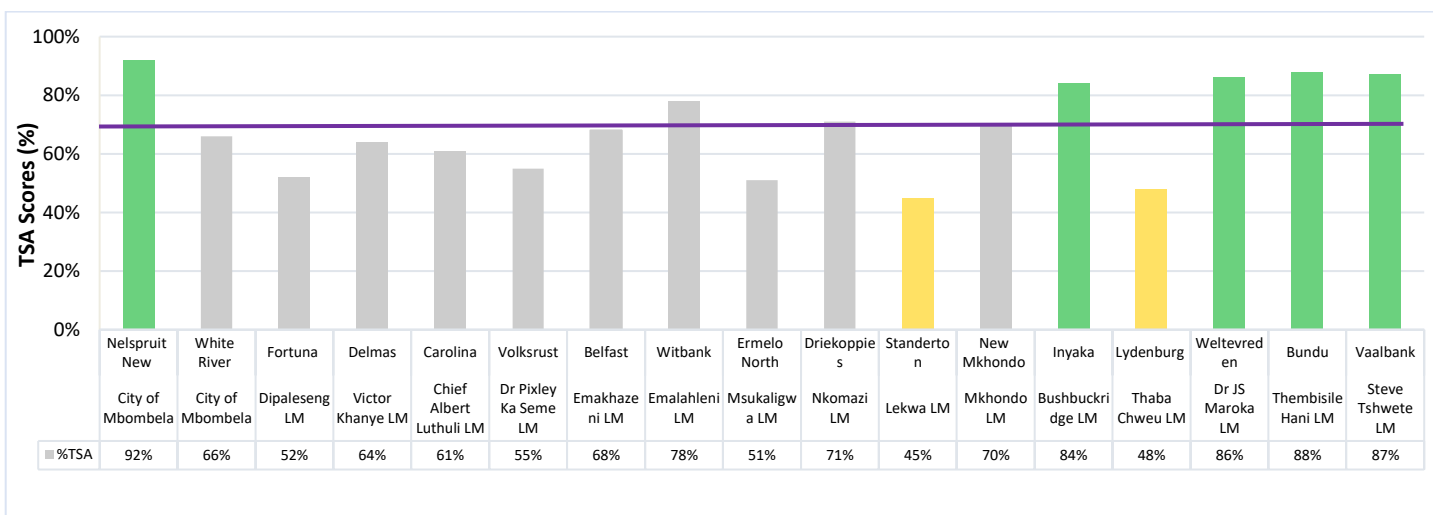
Figure 31 - MP TSA scores for all the BD Systems

An average of 69% was achieved for the 17 systems assessed, which means that infrastructure and processes are partially functional with an average performance. The best overall performance was found for City of Mbombela, followed by Thembisile Hani, Steve Tshwete and Dr JS Moroka. Lower performances were observed for Standerton and Lydenburg.

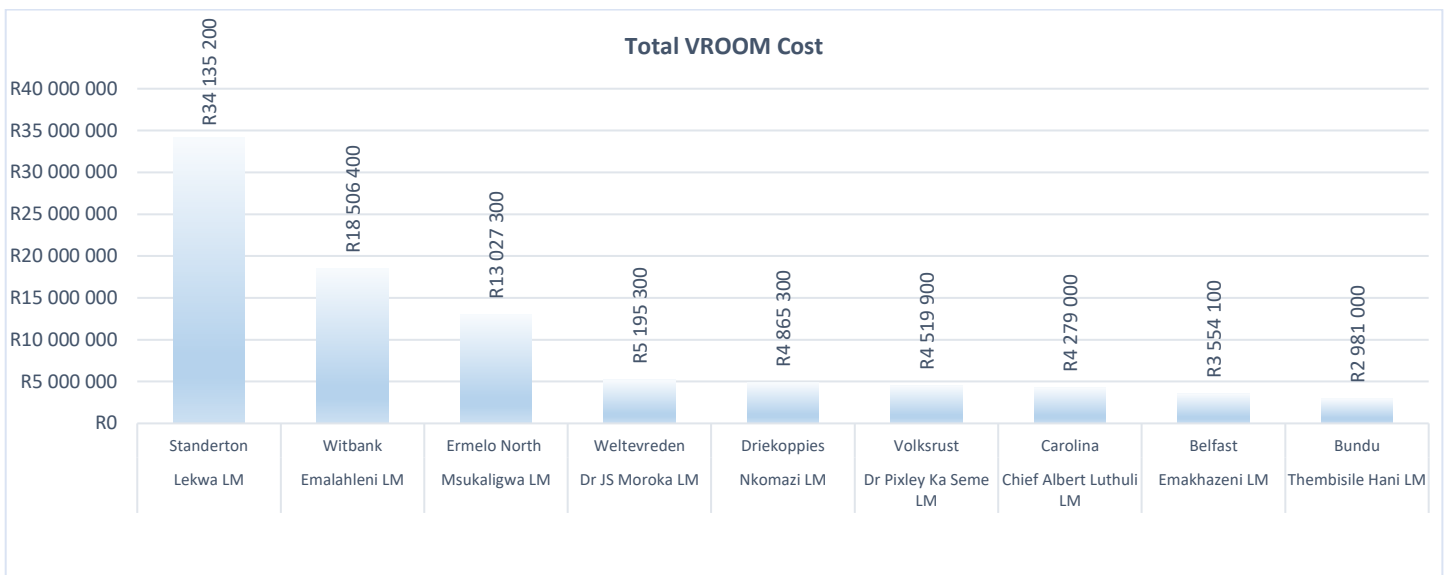
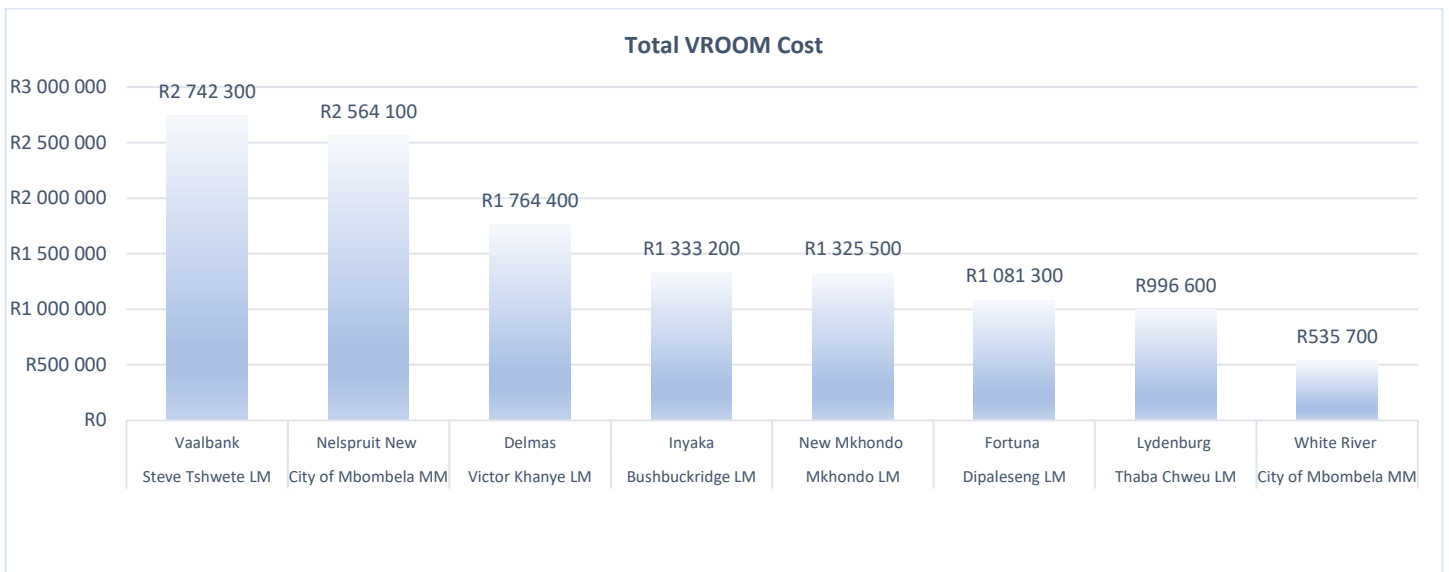
Figure 33 - Total VROOM Cost for the BD Systems Assessed

The associated VROOM costs for the 17 water supply systems assessed amounts to R103.4 million, with the bulk of investment needed for Standerton (Lekwa), Witbank (Emalahleni) and Ermelo North (Msukaligwa).

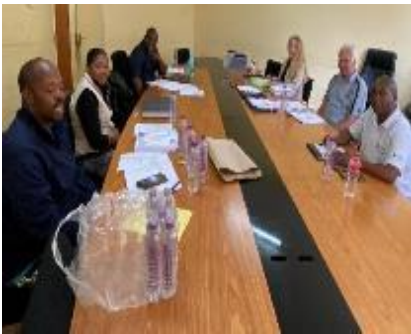
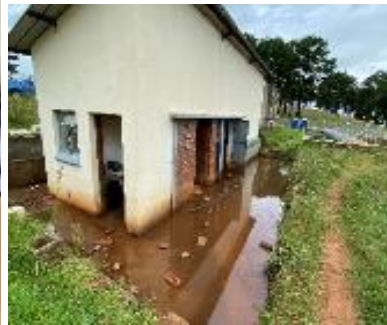
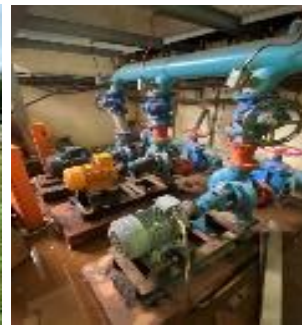
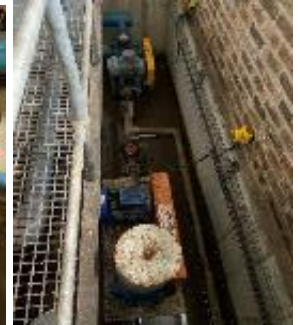
Watch #	Process Unit Assessed	% TSA	Observations
1	General aspects	27.8	Class B plant, maintenance, and repairs logbook not on site, hand-written logbooks are kept on-site, no O&M on site, no operational monitoring or jar-tests done, no PFD displayed, energy use must be recorded in plant logbooks and used for plant optimisation, the PCs need more equipment and/or tools as well as printed log-sheets which lists all the required aspects to be monitored on a daily basis.
2	Physical appearance of plant	18.8	The site is securely fenced but there is no signage, the access road is in a poor condition, there are construction activities on the site as the plant is being upgraded, there is however no effort to keep housekeeping in order even at the unit processes where the normal operation continues, there is no site management, the WSI was advised to urgently meet with the contractor and ECO and sort out the unacceptable state, no dedicated room for preparing lunches for PCs, the wash facilities and ablution were under water during the audit some OHS aspects were noted, <i>i.e.</i> falling and/or tripping hazards, chlorine handling, safety of female PCs, safety signs not adequate, fire extinguisher service date expired.

7	Disinfection		
	Clear water well	100.0	Contact time is more than 30 min, free chlorine measurement is done at the outlet point.
8	High Lift Pump Station	25.0	3 pumps are installed, 2 in working condition, no stand-by available which is a risk.
9	Sludge Treatment		
	Thickening in Sludge Dams	0.0	There is no sludge treatment, sludge is released directly into the stormwater system.
10	Bulk pipeline from plant to command reservoir	100.0	The PC indicated that there were no problems, valve chamber in good condition
11	Command reservoir	72.5	The site is fenced, and security available, no telemetry, one leak was observed.
12	Booster Pump Station	100.0	Two pumps installed, one in operation and one on standby, building is secure and within the security fencing of the reservoirs, MCC is in good condition.
	Total	61%

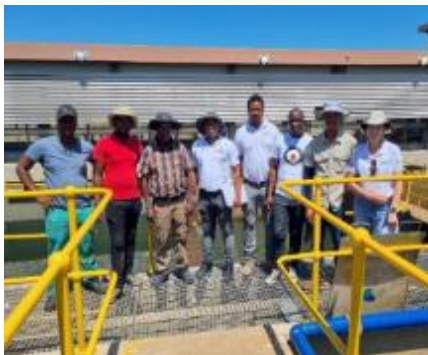
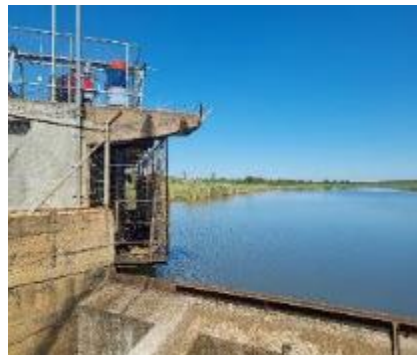
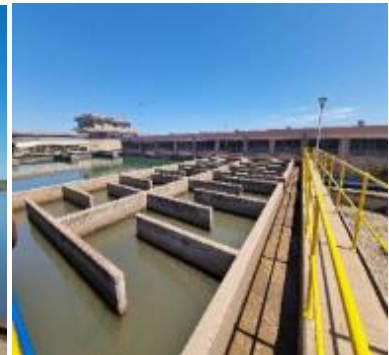
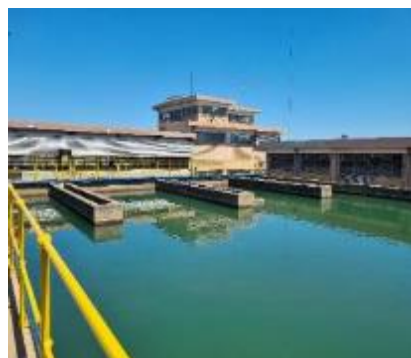
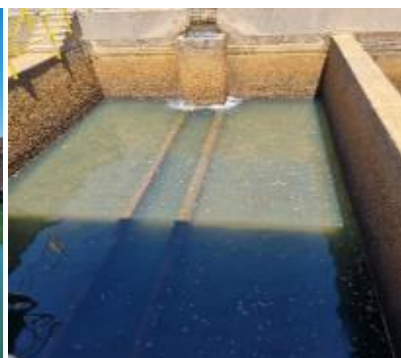
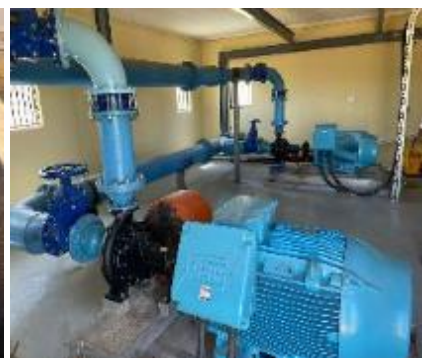
1. Final flow meters have been vandalised, in process of repair but security needs to be improved.
2. Half of the sand filters are offline for maintenance of the valves.
3. The sludge dams need to be cleaned, the area rehabilitated, and sludge handling facility upgraded.
4. Bulk pipe network are asbestos pipes that experience leaks but are in the process of replacement.
5. Flow metering not available at command reservoir.

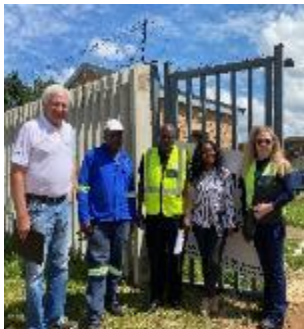
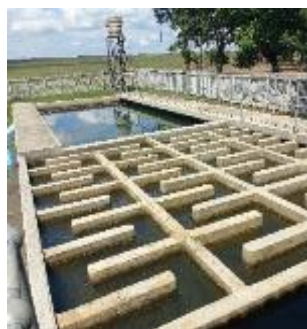
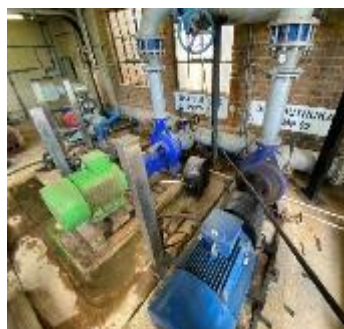
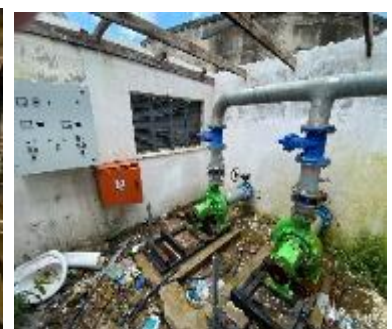
Watch #	Process Unit Assessed	% TSA	Observations
1	General aspects	72.2	Class C plant, hand-written logbooks are kept on-site, no O&M on site, no PFD displayed, signage at gate, energy use must be recorded in plant logbooks and used, the PCs need more equipment and/or tools as well as printed log-sheets which lists all the required aspects to be monitored daily.
2	Physical appearance of plant	78.1	Fenced, fairly neat terrain, access road needs to be addressed good housekeeping, OHS corrections at the WTW to include falling and/or tripping hazards and chlorine handling.
3	Raw water handling		
	Raw water pumpstation / gravity feed	50.0	The main source of raw water is the Belfast Dam which is just downstream from the Belfast WWTP and therefore the quality of raw water may be impacted, a small supplementary source is available from the Kraaispruit Dam OHS corrections required at the raw water pump station are numerous and range from electrical to tripping hazards, back-up pumps are not operational.

Sand Filtration	75.0	Two backwash pumps are installed, and one is in working condition, stand-by pump is not operational, air blower in operation but no stand-by available, two filters out of operation due to problems with inlet channel gates
7	Disinfection		
	Clear water well	100.0	Disinfection is done with chlorine gas and contact time is more than 30 minutes, free chlorine measurement is done at the discharge point from the clearwater sump
8	High Lift Pump Station	75.0	The high-lift pumpstation is 1,9 km away from the WTW site, four pumps are installed - two to Belfast and two to Siyathuthuka, two pumps in operation and two pumps are defective, no stand-by pumps available which poses a risk, inline flow meters operational, flow records captured daily. Risks need to be addressed in WaSP.
9	Sludge Treatment		
	Thickening in Sludge Dams	6.3	Sludge dams are overgrown and has never been used, no sludge treatment and management

10	Bulk pipeline from plant to command reservoir	100.0	Pipeline uPVC in good condition. One valve chamber was inspected and was found to be in a good condition.
11	Command reservoir	31.3	Siyathuthuka has two reservoirs and three elevated segmented steel tanks, fenced but not secure, gate house has been vandalised and there is no security in place. No telemetry.
12	Booster Pump Station	0.0	Pump station is within fenced area. But has been totally vandalised, MCC stripped. No security is in place.
	Total	68%

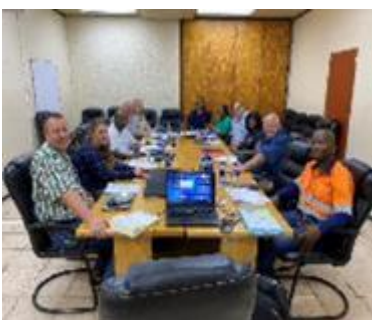
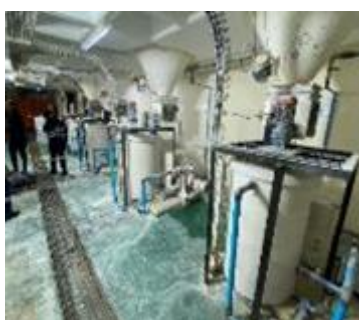
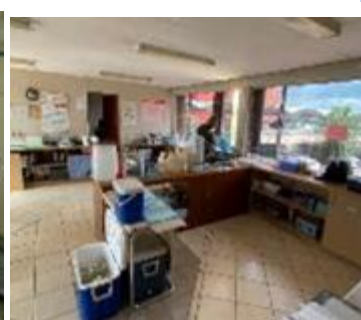
1. Raw water pipeline under N4 to be replaced.
2. Raw water standby pumps out of operation
3. Candy system settling tanks overflow weirs are short circuiting.
4. Sludge treatment facilities not operational
5. Open pipe channels with covers removed.

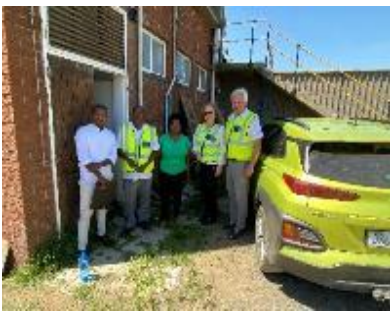
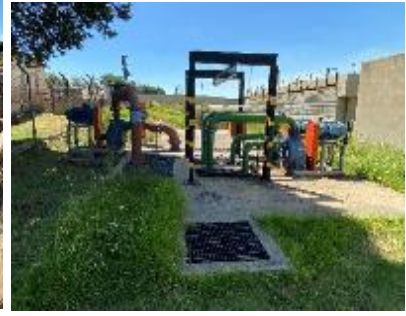
The Standerton water treatment plant is in a poor condition. The Water and Sanitation Manager seems overwhelmed, and it is our impression that there is not enough support from the other departments that are linked to the water treatment function of the WSI. During the audit a staff member responsible for asset management joined for a very short period and the financial person joined and even accompanied us to the site for a while which is commendable. It may well be that the relevant department now recognises the need for resources to be allocated to the business of water treatment, but only time will tell. The situation at the Standerton water treatment plant is a concern. Water quality is not monitored in accordance with SANS 241. The potable water is not microbiologically compliant and poses a very serious acute health risk to the community. There is no Water Safety Plan. The WSI is encouraged to immediately address water safety planning, not only for the Standerton WTW but also for the other WTW in its area of jurisdiction, the Morgenzon WTW. Annual process and network inspections must be performed by a professionally qualified person(s) and the findings must be used to update the risk assessment in the Water Safety Plan on a continuous basis. The monitoring programme needs to be updated with the correct determinands and sampling points. The WSI does not have a copy of the water use license and license conditions. In addition, the WSI is reminded to budget for assessments that must be conducted on an annual basis to ensure the delivery of adequate and safe water. The current situation must be improved, and it must start immediately with housekeeping and maintenance.

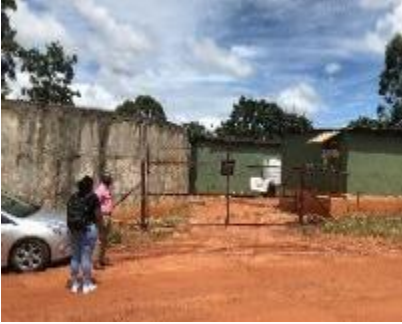
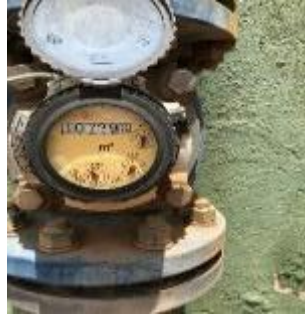
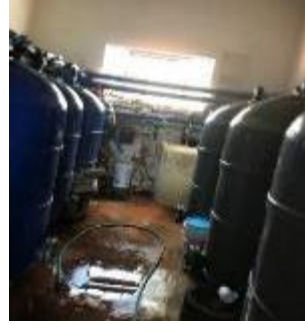
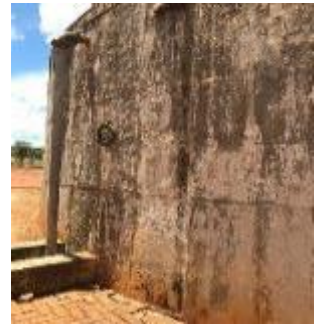
The New Mkhondo (Piet Retief) water treatment system was inspected to assess the condition and functionality of infrastructure and treatment processes on the ground, and to estimate the cost of restoration to full functionality.

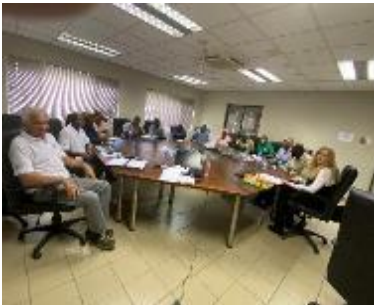
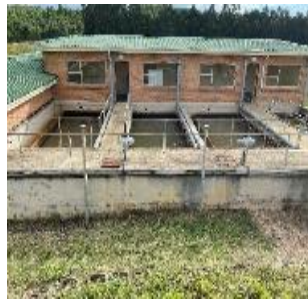
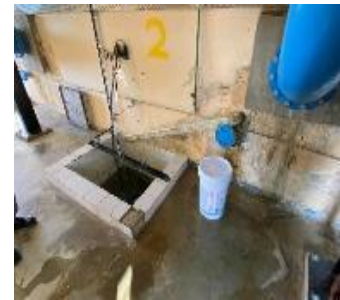
The Ermelo North water treatment system was inspected to assess the condition and functionality of infrastructure and treatment processes on the ground, and to estimate the cost of restoration to full functionality.

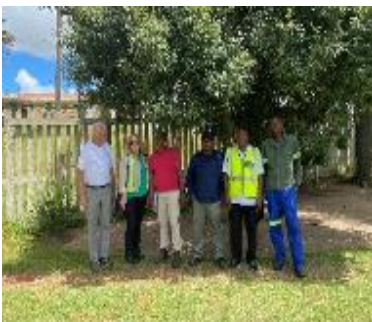
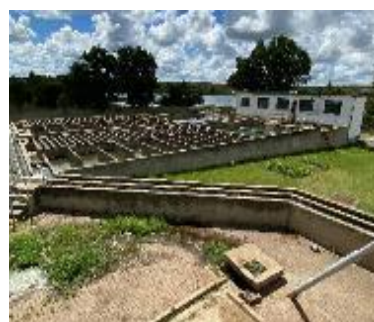
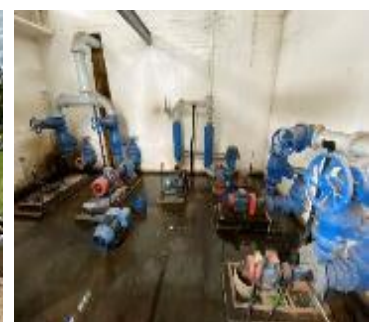
The Driekoppies water treatment system was inspected to assess the condition and functionality of infrastructure and treatment processes on the ground, and to estimate the cost of restoration to full functionality.

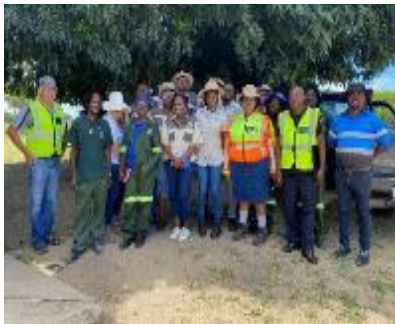
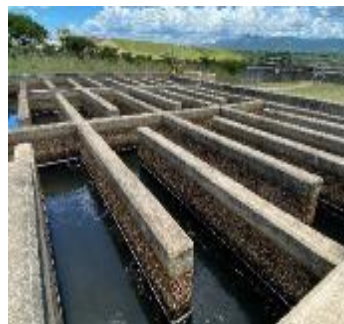
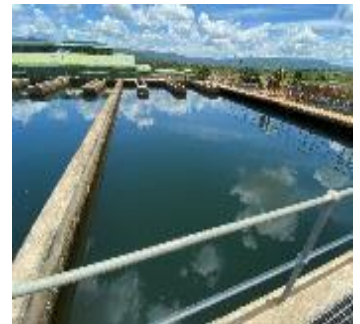
The Volksrust water treatment system was inspected to assess the condition and functionality of infrastructure and treatment processes on the ground, and to estimate the cost of restoration to full functionality.

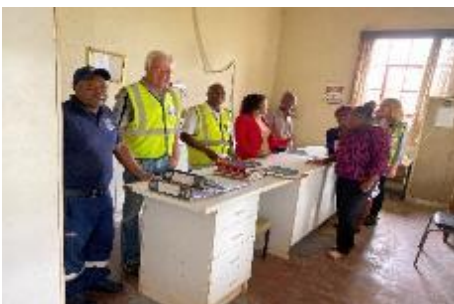
The Vaalbank water supply/treatment system was inspected to assess the condition and functionality of infrastructure and treatment processes on the ground, and to estimate the cost of restoration to full functionality.

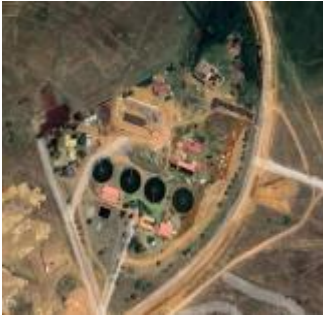
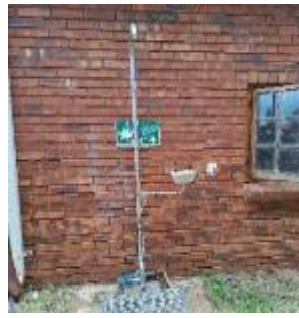
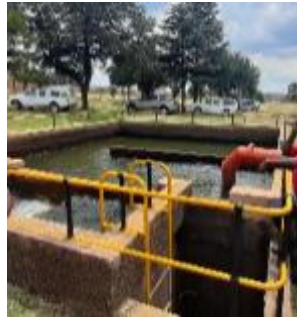
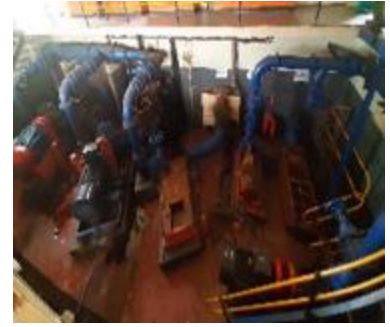
The Lydenburg water supply/treatment system was inspected to assess the condition and functionality of infrastructure and treatment processes on the ground, and to estimate the cost of restoration to full functionality.

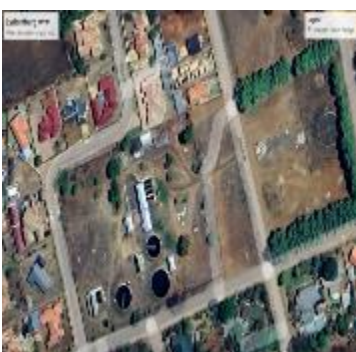
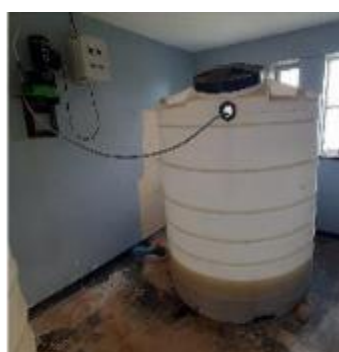
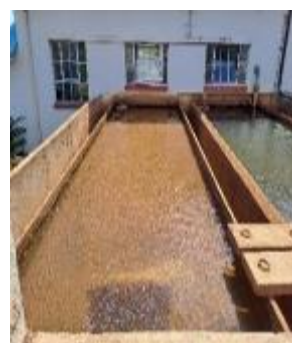
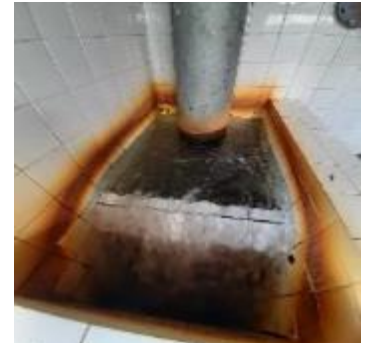
The Bundu water supply/treatment system was inspected to assess the condition and functionality of infrastructure and treatment processes on the ground, and to estimate the cost of restoration to full functionality.

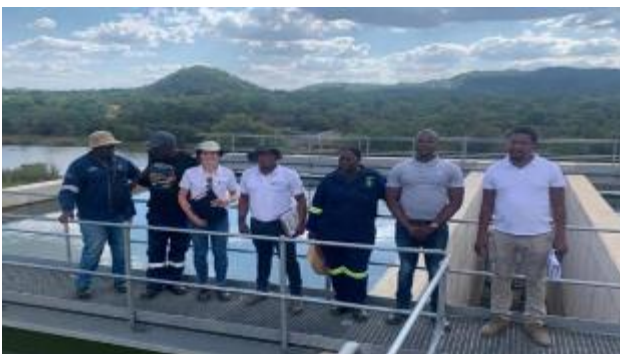
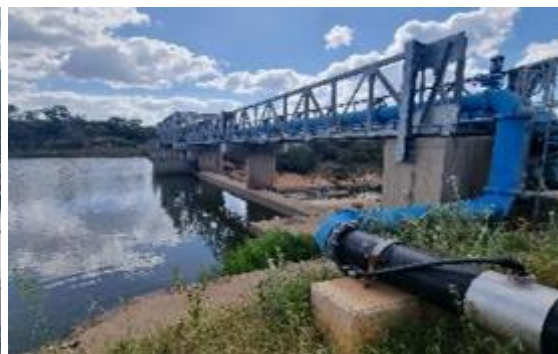
The Delmas water treatment works was inspected to assess the condition and functionality of infrastructure and treatment processes on the ground, and to estimate the cost of restoration to full functionality. The Delmas WTW is currently being refurbished and not in use. Water from Rand Water is diverted to Botleng town.

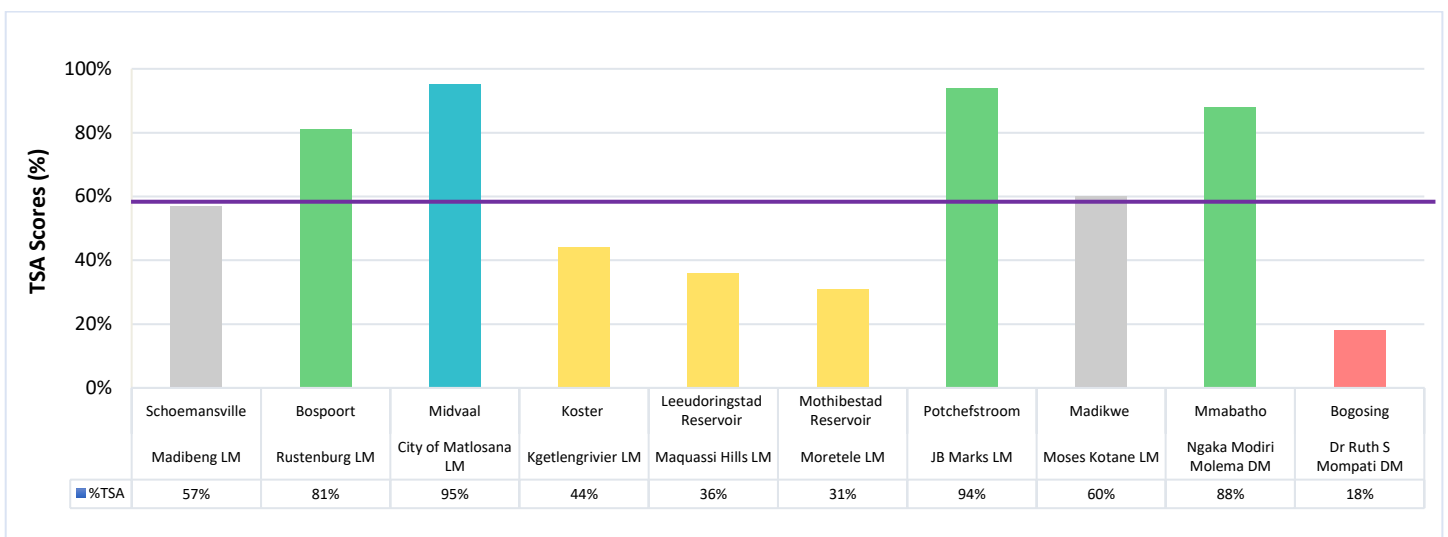
Figure 35 - NW TSA scores for all the BD Systems

An average of 60% was achieved for the 10 systems assessed, which means that infrastructure and processes are partially functional with an average performance. The best overall performance was found for City of Matlosana Midvaal Water, followed by JB Marks and Ngaka Modiri Molema. The water board provided for the best performing system. Lower performances were observed for Bogosing and Mothibestad Booster Pumpstation and command reservoir.

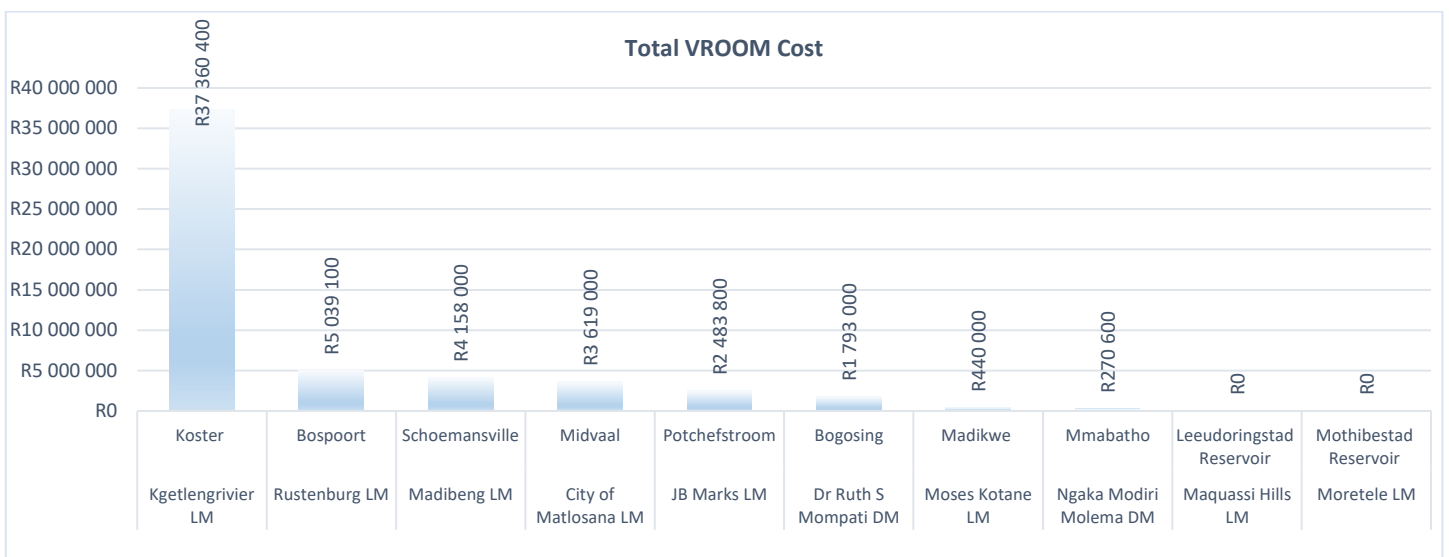
Figure 38 - Total VROOM Cost for the BD Systems Assessed

The associated VROOM costs for the 10 water supply systems assessed amounts to R55.2 million, with the bulk of investment needed for Koster (Kgetlengrivier).

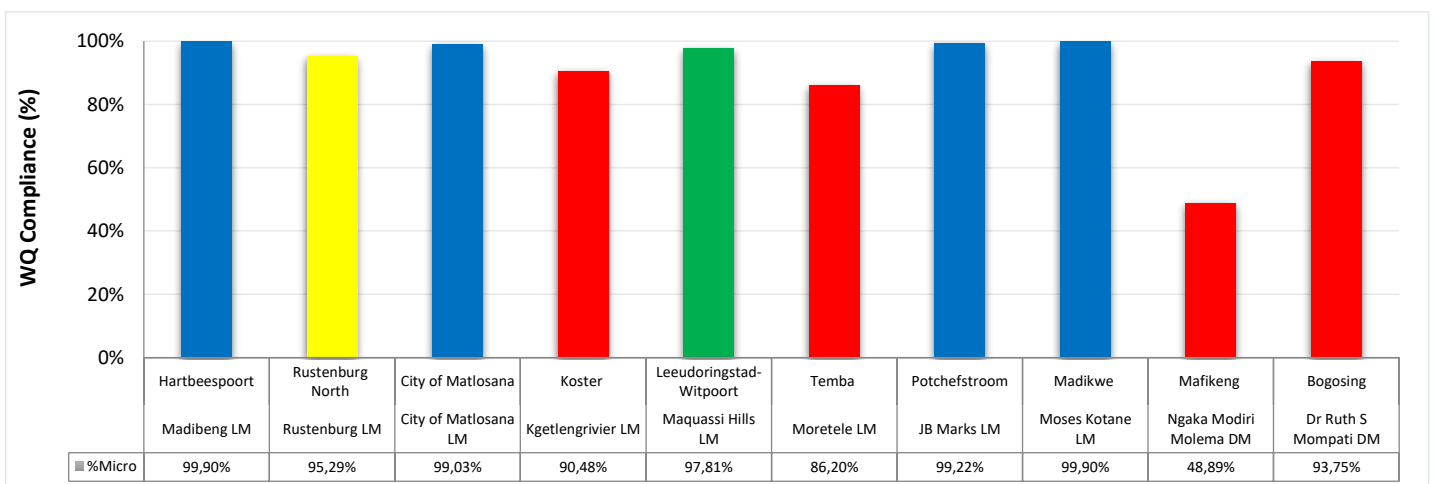
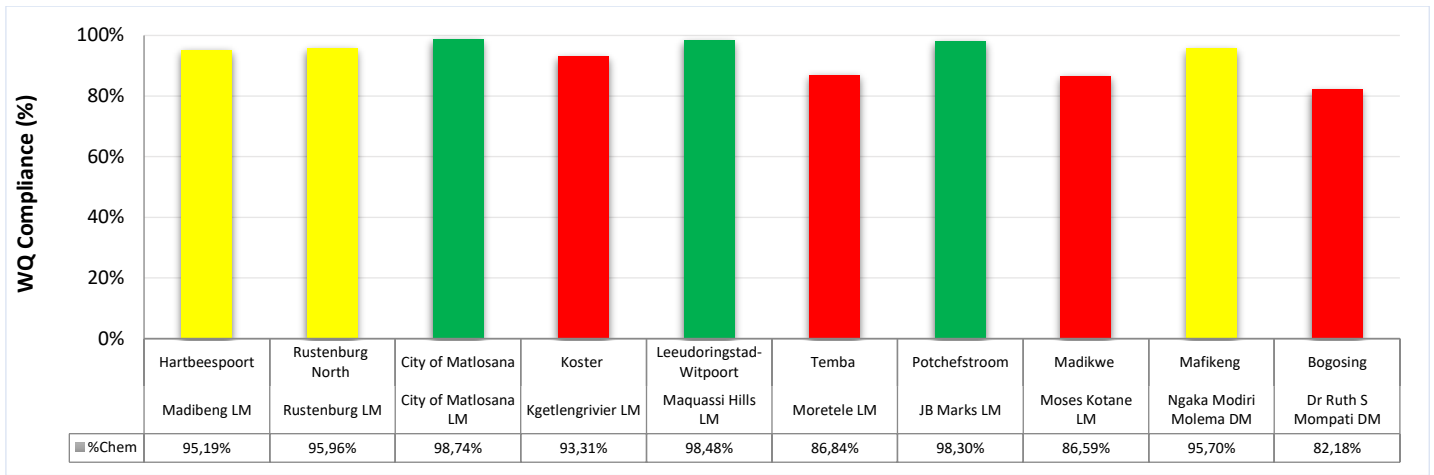
Figure 39 - NW Drinking Water Quality Status of all the TSA Water Supply Systems

The TSA and water quality results depict a different picture. The TSA shows 6 of the 10 water supply systems to be in the *excellent to average performance category*, and the water quality compliance shows that 60-80% of the systems *fail to produce compliant final water quality*.

Out of 10 treatment plants, 4 (40%) systems achieve excellent microbiological quality. A total of 1 (10%) system has poor and 5 (50%) systems have a bad microbiological water quality status. The water in these systems poses a serious acute health risk to the community. WSAs with poor microbiological water quality status must be assessed to confirm status in all systems to ensure rectification measures are comprehensive to safeguard communities. The direct cause of microbiological failures can be linked to the TSA sub-watch Area 7, which has a low contribution to the overall TSA score. The failure to produce water that meets E. coli standards can be linked back to poor operations, defective infrastructure, dosing rates, absence of disinfection chemicals, lack of monitoring, or lack of operating and chemistry knowledge. WSIs that are not monitoring the final water quality at the outlet of the treatment plant or at specific end use points must develop a monitoring programme and resume with compliance monitoring as a matter of urgency.

Chemical compliance shows that 2 (20%) have good water quality, whilst the majority of systems fail to achieve chemical compliance. A total of 3 (30%) and 5 (50%) systems have a poor and bad chemical water quality status.

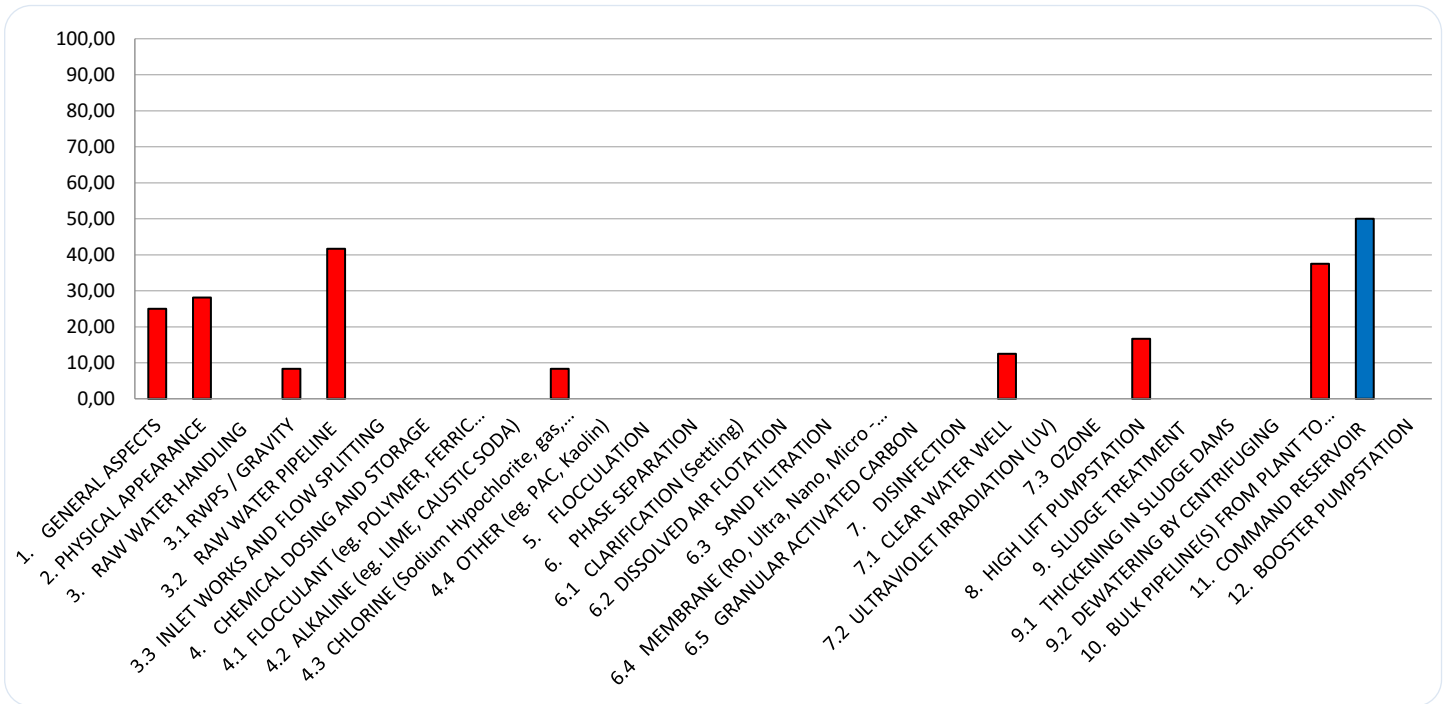
The following process units were inspected and rated according to the % score on the y-axis. Process units that score <50% are marked in red and needs urgent intervention.

Watch #	Process Unit Assessed	% TSA	Observations
1	General aspects	25.0	A Class C certificate was displayed on-site but little other information relating to the plant design was available. Daily operational logbook containing observations and shift logs was available. Process monitoring data was kept on the desktop computer on-site but there were significant gaps in the data due to non-functional monitoring equipment.
2	Physical appearance of plant	28.0	The site was not easily accessible due to the condition of access road. The site was fenced but not signposted and generally did not have the required safety signage and equipment available. General housekeeping and facilities for process controllers/workers was in a poor state.
3	Raw water handling		Raw water was gravity-fed from the Vaalharts canal into the raw water dams. The level of the off take from the canal was inadequate during times of low flow or when seasonal maintenance of the canal is undertaken, resulting in insufficient water supply. The inflow meter was not functional for an extended period exceeding 12 months.

Raw water pumpstation/ gravity feed	8.0	
	Raw water pipeline	42.0	
	Inlet works	0.0	
4	Chemical dosing and storage		
	Flocculant	0.0	Due to deteriorating raw water quality over the years flocculant dosing (SudFloc) was introduced, however as the plant was not designed for dosing, effectiveness was not optimal. Flocculant was not being used since the beginning of January 2022 due to the collapse of the sand filters.
	Chlorine	8.0	Chlorine gas was not in use due to the national shortage. HTH tablets was left as the only means of treatment/disinfection. Sufficient HTH stock was available however means of dosing could not be accurately calculated.
5	Flocculation	0.0	The WTW was designed for flocculation dosing thus effectiveness was not optimal.
6	Phase Separation		
	Sand filtration	0.0	Both pressure sand filter modules were not operational and was being by-passed at the time of the inspection.
7	Disinfection	13.0	Chlorine gas was not in use due to the national shortage. HTH was being dosed informally in the final on-site reservoir. Due to the "makeshift" nature of dosing, contact time and dosing rate could not be determined. Free chlorine measurement was however frequently conducted.

8	High lift pumpstation	17.0	No stand-by pumpset available. Outflow meter no operational.
9	Sludge treatment	0.0	As the WTW was not designed with flocculation in mind no sludge treatment/handling facilities were available. Backwash water from the filters was released back into the Vaalharts canal downstream of the raw water off-take.
10	Bulk pipeline from plant to command reservoir	38.0	No leaks were observed, maintenance is typically reactive and not proactive, thus condition of the pipeline was unknown. Valve chamber was inspected and possible. Chamber flooded and manhole was not covered, and anyone can have access. Thus viewed as a risk.
11	Command reservoir	50.0	Command reservoir on-site, thus fenced, and secure. The reservoir and associated pump station will be the only functional infrastructure in use once the New Taung WTW is fully commissioned thus there are provisions for telemetry to be installed and connected for remote monitoring, as well installation of an outflow meter.

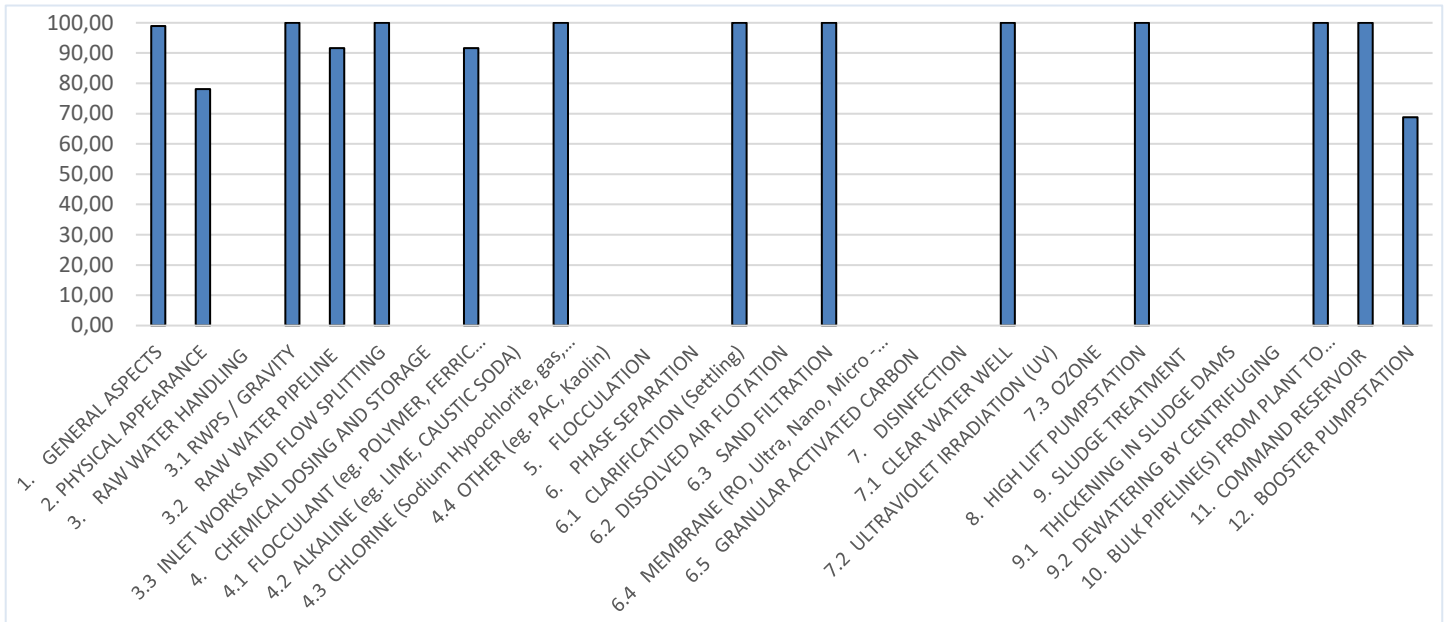
The following process units were inspected and rated according to the % score on the y-axis. Process units that score <50% are marked in red and needs urgent intervention.

Watch #	Process Unit Assessed	% TSA	Observations
1	General aspects	98.9	Classification certificate clearly displayed at administration building. Maintenance and Repairs and Operational log books available with relevant and up-to-date entries. The O&M/Procedure manual is done by Magalies Water and contains all relevant information and schedules. IMP available, up to date and displayed. All BD minimum requirements

3	Raw water handling		
	Raw water pumpstation/ gravity fed	100.0	Screens are in place (2 manual and 1 automatic screen). Screens are cleaned on a regular basis (8 hourly) and solids are disposed at the dumpsite. Raw water flows into the works via gravitational flow through a canal.
	Raw water pipeline	91.7	Process Controller has the impression that leakages are minimal and regular pipeline inspections are undertaken and maintenance is continuous. Pipe networks have no cathodic protection. Old asbestos pipes are slowly being replaced with new PVC pipes. Flow meter was seen and its operational and in working condition. Flow records are captured once per shift and records are kept.
	Inlet works and flow splitting	100.0	Even flow splitting could be seen at the distribution structure. Flash mixing is occurring and dosing occur at the highest point of turbulence. Visual dripping of flocculant could be seen at, and dosing conditions can be monitored.

4	Chemical dosing and storage		
	Flocculant	97.7	Two dosing pumps are installed - both pumps are in working condition. The dosing pumps are configured for one to be in use and the other to serve as a standby pump. The area untidy, dirty and contains spillages. Housekeeping needs to take place at the works. Spillages can be contained within the dosing room. Ferric Chloride is being used to bring about the flocculation process. There is enough chemical to last for more than a month. The storage area is bunded and any spillages can be contained. An emergency wash is situated outside the dosing room. Wash area is fully operational.
	Chlorine	100.0	Four rotameters operational during audit - both flowing free. Two chlorinators are being used and four dosing units available. Standby available for each unit. Two scales are being used to monitor gas levels in the cylinders. Both are fully operational and automatic switch over is in place. Safety shower in place and working, mask available in safety box and each process controller has their own gas mask as well. Chlorine gas is being used and more than 30 days stock is available.

5	Flocculation	na	
6	Phase Separation		
	Clarification	100.0	Limited floc carry over was observed. Desludging of the units are done every 4 hours or as needed. The de-sludging takes place manually as needed. The weirs are in good condition and allow for an even overflow. No algae growth was visible in the launders obstructing flow of the water.
	Sand filtration	100.0	Five backwash pumps are installed and all in working condition, 2 are currently being used and 3 are on standby. Both air blowers are in working condition, 1 is currently being used and one is on standby. An even overflow at all the outlet boxes are seen which indicates good flow distribution. Backwashing frequency of every filter is every 8 hours. Media looks in good condition with no visible signs of cracks. No mounds or uneven distribution of media was seen. The filters gallery is in good condition - all handrails in place. Walls are hosed down after backwashing. Handrails were being painted at the time of the inspection.

Watch #	Process Unit Assessed	% TSA	Observations
11	Command reservoir	100.0	The 25 ML reservoir is gated, and the fence is in good condition. Security (24 Hours) is available at the reservoir. The structure is in a good condition. The process controller reported that the telemetry is operational and controlled. Flow meter is operational. The total flow is compared to the total flow pumped from the WTP on a weekly basis
12	Booster pumpstation	68.8	Three pumps are present and fully operational. An additional 2 pumps sent in for repairs. There's 50% standby available. Signage was not visible around the pump station. Building is not secure, and door is dilapidated and broken. Maintenance needs to be done. MCC were in good condition, but minor housekeeping could be done.
Total		93.7%

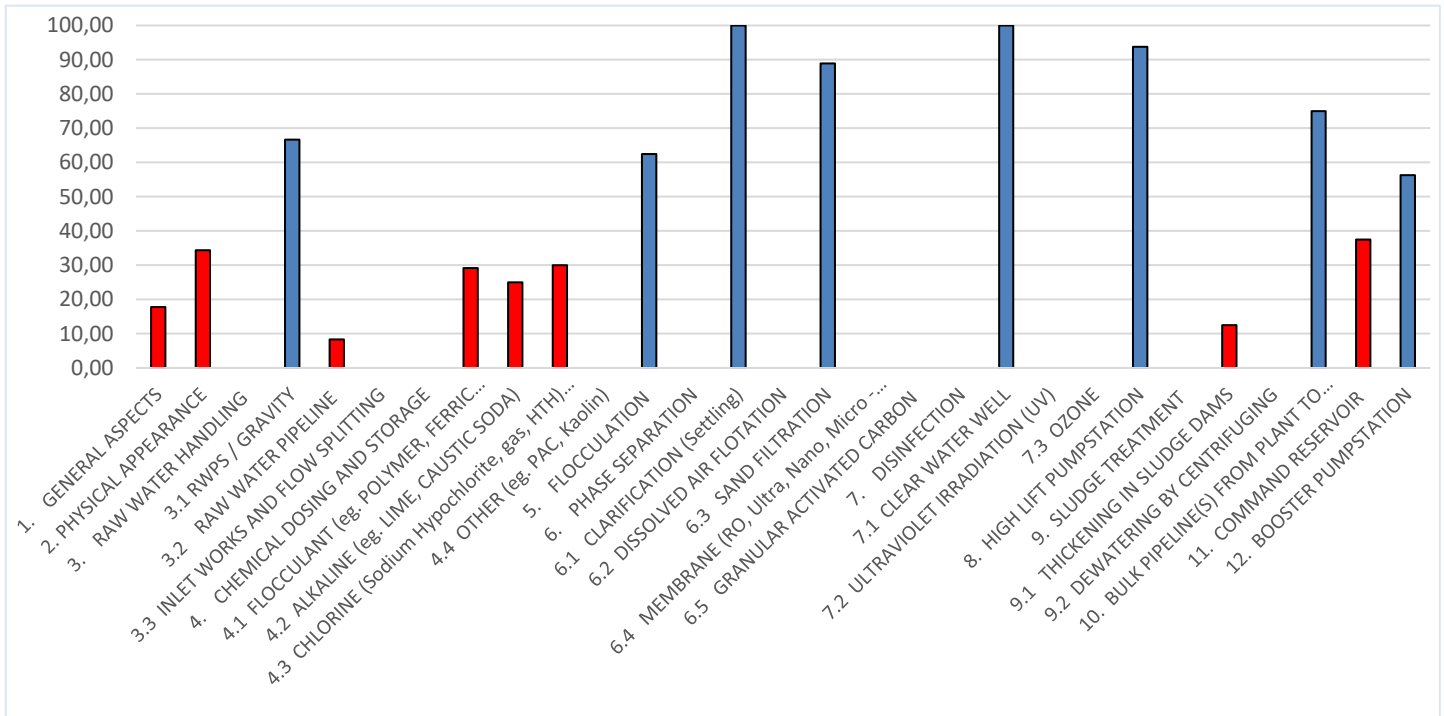
The following process units were inspected and rated according to the % score on the y-axis. Process units that score <50% are marked in red and needs urgent intervention.

Watch #	Process Unit Assessed	% TSA	Observations
1	General aspects	17.8	Class C Water Treatment Works and Process Controllers certificates were displayed in the office. There is no maintenance and repairs logbook at the treatment works. Only turbidity is analysed on Mondays, Tuesdays, and Fridays. However, results were not resented, and the testing equipment is not calibrated.
2	Physical appearance of plant	34.4	The entrance is not signposted. The surrounding is reasonably clean but there is room for improvement. There was some vegetation observed. Facility is fenced and there is no access to animals and public. Major OHS contravention that needs intervention.
3	Raw water handling	8.3	There are 2 raw water pumpstations, one is situated at Koster dam, and it supply the Witrand pumpstation which feed into Koster WTW holding dam. The holding dam is equipped with 2 raw water pumps. The Process Controller expressed that there is a lot of leakages on the raw water pipeline. Currently there is a project to replace the pipeline. There is no incoming flow meter in place. Chemical dosing is not effective as the stirrers were not working and lime is dosed manually using a bucket.

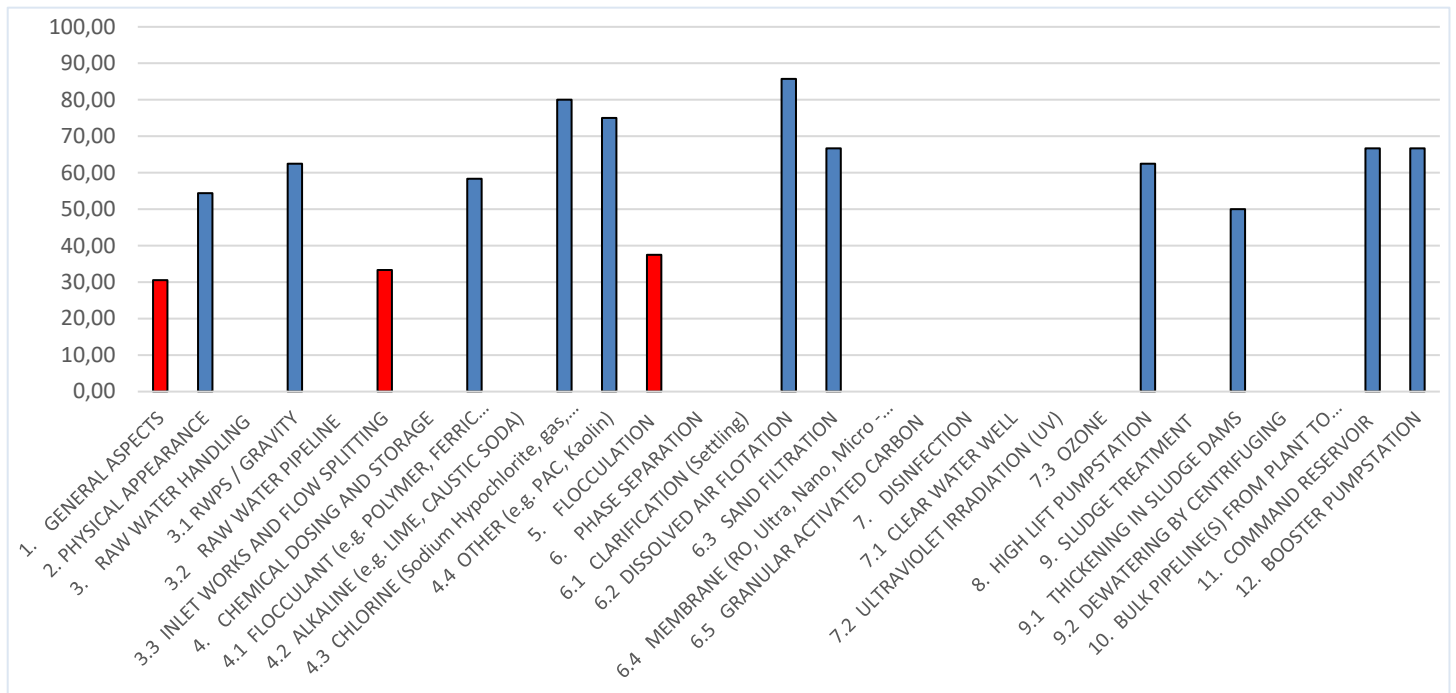
The following process units were inspected and rated according to the % score on the y-axis. Process units that score <50% are marked in red and needs urgent intervention.

Watch #	Process Unit Assessed	% TSA	Observations
1	General aspects	30.6	Class B WTW. Operational logbook with daily entries available. Operation and Maintenance manual, maintenance and repairs logbook and Incident management procedures and contact list were not available. Process monitoring equipment is present but not calibrated. The jar tester is still in its box and never used.
2	Physical appearance of plant	54.3	Facility is fenced with security on site. The garden and terrain are not maintained. The structure and buildings of the plant seems to be solid, with the workers' bathroom in a fair condition. Roads are in a fair condition, but with grass growing through the pavement, this is not going to keep in future. Very few safety signs available.
3	Raw water handling		
	Raw water pumpstation/ gravity feed	62.5	The inlet is managed by DWS. Two raw water pumps in use. The standby pump available but not connected to any pipeline.

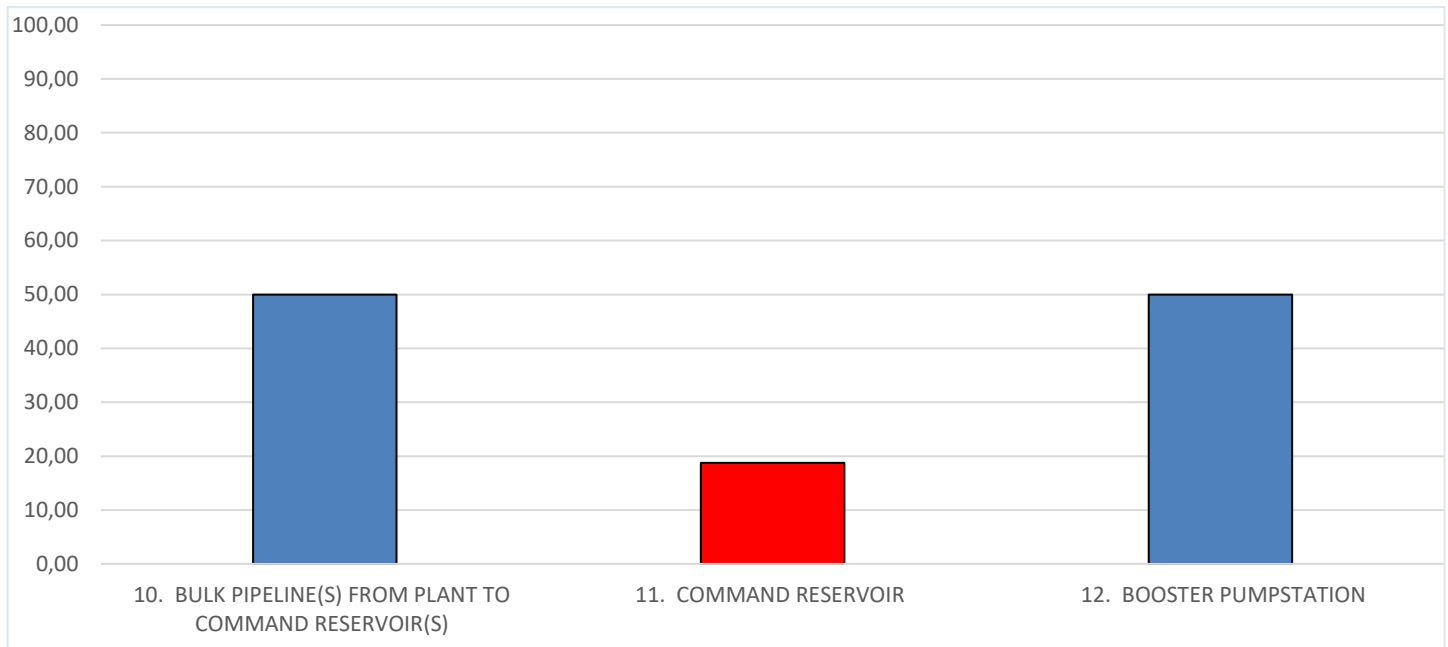
The following process units were inspected and rated according to the % score on the y-axis. Process units that score <50% are marked in red and needs urgent intervention.

Watch #	Process Unit Assessed	% TSA	Observations
10	Bulk pipeline from plant to command reservoir	50.0	No major leaks or problems were reported for the pipeline from the works to the reservoirs. No proof provided.
11	Command reservoir	18.8	There is no telemetry at the reservoir only at the Sedibeng's facilities. There is no flow meter at the reservoir and the volume that is supplied to the consumer is unknown. The structure of the reservoir is intact, though needs to be maintained. The area around the reservoirs also needs to be maintained as it has overgrown vegetation which is a Health and safety hazard.
12	Booster pumpstation	50.0	There are 2 pumpstations at the reservoir, 1 is supplying Leeudoringstad town and 1 is supplying Kgakala township. Each is equipped with 2 pumps. Only 1 of each pump is working. There are no standby pumps. MCC for both pumpstations are in good condition. Signage not available.
