BLUE DROP

Watch Report

BLUE DROP WATCH REPORT 2023: TECHNICAL ASSESSMENT OF THE CONDITION OF MUNICIPAL DRINKING WATER TREATMENT AND DISTRIBUTION SYSTEMS IN SOUTH AFRICA

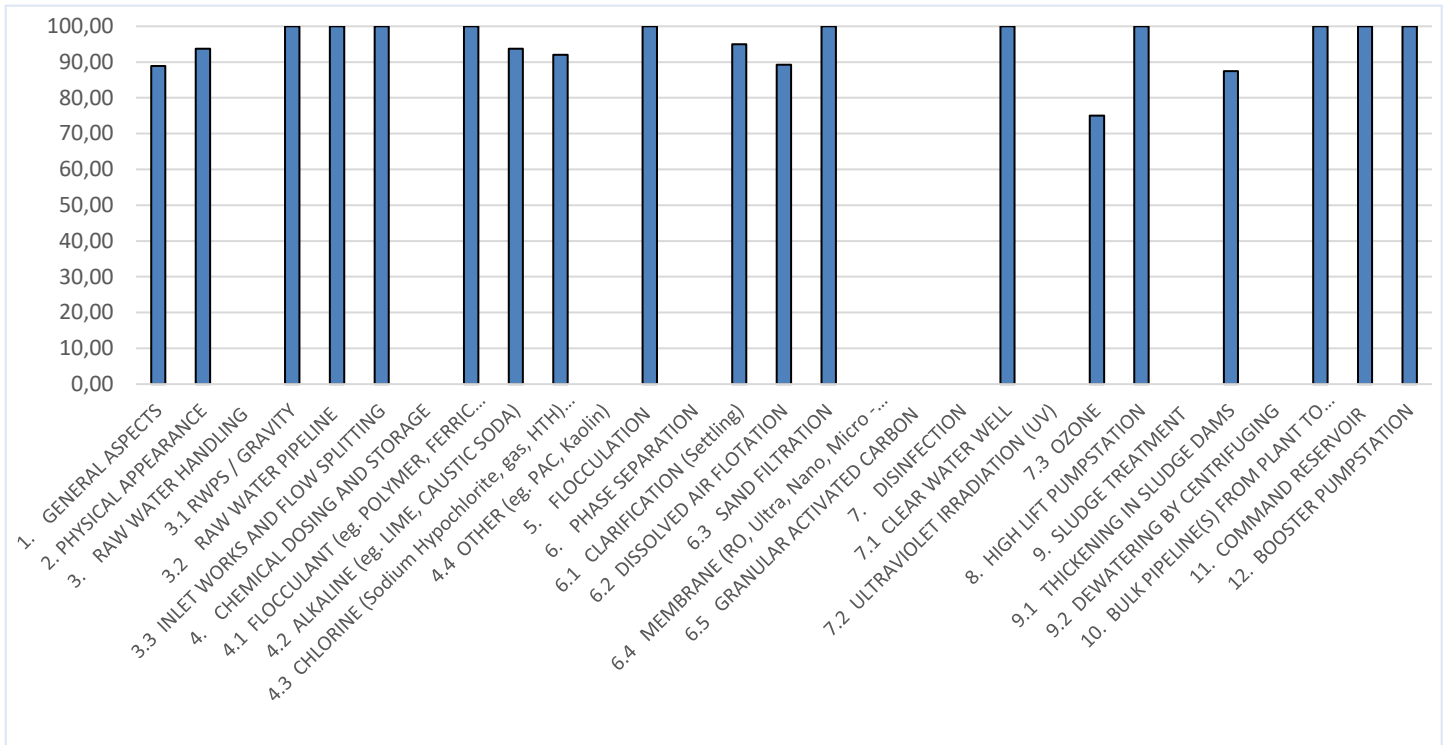
Watch #	Process Unit Assessed	% TSA	Observations
1	General aspects	88.9	Class A plant, logbooks in place, Maintenance team logbook is not available onsite. PFD displayed on the wall. Excellent signage at gate and the surrounding area.
2	Physical appearance of plant	94.0	The garden is well maintained, and the grass is cut. Good housekeeping observed. Fully fenced with proper access control. Personnel are satisfied with the working conditions.
3	Raw water handling	100.0	Raw water abstraction from Vaal River, there are 6 raw water pumps in total. 3 are from East and 3 from West. 2 duty and 4 on standby. The pumps are in good conditions and no leaks were observed. flocculant chemical in stock, good flash mixing conditions, 2 Inflow meters for East and West in place. Both are functional. Electrical panel and cabling in good condition.
	Raw water pumpstation/ gravity feed		
	Raw water pipeline Inlet works

4	Chemical dosing and storage	100.0	18 tone of poly Ultra floc 500, Ferric chloride. Ferric Sulphate and it is sufficient for 30 days. 14 pumps running and 8 standbys for pre and post dosing. Dosing area was neat and good housekeeping observed. There was one which was leaking however, it was repaired. Emergency shower at ground level and upper level next to the primary dosing point.
	Flocculant		
	Alkaline		
	Chlorine	92.0	Two rotameters operational during audit - both flowing free. 4 chlorine cylinders were connected. 2 duty and 2 standbys. Safety shower in place and working, fans working, masks in safety box. Chlorinator was set on 6 kg/h for the east and western side. This is 3700 kg/month. WSI has 4 cylinders connected with automatic switch over. 4 of 925 kg spare cylinders on site. More than 30 days storage.
	Other (PAC, Kaolin, etc.)	na	There is no unit for PAC however, there are bags of PAC which are available onsite and are dosed when there is ordo and too many algae coming into the plant.

5	Flocculation	100.0	The flocs were visible at the end of the flocculation channel. The overall condition of the flocculation unit is good and has no visible sludge nor algae.
6	Phase Separation	95.0	No carry over observed, and channels were in good condition. De-sludge only once per day. automatic desludging every 45 min. The lauders were covered with algae that may prevent even and free flow. however, they are cleaned ever shift.
	Clarification (settling)		
	Dissolve air floatation (DAF)	89.0	There are 5 pumps in good condition. 1 standby. The pumps alternate every week. Two of the 3 available compressors serve as a standby. There are fine bubbles observed on the surface of the 5 DAF units. Marker level were high in all 4 DAF units which resulted in large, isolated bubbles. De sludging of the sludge layer is done once per shift. Floating materials had accumulated at the inlet of some of the DAF units. The next service date is the 14th of June 2023.

Sand filtration	100.0	Two pumps installed and they alternate every week. 2 Air blowers installed. Even bubble distribution of air during backwash. Backwashing done Once per shift.
7	Disinfection	100.0	Contact time was reported to be 1h20 min by the process controllers.
	Clear water well		
	Ozone	75.0	There are 3 compressors, 1 was not operational. There other 2 are working on 1 duty and 1 standby. There are 3 ozonators, 2 working and 1 not working.
8	High lift pumpstation	100.0	There are 3 pumps installed and in working condition. 2 operational 1 standby basis. outflow meter in-place.
9	Sludge treatment	88.0	There are 3 sludge lagoons. Fair indication of reeds. One pond has just been cleared
	Thickening in sludge dams		
10	Bulk pipeline from plant to command reservoir	100.0	The bulk pipeline is in good condition. No leakages reported.
11	Command reservoir	100.0	Midvaal Water: The 10 MI reservoir is gated, and the fence is in good condition. No security at the gate but there is an alarm installed triggered by movement. There is a telemetry is operational and controlled by the level sensor. The flow is verified through the SCADA system. The structure is in a good condition and the reservoir was covered.

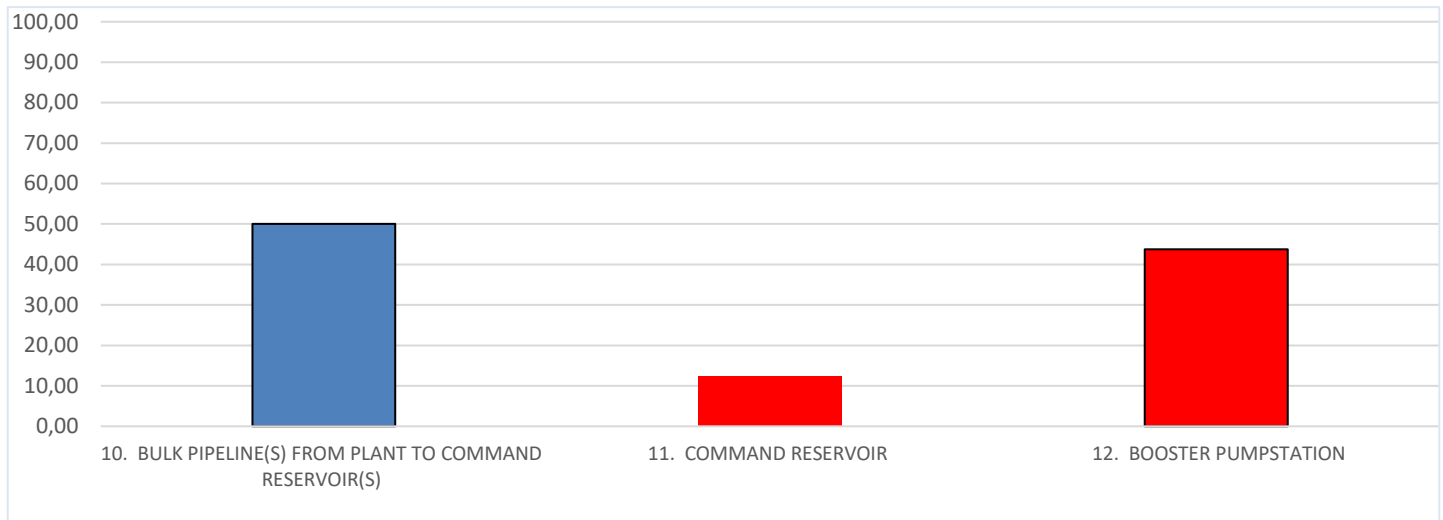
Watch #	Process Unit Assessed	% TSA	Observations
10	Bulk pipeline from plant to command reservoir	50.0	No major leaks or problems were reported for the pipeline from the works to the reservoirs. The incident register was not provided for the reticulation network from the municipality side.
11	Command reservoir	12.5	There is a security guard onsite and there is proper access control. The facility is fully fenced, and gate is lockable. The surrounding is not well maintained and was overgrown with vegetation. There is no telemetry, and the reservoir were not operational. The structure is intact however, due to unavailability of flow it could not be verified. The top of the reservoir was not assessed.

Watch #	Process Unit Assessed	% TSA	Observations
12	Booster pumpstation	43.8	Two pumps have been installed, but they are not operational due to low water pressure in the pipeline and leaking reservoir. There is well constructed pump house which is well ventilated. There was no signage. MCC are in good condition
	Total	31%

1. There is no command reservoir and drinking water cannot be stored leading to shortage of water supply.
2. Booster Pumpstations were never operational since their construction.
3. All nine reservoirs at the reticulation network are empty and water is consumed directly from the pipes.
4. Network study or condition assessment has not been conducted for Temba Water Supply System.
5. Poor management of project which led to non-functional equipment.

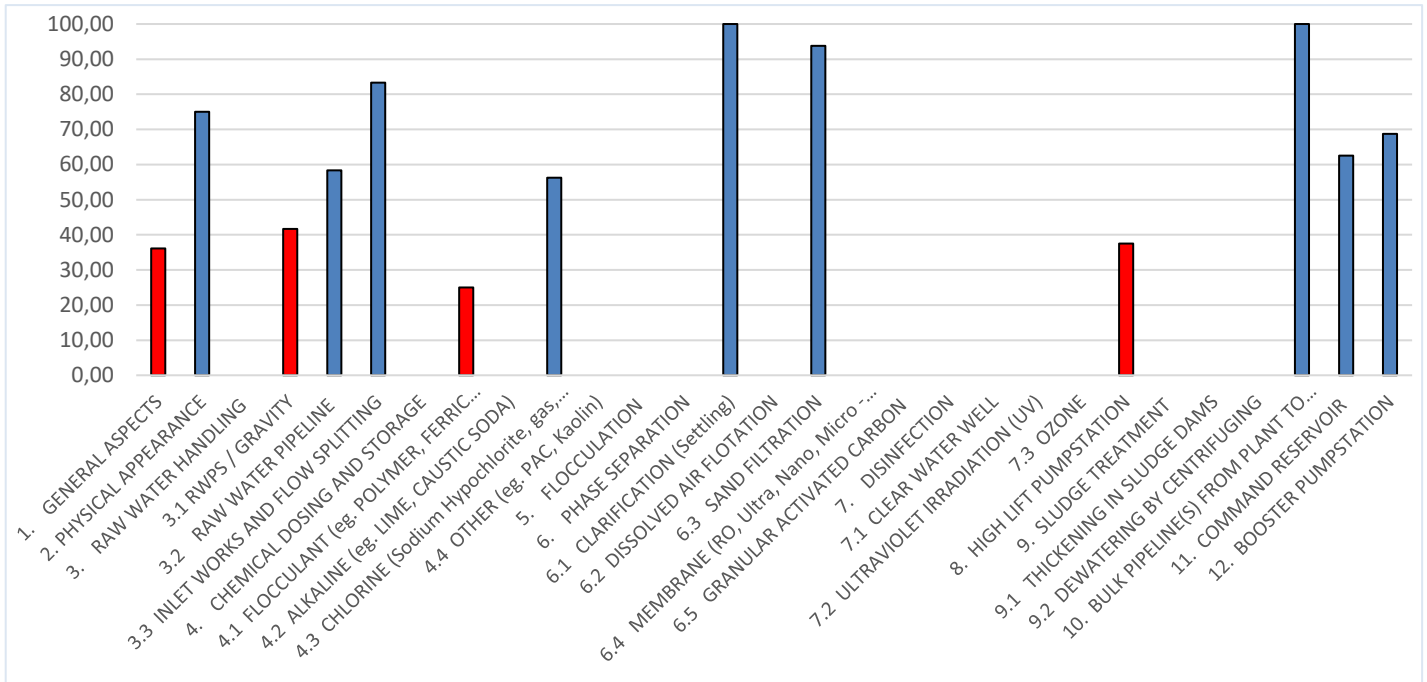
Watch #	Process Unit Assessed	% TSA	Observations
1	General aspects	36.1	Class C works. There was no maintenance & repairs logbook on-site. Only flow is recorded for 21/22. Operational monitoring records were last updated in January 2020. O&M Manual not available at the time of the audit. IMP not in place. Multi-meter for pH, EC, TDS & Temp; Turbidity & Chlorine meter available but these instruments are defective and not in use. Jar testing equipment are available however they are also not in use.
2	Physical appearance of plant	75.0	Entrance is signposted with name of the WTW and dam. Site is fenced, with access control and security at the gate. WTW road is tarred and no gravel. The site is tidy and well kept. Garden and terrain are well kept. Grass is cut, there appears to be some minor damage at the entrance to the filter room, which makes the WTW looks untidy. Worker's bathroom is not in good condition, shower doors has fallen and needs to be attended to. Over and above, the bathroom available is shared between male and female workers. There are minimal safety signs at Madikwe WTW. WSA in the phase 2 of the WTW refurbishment must ensure that relevant safety signs are posted to relevant equipment/unit processes

3	Raw water handling		
	Raw water pumpstation/ gravity feed	41.7	Raw water pumps are not equipped with screens at the abstraction point. Three pumps installed to work on a 2+1 configuration. However, the standby pump is defective and out of service, for repairs.
	Raw water pipeline	58.3	Pipe network have not been assessed nor maintained against corrosion. Flow meter installed at the inlet of the WTW to measure raw water flows, however it has not been calibrated in the past 24 months. Flows are recorded and kept in the logbook.
	Inlet works	83.3	There is even flow split as the raw water is fed into two modules. Flocculant is dosed inline (inside the pipe infrastructure). Monitoring is not possible due to inline dosing mechanism as per the design of the WTW, however the pumps are set at various percentages (which ultimately works out volumetric flow rates, the PC have done pump/timer tests to know at a certain percentage pump setting represents a specific flow rate)

4	Chemical dosing & storage		
	Flocculant	25.0	Two pumps are installed working on a 1 duty and a standby arrangement. The standby pump can only be switched manually. The electrical wiring presents a hazard and a safety risk as the wires are exposed. The dosing area is not bunded and spillages cannot be contained. Insufficient stock available at the WTW. The storage area is not bunded and any spillages cannot be contained. There is no emergency wash near the dosing room.
	Chlorine	56.3	HTH and chlorine chips are used. The dry feeder is in a good working order. The WTW is equipped with two dosing dry feeders, resulting in a 100% standby availability. There are no safety equipment observed during the site assessment. The chlorine stored on site is shared amongst all the WTW operated by the WSA. Currently on site there are 14 buckets for this WTW, and this will last between 4-5 days.
5	Flocculation	na

6	Phase Separation		
	Clarification (settling)	100.0	The works is equipped with 16 settling tanks. There is limited floc carryover of the flocs. Desludging is done once per shift and /or based on the quality of water. The settling tanks are equipped with discharge holes and are in good condition and allow for even flow.
	Sand filtration	93.8	20 pressure filters are installed but one (1) is out of order. Two back wash pumps are installed and in working condition. Each pressure filter bank is connected to one pump & no standby for each bank. The pumps are also used as high lift pumps to pump final water to the reservoirs <2 Km away. The filters are fitted with pressure gauge which is used a guide for backwashing procedure when it reached 200Kpa. Backwashing frequency of every filter is 24 hours. The housekeeping around the pressure filters filter is good and the area is free obstacles.
7	Disinfection

Clear water well	na	There is a huge design flaw in a sense that, chlorine is dosed before the pressure filters. This is unusual however there must be further investigation on whether this does not impact on efficacy of disinfection particularly residual chlorine in the network.
8	High lift pumpstation	37.5	Two pumps installed to function as high lift & backwash pumps. The pumps feed into the reservoirs. No standby pumps installed. There is a flow meter installed however is not in good working condition and flows are not recorded
9	Sludge treatment	na	
10	Bulk pipeline from plant to command reservoir	100.0	The network team is responsible for bulk pipeline management. Valves are intact, no signs of rust or leaks.
11	Command reservoir	62.5	Reservoir is secured and fenced with lockable gates. The reservoir is less than 2 km from the WTW and there are securities on site and some PC are staying at the WTW. Structure is leak free and closed at the top. There is a telemetry in place, though not yet connected to the Scada (to be included in the phase 2 refurbishment work), however there is a manual level indicator installed though not recorded. No flow measuring device in place.

12	Booster pumpstation	68.8	Three pumps are installed, only 2 working and on duty, 1 pump is out of order, currently no standby available. Building is secured, fenced and lockable gates. No signs were observed. MCC in place and in good condition.
	Total	60%

1. One defective pump at the booster pumpstation needs to be fixed, this poses a huge risk for water supply should the pump on duty fail and the pump for raw water.
2. Calibration of meters.
3. Investigate chlorination prior to filtration.
4. Maintenance of the standby pump for raw water.
5. Maintenance of flocculant dosing pumps and attend to the electrical wires.

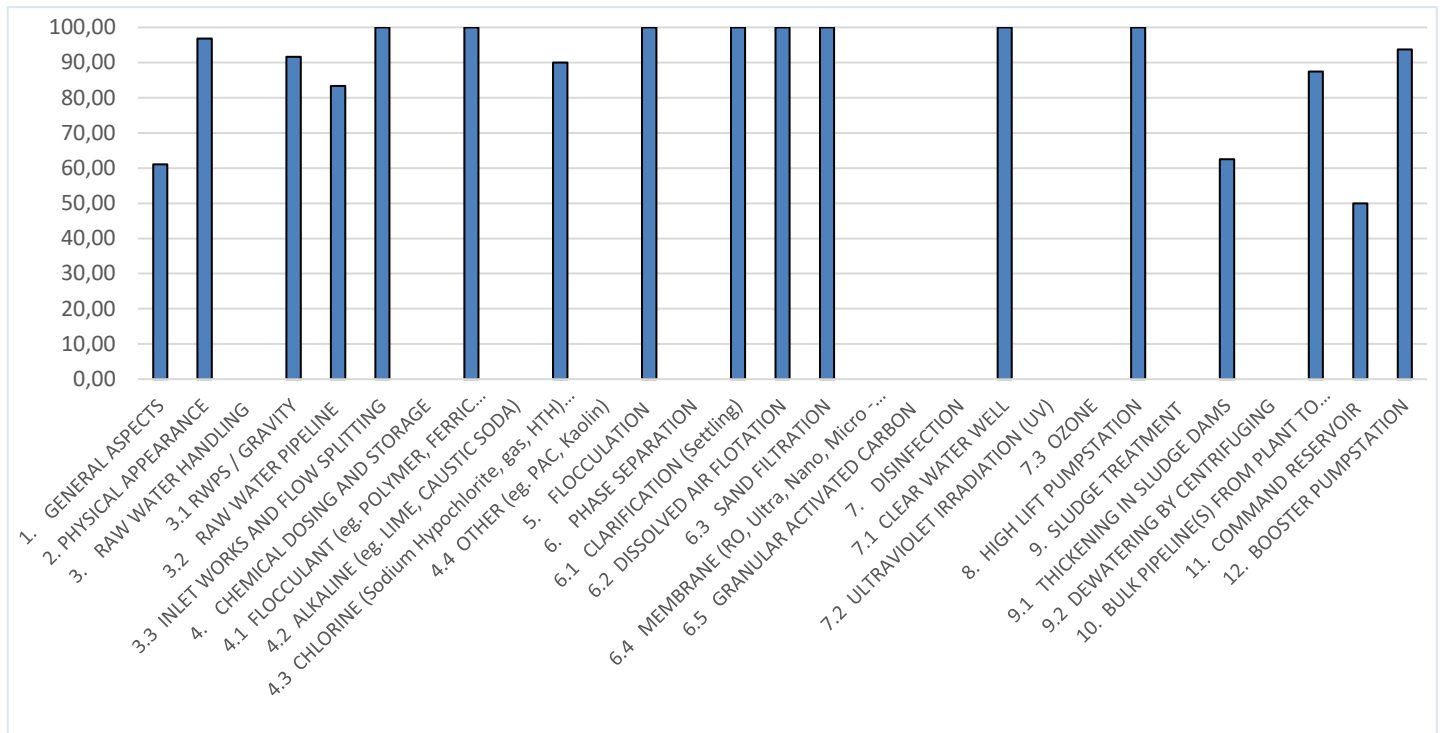
Watch #	Process Unit Assessed	% TSA	Observations
1	General aspects	61.1	Class C WTW. The certificate displayed is old, as it still refers to Department Water Affairs and Forestry. It needs to be replaced with the updated DWS certificate. There is a maintenance & repairs logbook on-site, which includes mechanical instruments that have been attended to. Operational logbook in place, with tests for pH, EC, Turbidity taken every 2 hours. O&M Manual not available at the time of the audit. IMP not in place. Multi meter for pH, EC, Temperature is available. Turbidity and Chlorine meters available but have been calibrated with standards that expired on 12/2022. Jar testing equipment are available however they are only used seasonally. Electricity meter, is not accessible to the WTW and reading are not recorded.
2	Physical appearance of plant	96.9	Entrance is signposted with name of the WTW. Site is fenced, with access control and security at the gate. WTW roads are tarred. The site is tidy and well kept. Garden and terrain are well kept, there is paving installed on site. Worker's bathroom is in good condition, equipped with hand wash facility and the workers have facility for having lunch, with microwave and sink. The site despite its age is still in good condition. There are relevant safety signs in unit processes and equipment.

3	Raw water handling		
	Raw water pumpstation/ gravity feed	91.7	Raw water pump house was locked however it was reported by the PC on shift that, they are equipped with screens at the abstraction point. Four pumps installed to work on a 1+3 configuration. However, 1 pump is defective and out of service, for repairs as a result, there are only 2 standby pumps available.
	Raw water pipeline	83.3	Based on the observation and verbal report with the PC and based on the observation during the site assessment, there were no leakages observed. However, the pipe network is not equipped with cathodic protection and no regular maintenance is done. A magnetic flow meter installed and in working condition. Flow rates are recorded and kept in the logbook.
	Inlet works	100.0	Water is pumped from Setumo Dam and evenly split into the two settling tanks. The turbulence created as the water falls over the weir at the inlet provides enough energy for proper mixing of the dosing point of the poly electrolyte. Dripping of flocculant was visible at the inlet works.

4	Chemical dosing and storage		
	Flocculant	100.0	Two pumps are installed for Poly and 2 dosing pumps for ferric chloride. The pumps use 1+1 configuration, resulting in a 100% standby availability. The dosing area neat and can contain any spillages. Polyelectrolytes was used. There are 2 x 10 000 litres containers available- adequate capacity to last for more than 30 days. The storage area is bunded and any spillages can be contained. An emergency wash is available, near the dosing room.
	Chlorine	90.0	Chlorine gas is used. The chlorine dosing pumps are in good condition with all equipment working, Two chlorine cylinders were connected equipped with an automatic switch over system, to come into operation when a 1 cylinder is empty. There are fire extinguishers, the area is well ventilated in a sense that it is opened up and air flow from outside. However, ammonia and alarms are not available. Chlorinator was set on 4 kg/h post chlorine, which indicates 96kg/d. There are 2 x 925kg full cylinders which makes up 2850 Kg available. There is approximately 30 days of storage availability. In addition there is HTH on site.

5	Flocculation	100.0	The settling tanks design incorporates flocculation. It is equipped with mechanical mixers to promote agitation and can be set in various speeds. Each settling tank is fitted with 3 mixers and there are two settling tanks in operation. The is no scum visible however floc formation is observed through in the compartment fitted with mixers.
6	Phase Separation		
	Clarification (settling)	100.0	Floc carry-over was not visible at the weirs of the clarifiers. Two clarifiers are in place & operational. De-sludge is conducted once in two shifts. Each clarifier is fitted with operational de-sludge pump. The settling tanks are equipped with discharge holes and are in good condition and allow for even flow.
	Dissolve air floatation (DAF)	100.0	Three recycle pumps installed are in working condition. There are 50% standby for all the recycle pumps. When 2 are on duty and 1 is on standby. Three compressors are installed and in operation with a 100% standby available. Fine bubbles, dense and no individual large bubbles could be seen. Desludging is done once per week however de-scum is done twice per shift. The saturator was serviced in the last 12 months.

Sand filtration	100.0	There are 6 sand filters installed and in working condition. Two back wash pumps are installed and in working condition. There are 3 compressors installed and in good working condition, with 100% percent standby. The sand filters are enclosed and connected by pipes. It is not possible to observe the flow. A backwash was performed and even bubble distribution during backwash is seen. Backwashing frequency of every filter is 24 hours. Filter media surface is smooth with no signs of cracks or mounds.

10	Bulk pipeline from plant to command reservoir	87.5	The raw water pipeline is free of leaks & PVC pipe is used. Plant feed to Lekaleng booster pump station thereafter final water is pumped into two reservoirs at Signal Hill from where it feeds into the reticulation system through gravity. Valves are in good working condition except for one minor valve leaks at the high lift pump station.
11	Command reservoir	50.0	The Signal Hill reservoirs secure in terms of gate & fence. There is one security personnel on-site. The reservoirs are structurally in a good condition and not leaking. They are properly closed with no risk of contamination. The telemetric system room at Signal Hill Reservoirs is out of order. Signal Hill Reservoirs are not fitted with final flow meter.
12	Booster pumpstation	93.8	Lokaleng Booster is fitted with six installed pumps, except one is not in working condition. More than 50% standby pump set arrangement is in place. The building is secure with insufficient ventilation, the facility is well fenced & no signage in place. Each pump has its own MCC, and all are in good condition & accessible.

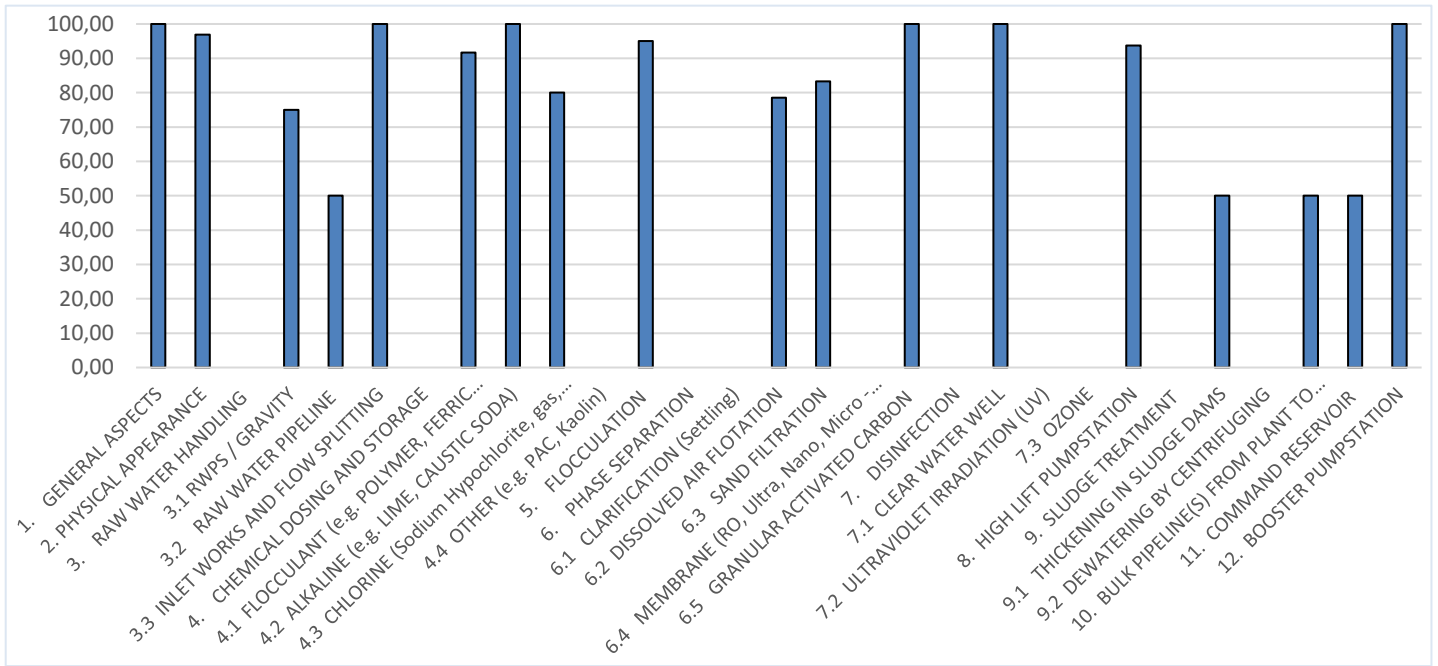
Watch #	Process Unit Assessed	% TSA	Observations
1	General aspects	100.0	Class A plant, record keeping in place, IMP and PFD displayed. Monitoring equipment functional and calibrated.
2	Physical appearance of plant	96.9	Facility fully fenced with entrance signposted. Terrain, buildings, and facilities neat and tidy. Access road to the WTW maintained routinely. All relevant safety signs posted.
3	Raw water handling		
	Raw water pumpstation/ gravity feed	75.0	Raw water is fed by gravity. A basket is available but difficult to remove and clean. Two emergency handpumps are available when the dam level is low.
	Raw water pipeline	50.0	The raw water pipeline belongs to DWS. It is short and rubber lined. The inflow meter was damaged by power failures. A new meter has been ordered.
	Inlet works	100.0	The onflow split evenly into two chambers. Dosing conditions at the inlet works can be monitored with effective flash mixing conditions.

4	Chemical dosing and storage		
	Flocculant	91.7	Dosing pumps in a working condition with a 50% standby. The dosing area is neat and bunded and spills can be contained. An emergency wash area is close by. Stock is recorded daily with a minimum level informing the order of new stock.
	Alkaline	100.0	Lime is stored in a silo with sufficient storage volume of 30 days. Two lime feeders available, one in use and one on standby.
	Chlorine	80.0	Chlorine gas is dosed using all three dosing pumps. No standby pumps available. Both scales are working and all safety equipment available and in a working condition.
5	Flocculation	95.0	The channels are in a good condition. Flocs are visible at the end of the flocculation process, with a little scum observed.
6	Phase Separation		
	Dissolve air floatation (DAF)	78.6	All recycle pumps in a working condition with 50% standby available. Both air compressors in use, no standby. The saturator is serviced annually. Fine bubbles were observed, with removal of the sludge layer scheduled for once per shift, more frequent depending on the sludge layer.

Sand filtration	83.3	Filters in a good condition, with all handrails in place. The filter media is smooth and was replaced Jan/Feb 2021. Backwashing of filters done daily but more frequently with high turbidity results. Backwashing not observed - nozzles are inspected annually. All backwash pumps and air blowers working. No standby pumps, 100% standby air blowers.
	Granular activated carbon (GAC)	100.0	Filters in a good condition, with all handrails in place. Tests are conducted every 6 months and then the GAC is replaced not reactivated. Backwashing not observed - nozzles are inspected annually. Two backwash pumps working with no standby capacity.
7	Disinfection		
	Clear water well	100.0	Chlorine contact time in the CWW not sufficient, but the pipeline to town 25 km ensures sufficient contact time. Free chlorine done every 2 hours, before water leaves the plant to the command reservoirs.
8	High lift pumpstation	93.8	Four pumps all in working condition. With two pumps on standby. Magflow meter in place to measure the final outflow, recoded daily but not interpreted.

9	Sludge treatment		
	Thickening in sludge dams	50.0	Sludge dams not well maintained; it was last cleaned Jun to Aug 2022.
10	Bulk pipeline from plant to command reservoir	50.0	The pipeline is in a bad condition and needs to be replaced. Valves are inspected daily and serviced annually.
11	Command reservoir	50.0	The reservoirs are not fenced. Structures are in a good condition and closed at the top. Telemetry is in place but flow from the reservoirs is not measured.
12	Booster pumpstation	100.0	Building secure. Two pumps installed, working with one on standby. VSDs In good condition.
	Total	81.4%

1. Intake pumps (hand pumps) and screens (basket difficult to remove and cleaned) not sustainable.
2. There are not sufficient standby pumps (dosing, recycle and backwash) and compressors available.
3. Water first flows through the GAC and only then to the sand filters. This process should be reversed for optimal polishing of the final product.
4. The sludge dams should be better maintained with regular cleaning of banks, etc.
5. Replace final water pipeline from WTW to command reservoirs.

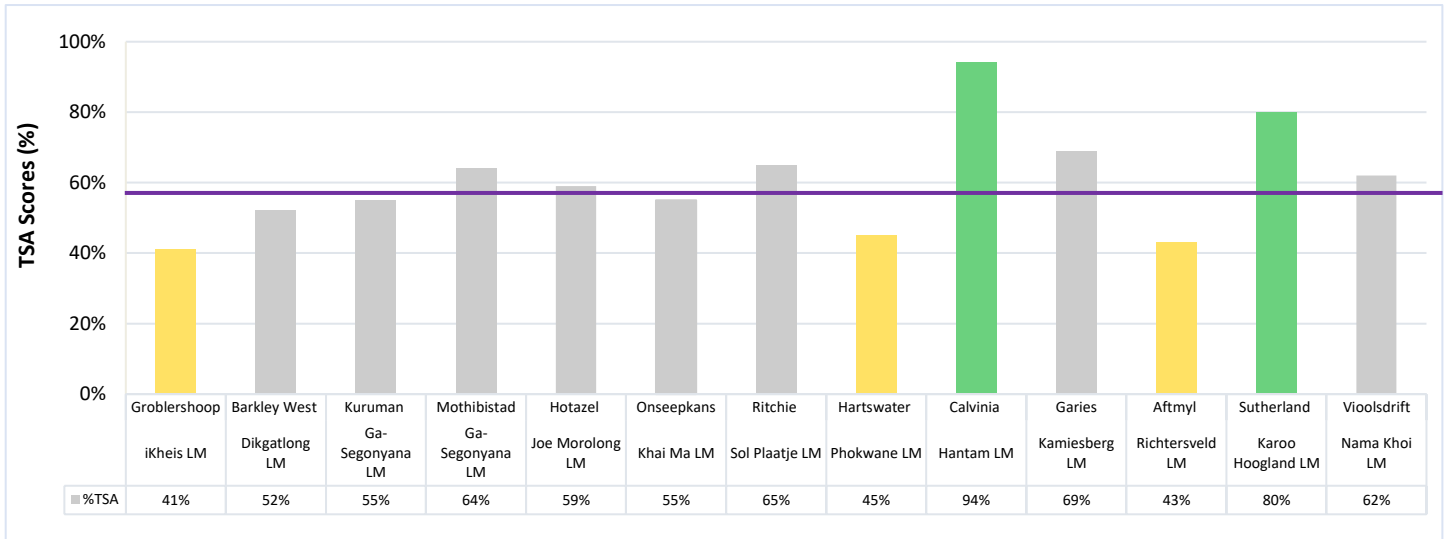
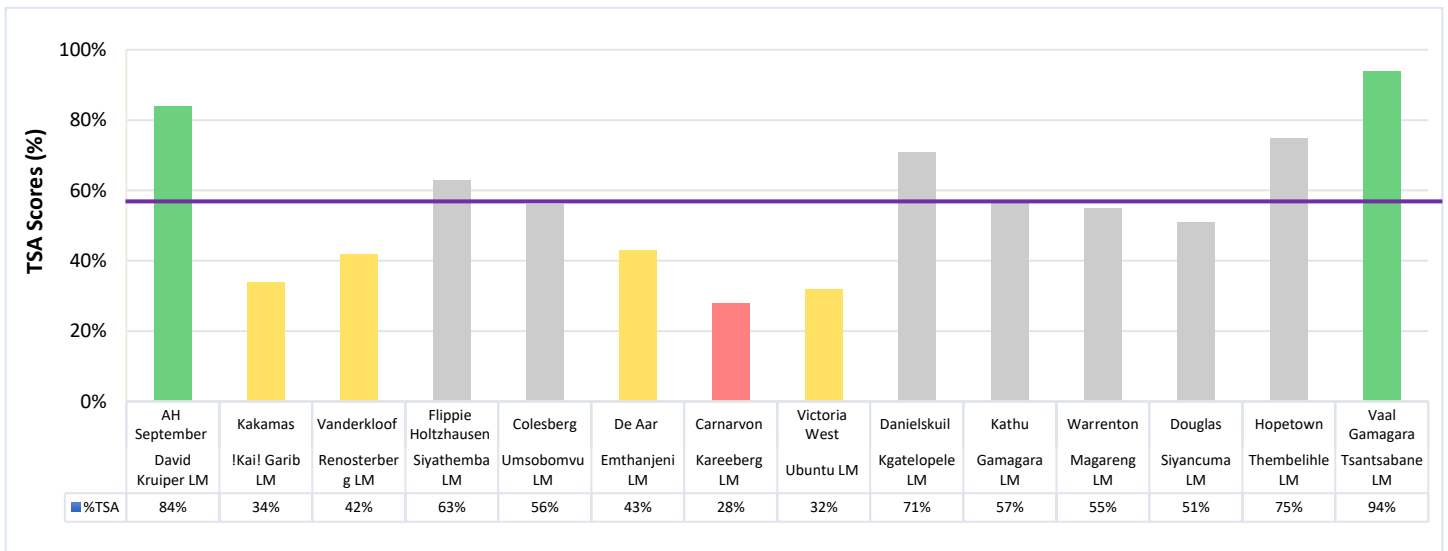
Figure 40 - NC TSA scores for all the BD Systems

An average of 58% was achieved for the 27 systems assessed, which means that infrastructure and processes are partially functional with an average performance. The best overall performance was found for Tsantsabane Bloem Water, followed by Hantam, David Kruiper and Karoo Hoogland. The water board provided one of the better performing systems. Lower performances were observed for Carnarvon Borehole and Victoria West Borehole.

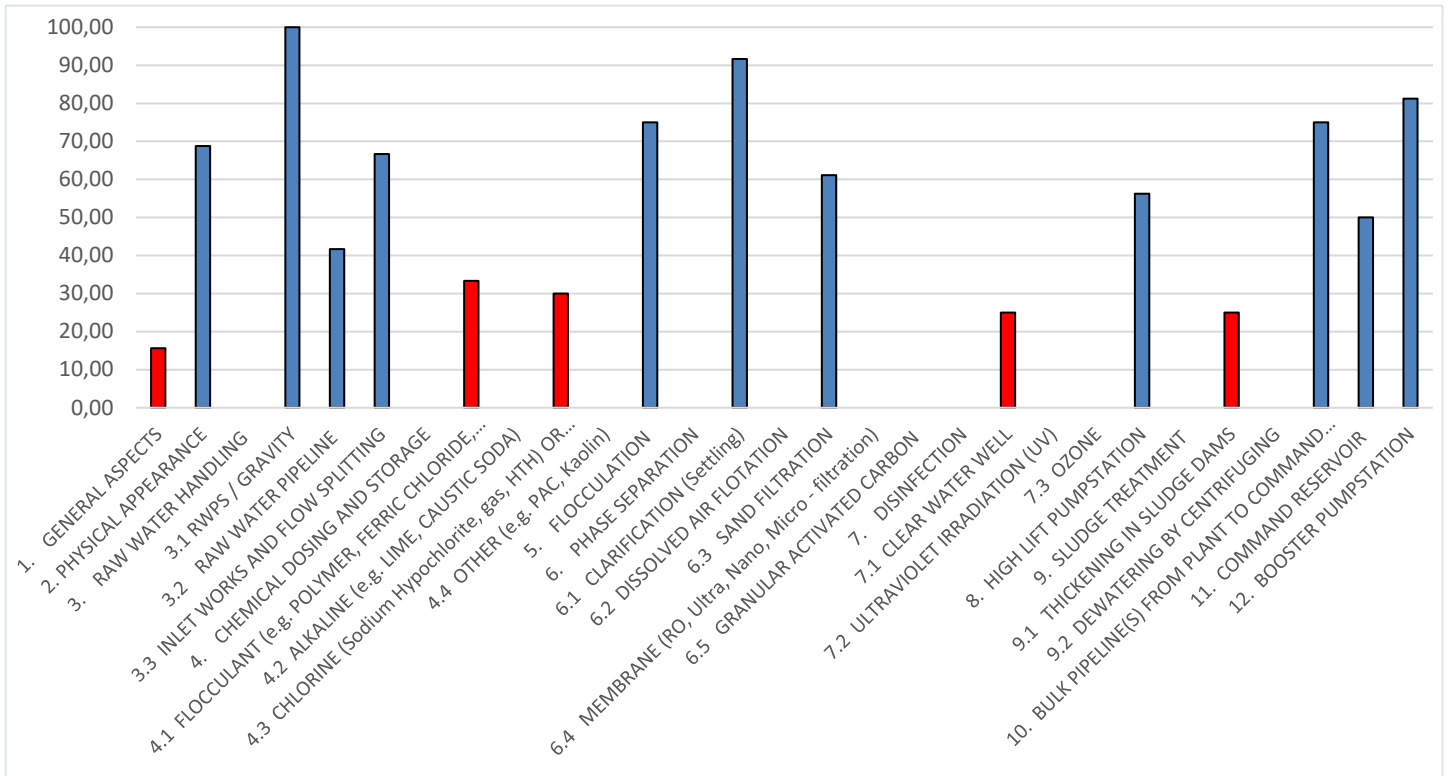
Watch #	Process Unit Assessed	% TSA	Observations
1	General aspects	16.0	There is no O&M manual, instruments are not calibrated.
2	Physical appearance of plant	69.0	Signage to be renewed at the entrance to the water treatment works.
3	Raw water handling		
	Raw water pumpstation/ gravity feed	100.0	
	Raw water pipeline	42.0	Inflow meters are not operational.
	Inlet works	67.0	Inflow not metered, inflow too high for the available infrastructure in operation. Floc channels are overflowing.
4	Chemical dosing and storage		
	Flocculant	33.0	The flocculant system has a single pump and is leaking. Drop tests are not conducted—no back calculation on the chemical stock.
	Alkaline	na	Lime dosing has never been commissioned and has fallen into total disrepair.
	Chlorine	30.0	The chlorine installation is unsafe, and staff has been trained, but no practical training or a site inspection as part of the training.
5	Flocculation	75%	Floc channels overflowing. No drop tests were conducted.

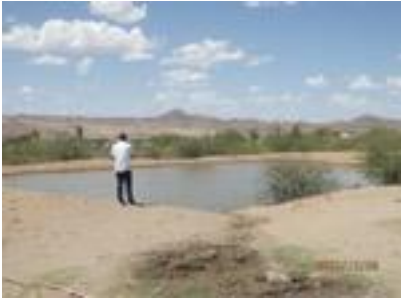
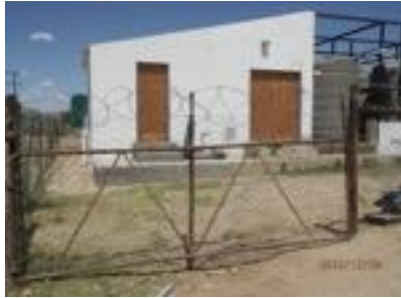
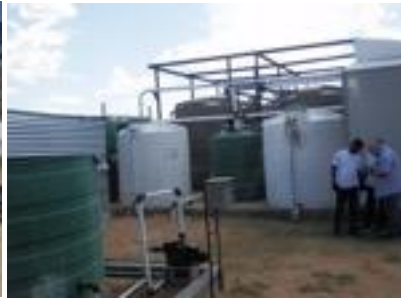
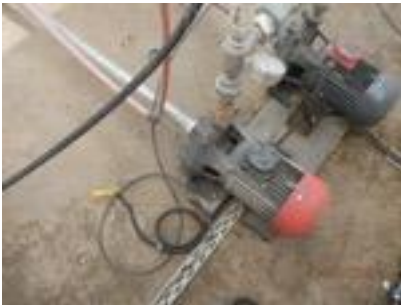
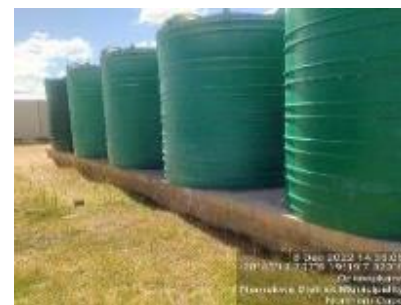
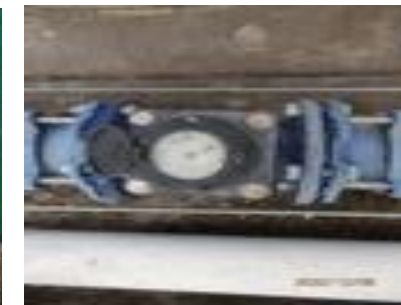
The Kakamas water treatment works was inspected to assess the condition and functionality of infrastructure and treatment processes on the ground, and to estimate the cost of restoration to full functionality. The Kakamas water treatment works was 6 400 kl/d and is registered as a class C plant and therefore requires process controllers with a class III certificate to operate and manage the water treatment processes.

Watch #	Process Unit Assessed	% TSA	Observations
1	General aspects	22.0	Class C plant certificate was displayed on the wall at the plant. The municipality should improve maintenance and repairs logbook records.
2	Physical appearance of plant	36.0	WTW was fenced and entrance was signposted displaying the name of the works and warnings. The Facility was characterised by overgrown vegetation and housekeeping was very poor.
3	Raw water handling		The raw water is abstracted from the Orange river. The Inspectors noted that one pump was installed. No standby capacity is in place. Raw and treated flow rates were not recorded and interpreted by the process controllers.
	Raw water pumpstation / gravity feed	58.0	
	Raw water pipeline	66.0	
	Inlet works	42.0	
4	Chemical dosing and storage		The two pumps were installed on 1 duty and 1 standby configuration. Therefore 100% standby was available.
	Flocculant	4.0

5	Flocculation	63.0	The chemical dosing area was not neat, the electrical cables were not properly connected. There were no dedicated flocculation channels therefore the WTW relied on pipeline distance to the portable clarifiers for flocculation.
6	Phase Separation		Floc accumulated in the portable clarifier tanks were observed and this led to excessive solid built up and solids carried over filters. The state of the clarifiers is very concerning.
	Clarification (settling)	0.0	
7	Sand filtration	19.0	The pumps that are used for high lift to command reservoirs were used for backwashing. There was a provision for four pumps to be installed but only two were connected and operational while the remaining two pumps had been removed for repairs for long period therefore there were no standby pumps.
8	Disinfection		There was no information on the size of the tank and contact time was not calculated. Dosing also took place directly into the clear water tank. No disinfection was taking place during the technical assessment as the plant had run out of HTH stock.

1. Clarifiers were in poor condition.
2. Flocculant dosing system requires urgent upgrade and the measurement of correct volumes.
3. Disinfectant dosing system requires urgent upgrade.
4. No standby pumps were available for raw water abstraction and high lift pump station.
5. No flocculation channel between holding dam and portable clarifiers.

- Focus on and prioritise the high risks identified above,
- Strengthen supply chain management to ensure that maintenance and chemical supply contracts are in place to support operation maintenance of water treatment works.
- The municipality must take note of the VROOM refurbishment cost estimate above and take appropriate action to upgrade the entire water treatment facility to enhance its condition to supply safe drinking water to Kakamas residents.
- Consider all condition assessment findings raised on the table above and develop a water safety plan, conduct risk assessment, and identify appropriate control measures to mitigate all risks identified that are associated within the water treatment works.

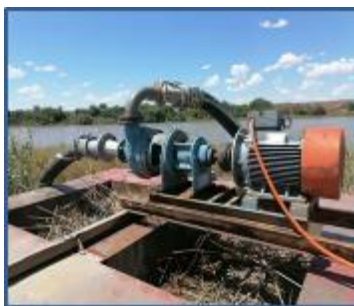
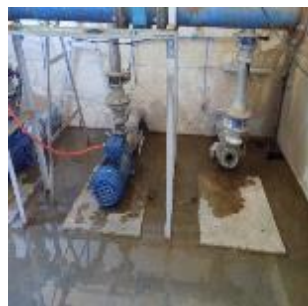
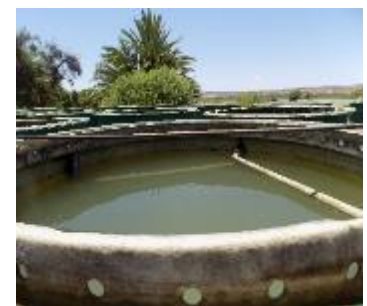
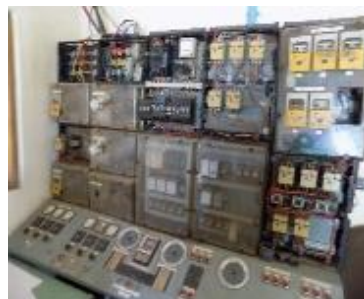
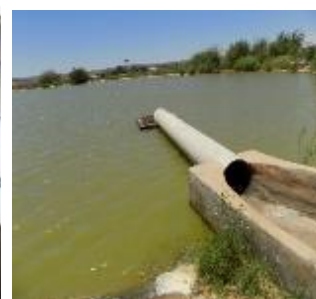
The Groblershoop water treatment system was inspected to assess the condition and functionality of infrastructure and treatment processes on the ground and to estimate the restoration cost to full functionality.

Watch #	Process Unit Assessed	% TSA	Observations
1	General aspects	22.0	Recordkeeping is limited with no control over the dosing.
2	Physical appearance of plant	50.0	The facility is fenced, housekeeping can improve and better installation of pumps.
3	Raw water handling		
	Raw water pumpstation/ gravity feed	25.0	A single pump is provided with unsafe electrical connection.
	Raw water pipeline	25.0	Inflow meter not working while pipeline is sufficiently sized.
	Inlet works	67.0	Flow splits equally but no provision for the measurement of chemical dosing.
4	Chemical dosing and storage		
	Flocculant	29.0	Poor dosing control with dilutions to ensure dosing takes place, although not enough.
	Alkaline	na	
	Chlorine	15.0	Single dosing pump, no back calculation of dosing, no MSDS, etc.
	Other (PAC, Kaolin, etc.)	na	
5	Flocculation	38.0	No dosing points, some scum but a closed system so flocculation cannot be observed (package plant).

6	Phase Separation		
	Clarification (settling)	67.0	Several leaking tanks, desludging done daily but sludge discharged back into canal.
	Dissolve air floatation (DAF)	na	
	Sand filtration	50.0	Some leaks were observed on the piping. Filters washed too frequently due to poor dosing control and lack of funds to procure flocculant. Filter media levels unknown and never checked.
	Membrane	na	
	Granular activated carbon (GAC)	na	
7	Disinfection		
	Clear water well	50.0	Sufficient space for contact time but no tests to confirm disinfectant residual.
	Ultraviolet irradiation (UV)	na	
	Ozone	na	
8	High lift pumpstation	56.0	Pumps installed in small space making access difficult. Must pump sets consists only of a single pump and may result in water shortages when failures occur.
9	Sludge treatment		
	Thickening in sludge dams	na	
	Dewatering by centrifuging	na	
10	Bulk pipeline from plant to command reservoir	75.0	No major leaks were reported and inspected.

1. Raw water is supplied by a single raw water pump, putting the water supply at risk.
2. The water treatment works cannot supply the demand as there ongoing development. The works will require urgent upgrading.
3. The poor condition of the clarifiers and filters further contribute to water losses within the treatment process.
4. The high lift pumps are not in a good condition, and some require urgent repairs.
5. The lack of sufficient chemicals and dosing according to quantity left results in possible underdosing.

The Groblershoop water treatment works, and supply system was inspected to evaluate the water treatment and water quality. The system is at risk with a single raw water pump, while the clarifiers and the filters are leaking, resulting in high water losses. The losses could not be calculated as the raw water meter is defective. Chemical dosing is adjusted, based on the quantity of flocculant available, resulting in water with very high turbidity. Disinfection is done by adding Calcium Hypochlorite, but no equipment is available for the measurement of chlorine residuals. The high lift pumps were upgraded and require some attention. The buildings are too small to allow proper access to the pumps.

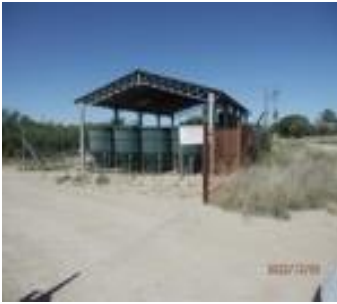
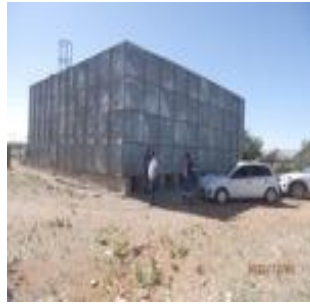
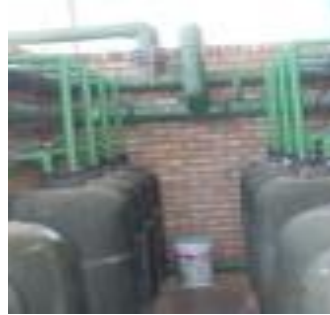
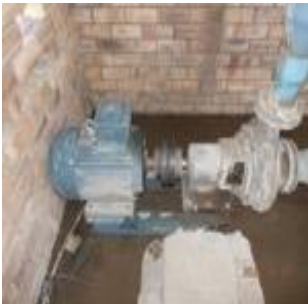
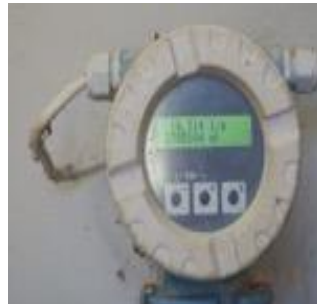
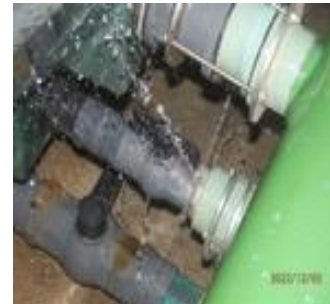
This supply system supplies drinking water to the community of Magareng Local Municipality at Warrenton, Ikhutseng and Warrenvale. It was inspected on 01 February 2023 to assess the condition and functionality of the infrastructure and treatment processes on the ground as well estimate the cost of those items that were not in full operation.

Watch #	Process Unit Assessed	% TSA	Observations
1	General aspects	47.0	Class C plant, of the eight aspects checked under this criterion: The plant did not have the maintenance and repairs logbook; there was no copy of O&M manual; and Jar Testing is only done once a month by a private Laboratory which is contracted to the Municipality.
2	Physical appearance of plant	57.0	Of the aspects checked during the site visit, the following scored less than 50%: The WTW building, and concrete/cement pavement show cracks, and this could be an indication of unstable foundation or soil movement and this concern was mentioned by staff who also showed the assessors cracks in the toilet as well falling ceiling. This is the main concern under this aspect. And it is an OHS issue. In addition, which may make this site untidy is the unfinished construction areas within the premises with some of construction material left unattended.

Chlorine	44.0	
5	Flocculation	00.0	The flocculation tank for this plant (Warrenton) is not working and is currently by-passed. It means its purpose now is done by the sedimentation tanks. It is a concern and the flocculation tank need to be fixed.
6	Phase Separation		
	Clarification (settling)	25.0	There are four compact sedimentation tanks equipped with lamella plates and these are now used both for flocculation and settling. It is a concern. The staff informed the assessors that desludging of the tank is difficult due to desludge pipes frequent blockages. The assessors during the visit noted algal filaments on the lamella plates. The issue of blocking outlet desludge pipes need investigation and the flocculation tank need to be fixed.
	Sand filtration	78.0	There are three filters and the assessors noted media surface cracks and in the TSA an allowance under civil is made to assess the filter media including checking of filter nozzles.

1. The Jar Test or floc formation test need to be performed regularly in order to accurately set the water treatment chemical dosage rate.
2. Due to the concern of soil movements that results of cracks to the plant building and “some” process units. The Municipality should get the services of a Geo-Technical Engineer to investigate and report. It is an OHS issue.
3. At the inlet works, additional low lift pump(s) to act as standby are required.
4. The flocculation tank that is broken and currently by-passed need to be fixed.
5. The desludge piping of the sedimentation tank need to be checked and fixed. The onsite staff have difficulties to desludge the sedimentation tanks.

The staff at Warrenton Water Purification Plant is doing the best to operate it as efficiently as it is possibly and are commended, noting that there are many process units which are performing below capacity due to broken items. These are: (a). The flocculation tank is not working and is by passed. (b). The sedimentation tanks desludge mechanism is not working and it results in high turbidity going into the filters. (c). The plant building and process units have cracks which is linked to onsite soil movement, and this is an OHS issue. The Municipality should seek an assistance of a Water Engineer to identify all the problems including the above mentioned so that they are attended to. The non-compliance to SANS 241 with microbiological compliance poses a significant risk for community health in the WSA area of responsibility.

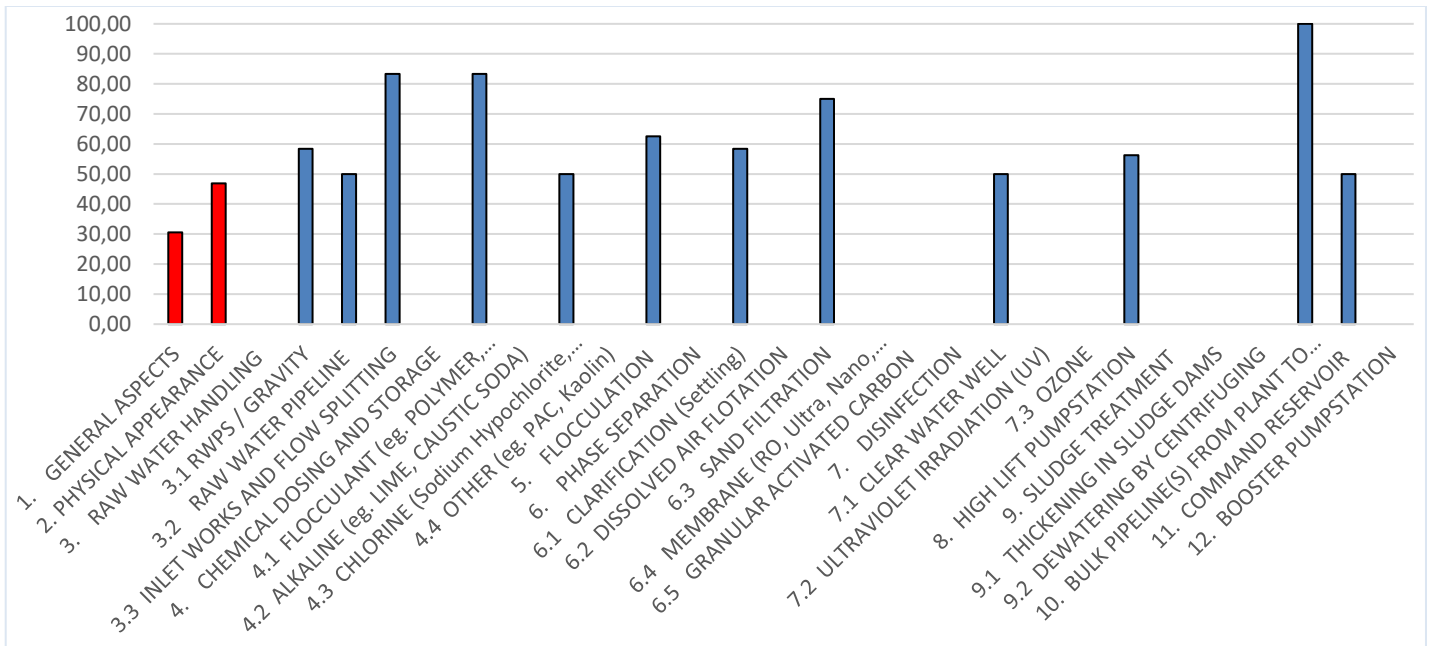
Performance Profile

The following process units were inspected and rated according to the % score on the y-axis. Process units that score <50% are marked in red and need urgent intervention.

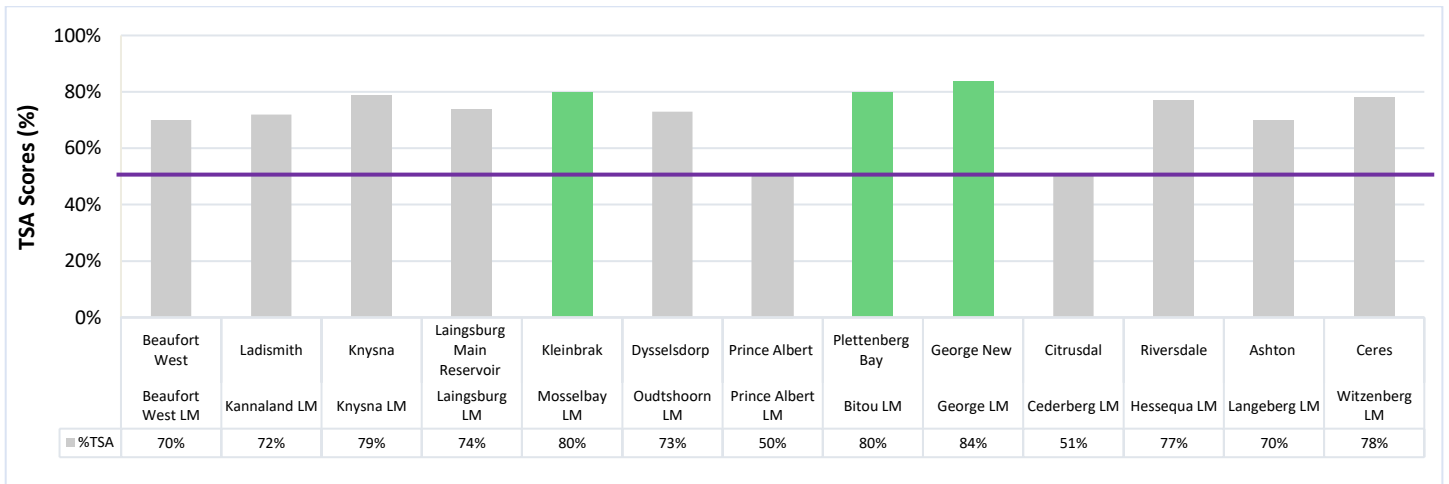
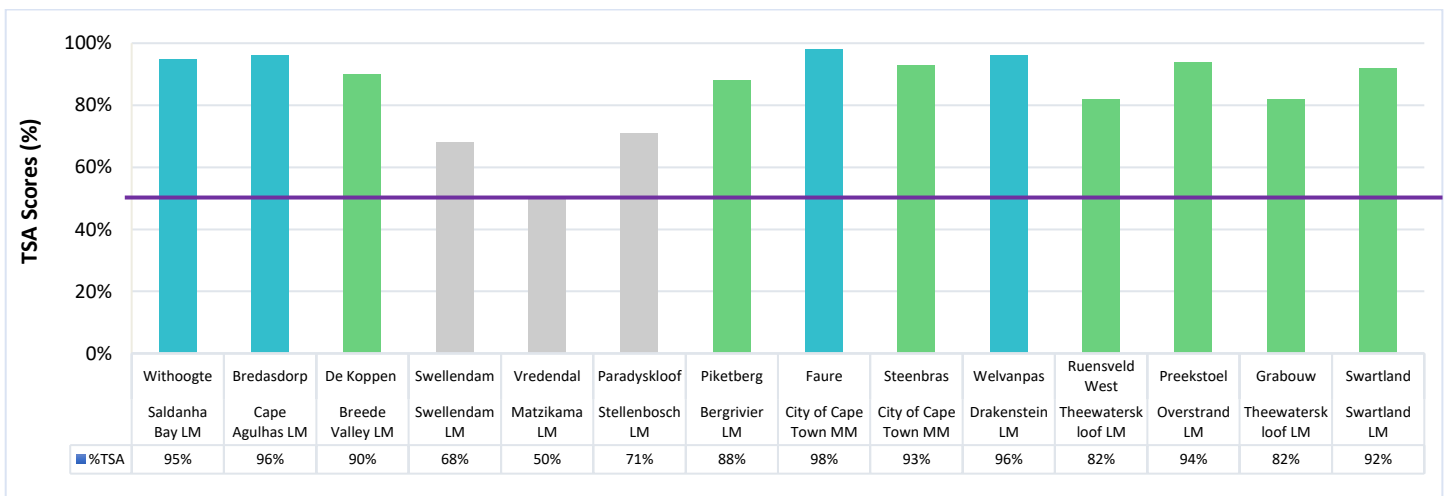
Figure 45 - WC TSA scores for all the BD Systems

An average of 79% was achieved for the 27 systems assessed, which means that infrastructure and processes are partially functional with an average (close to good) performance. The best overall performance was found for City of Cape Town, followed by Drakenstein, Cape Agulhas and Saldanha Bay. Two of the water boards and bulk suppliers provided some of the better performing systems. Lower performances were observed for Prince Albert, Vredendal and Citrusdal.
