BLUE DROP

Watch Report

BLUE DROP WATCH REPORT 2023: TECHNICAL ASSESSMENT OF THE CONDITION OF MUNICIPAL DRINKING WATER TREATMENT AND DISTRIBUTION SYSTEMS IN SOUTH AFRICA

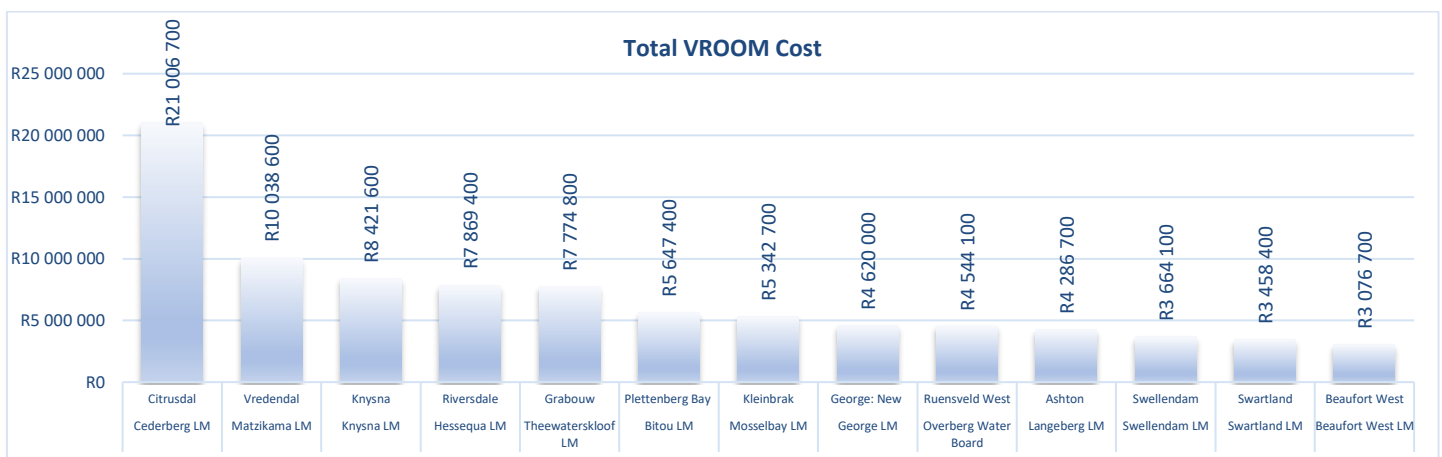
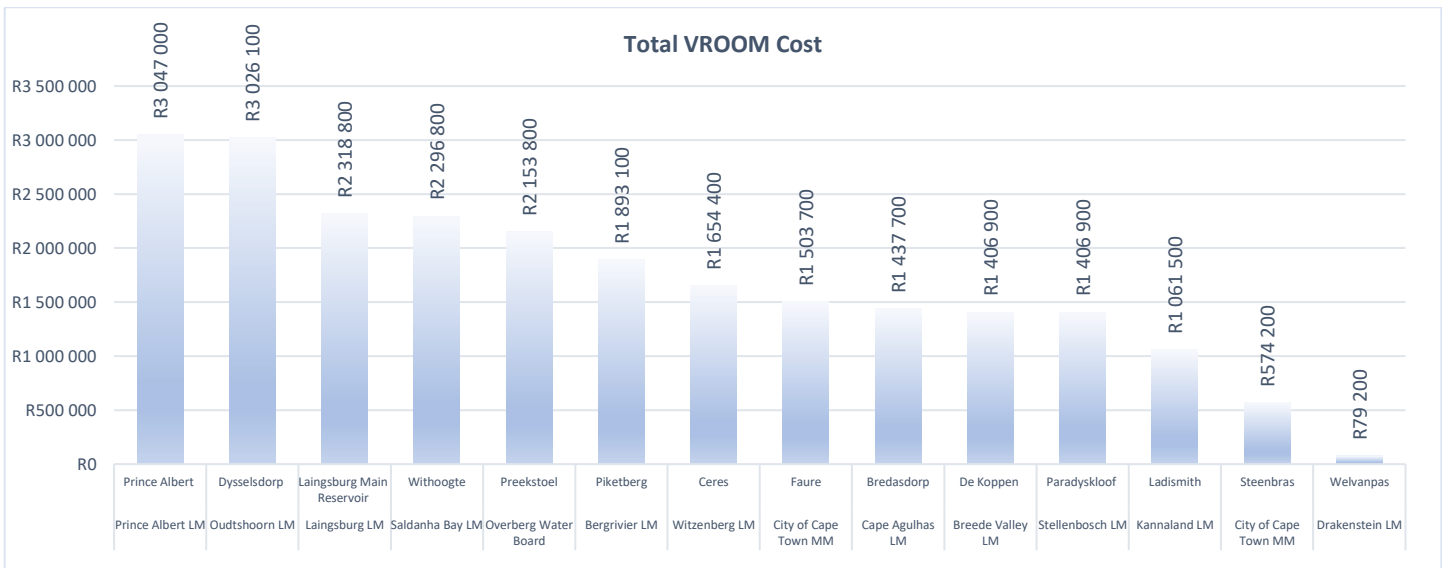
Figure 47 - Total VROOM Cost for the BD Systems Assessed

The associated VROOM costs for the 27 water supply systems assessed amounts to R113.6 million, with the bulk of investment needed for Citrusdal (Cederberg), Vredendal (Matzikama) and Laingsburg Main Reservoir (Laingsburg).

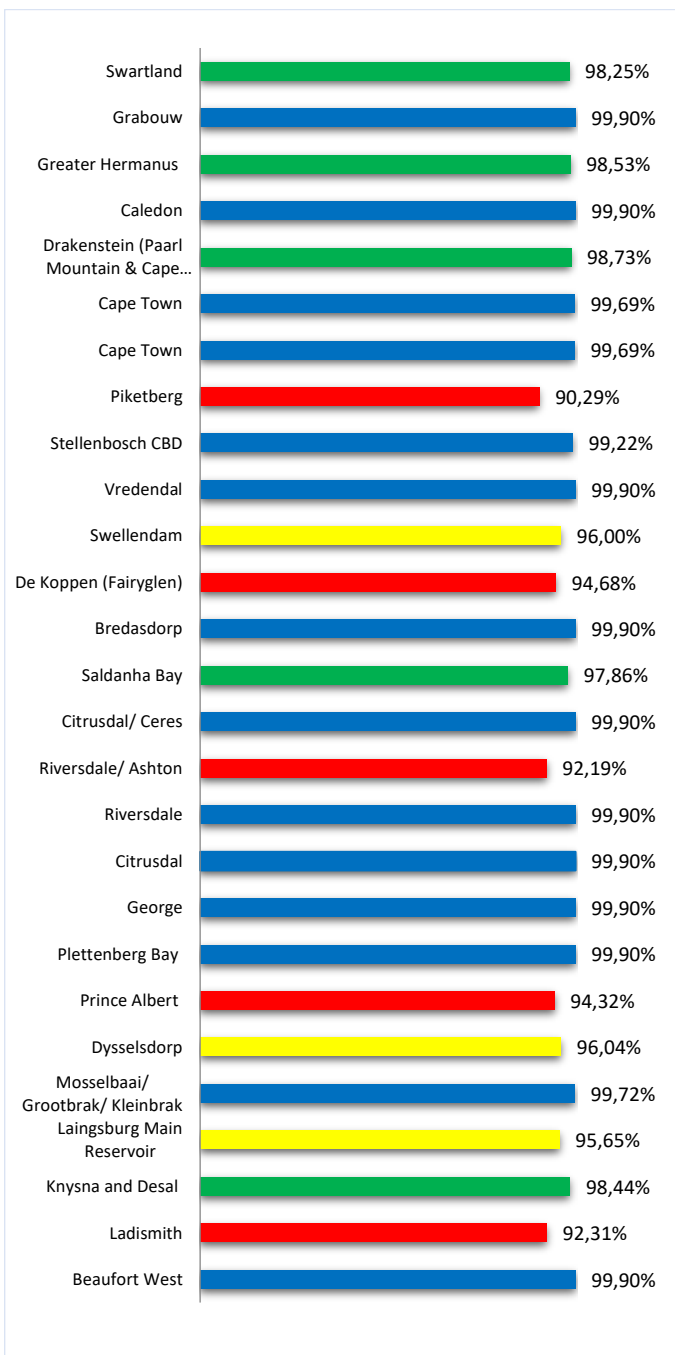
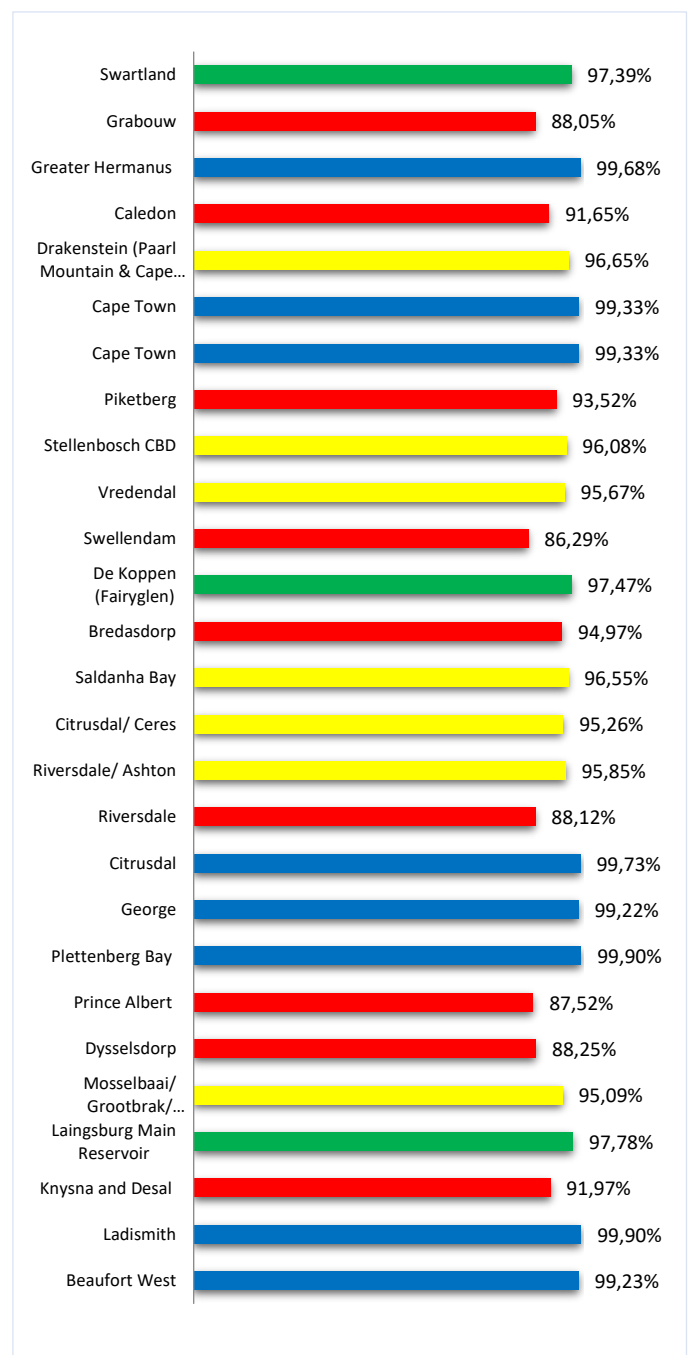
Figure 48 - WC Drinking Water Quality Status of all the TSA Water Supply Systems

The TSA and water quality results depict a different picture. The TSA shows 27 of the 27 (100%) water supply systems to be in the *excellent to average performance category*, and the water quality compliance shows that 29-59% of the systems *fail to produce compliant final water quality*.

Out of 27 treatment plants, 14 (53%) and 5 (18%) of systems achieve excellent and good microbiological quality. A total of 3 (11%) systems have poor microbiological compliance and 5 (18%) systems have bad microbiological water quality status. The water in these systems poses a serious acute health risk to the community. WSAs with poor microbiological water quality status must be assessed to confirm status in all systems to ensure rectification measures are comprehensive to safeguard communities. The direct cause of microbiological failures can be linked to the TSA sub-watch Area 7, which has a low contribution to the overall TSA score. The failure to produce water that meets E. coli standards can be linked back to poor operations, defective infrastructure, dosing rates, absence of disinfection chemicals, lack of monitoring, or lack of operating and chemistry knowledge. WSIs that are not monitoring the final water quality at the outlet of the treatment plant or at specific end use points must develop a monitoring programme and resume with compliance monitoring as a matter of urgency.

Chemical compliance shows that 8 (30%) and 3 (11%) have excellent and good water quality, whilst the majority of systems fail to achieve chemical compliance. A total of 7 (26%) and 9 (33%) systems have a poor and bad chemical water quality status.

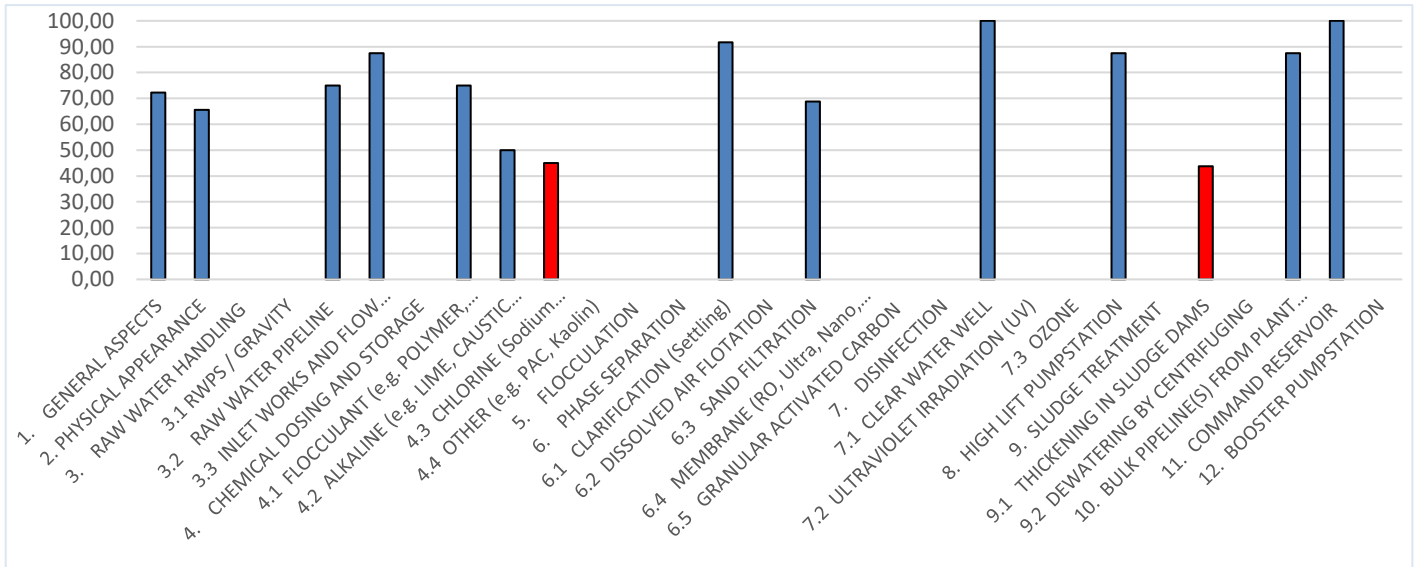
Performance Profile

The following process units were inspected and rated according to the % score on the y-axis. Process units that score <50% are marked in red and needs urgent intervention.

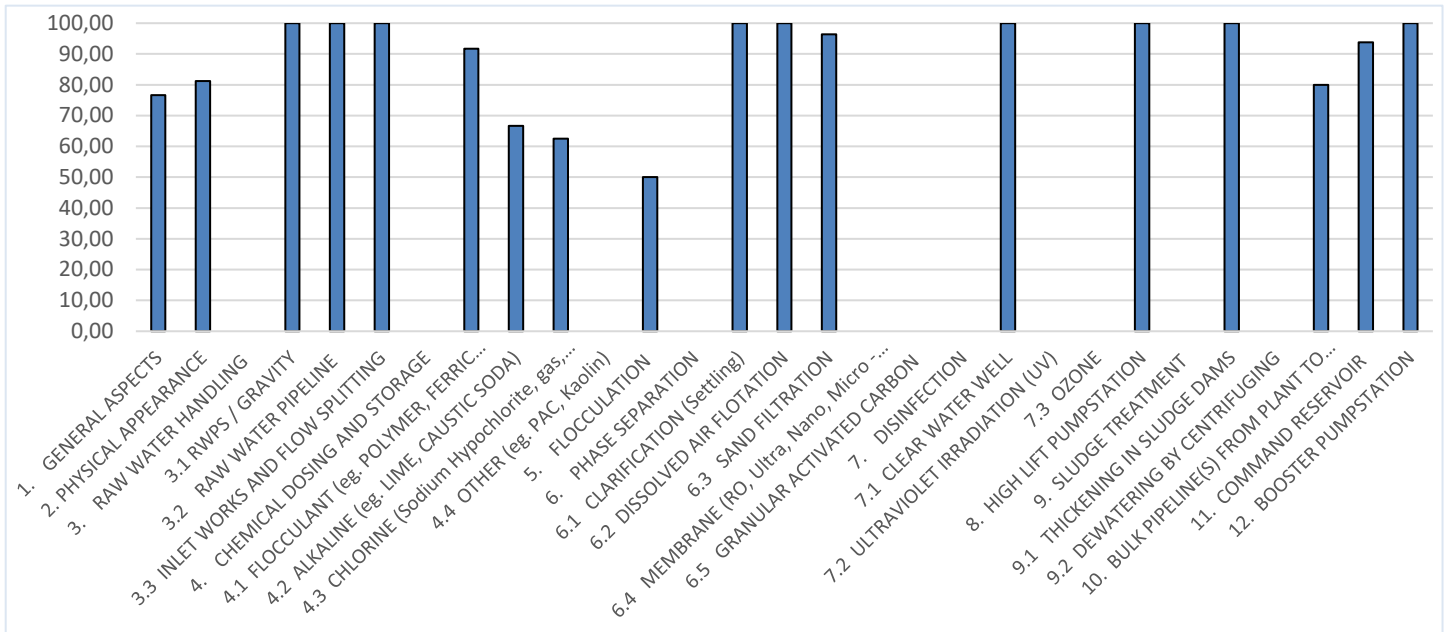
Performance Profile

The following process units were inspected and rated according to the % score on the y-axis. Process units that score <50% are marked in red and needs urgent intervention.

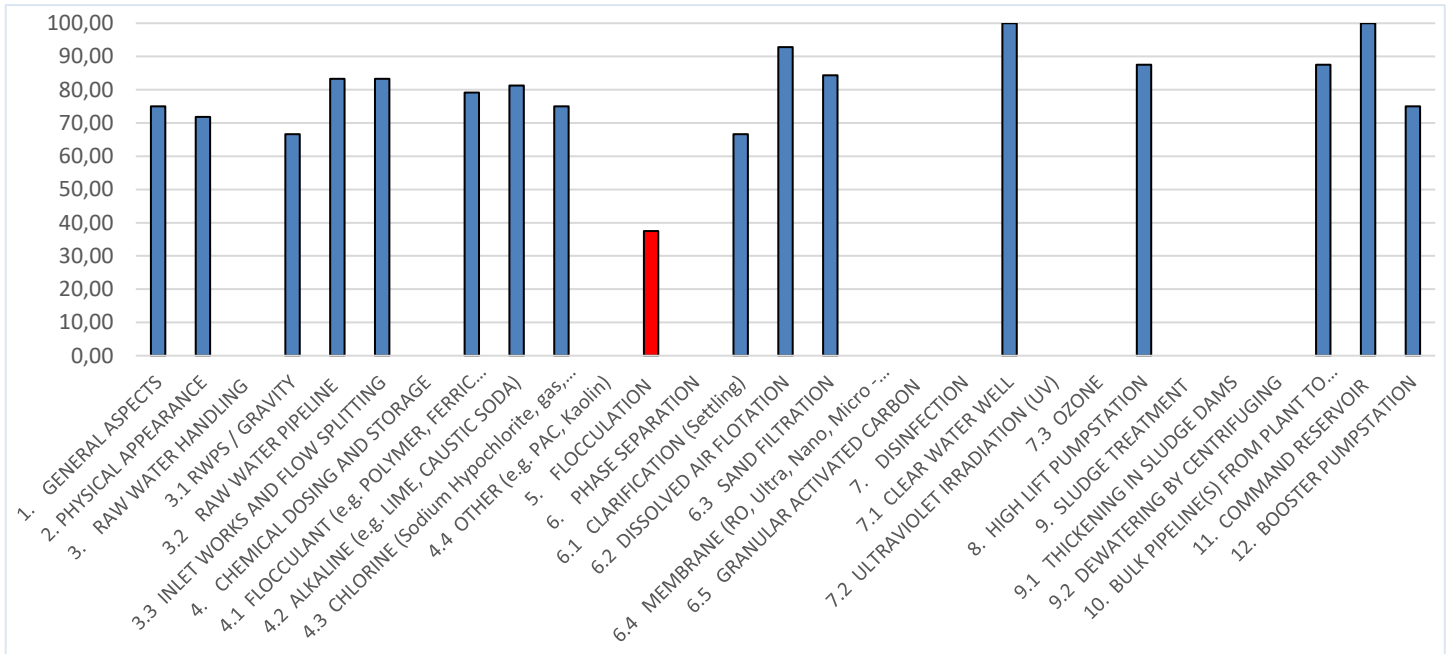
Performance Profile

The following process units were inspected and rated according to the % score on the y-axis. Process units that score <50% are marked in red and needs urgent intervention.

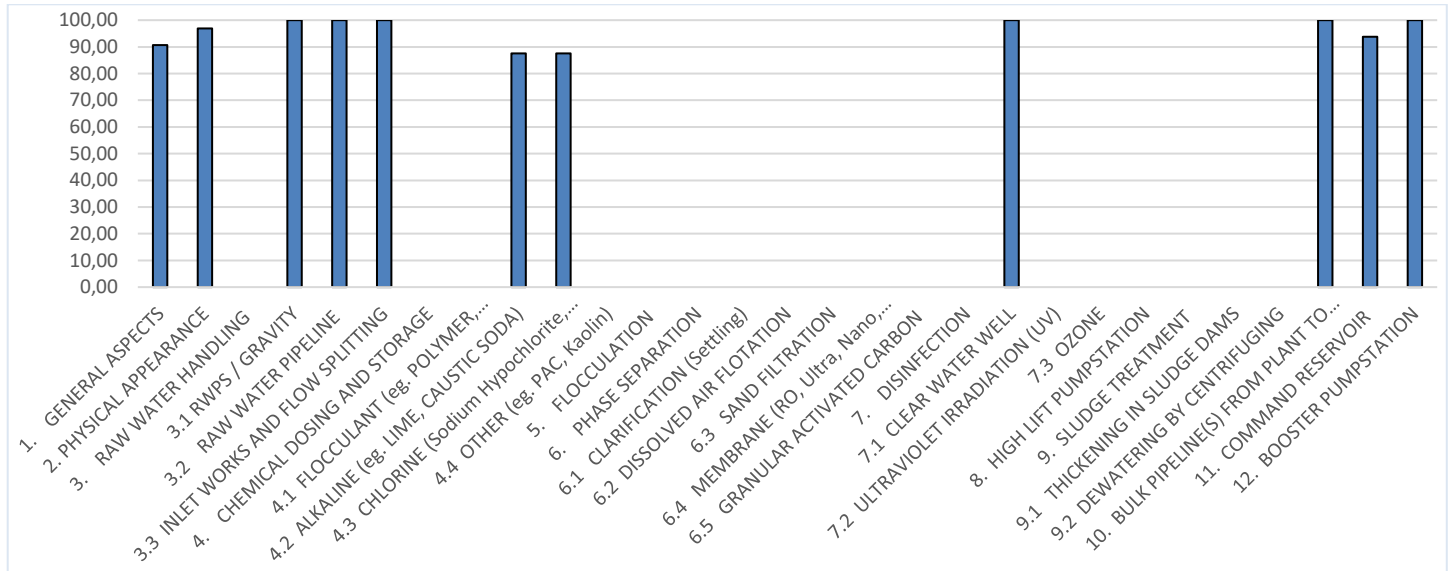
Performance Profile

The following process units were inspected and rated according to the % score on the y-axis. Process units that score <50% are marked in red and need urgent intervention.

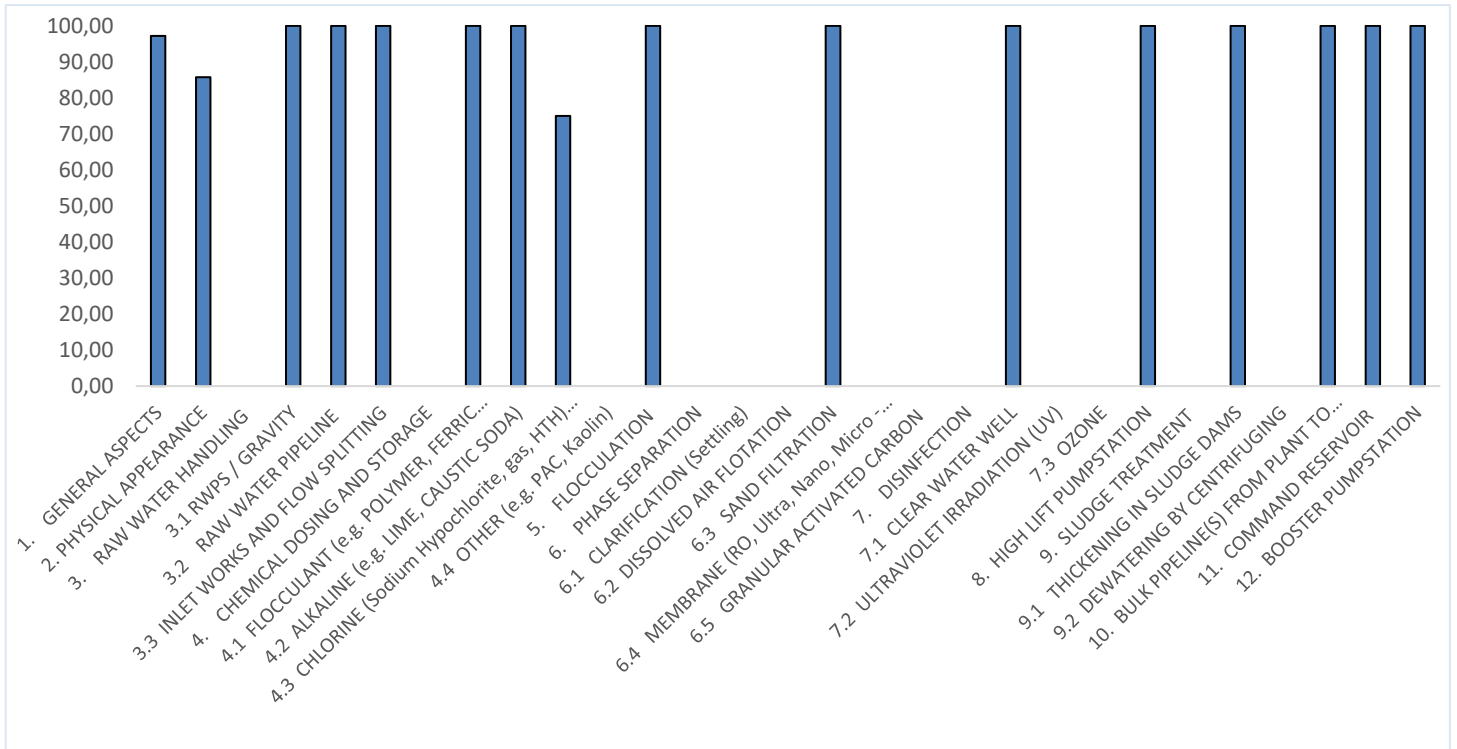
Performance Profile

The following process units were inspected and rated according to the % score on the y-axis. Process units that score <50% are marked in red and needs urgent intervention.

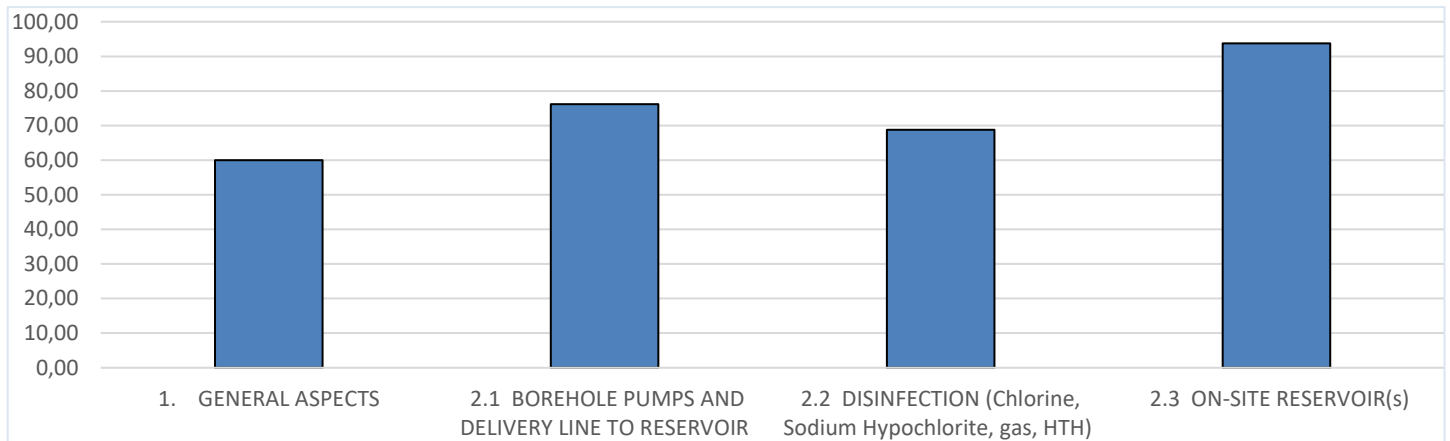
Watch #	Process Unit Assessed	% TSA	Observations
1	General aspects	60.0	Flow, pH & Residual Chlorine recorded as part of operational monitoring – this list should be expanded on to meet SANS 241:2015: Table 1 requirements.
2	Technical

2.3	On-site reservoir	93.7	Fence repairs are an ongoing task. The last section of the access road should be upgraded, especially since chlorine gas needs to be transported to site
Total		74%

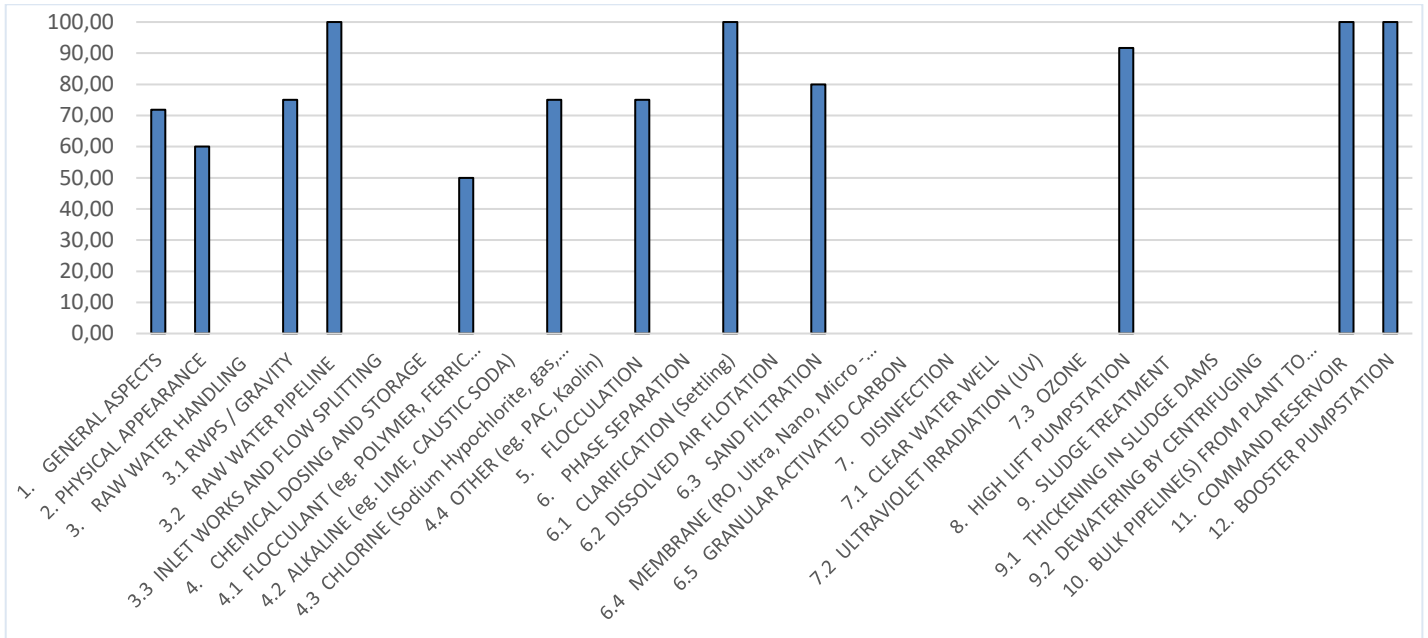
Watch #	Process Unit Assessed	% TSA	Observations
1	General aspects	71.8	Class B plant, logbooks in place, process monitoring equipment in good condition and calibrated. IMP not in place
2	Physical appearance of plant	60.0	Plant signposted, fenced, and gated. Access control and lighting required. Housekeeping and hygiene can improve. No dedicated kitchen for plant personnel.
3	Raw water handling		6 x duty Raw water abstraction from Breede River with one standby pump, investigate pump size & pipe capacity to match the water supply demand during peak use periods, all pumps and Flow meter in good condition. Flow recorded regularly per shift.

3.1	Raw water pumpstation / gravity feed	75.0	
3.2.	Raw water pipeline	100.0	
3.3.	Inlet works and flow splitting	na	
4	Chemical dosing and storage		
4.1.	Flocculant	50.0	Spillage control of Ultra Flocc lacking. Dosing pumps in good condition. Storage volume adequate. Emergency shower needs to be installed.

4.3.	Chlorine	75.0	Rotameters operational. 100% Standby for chlorine dosing pumps. Safety signage and some equipment available. 2x 70kg cylinders available in storage. Minimisation of accidental exposure to chlorine needs to be investigated.
5	Flocculation	75.0	Floc formation could not be assessed. Good condition of both flocculation units.
6	Phase Separation

6.1	Clarification	100.0	Desludging of the units conducted regularly. Weir plates in good condition.
6.3.	Sand Filtration	80.0	Two duty backwash pumps and 1 blower-no standby. All filters in good condition. Handrails required for structures at ground level.
7	Disinfection	0.0	Inadequate contact time. Chlorine is dosed after the onsite reservoir. Free chlorine not measured at the correct place.
9	Sludge Treatment	0.0	Sludge dam not well maintained. Recycling pumps clog frequently.
10	Bulk pipeline from plant to command reservoir	na	Pipeline underground.
11	Command reservoir	100.0	Onsite reservoir and in good condition. Telemetry in place and operational.
12	Booster Pumpstation	100.0	Two pumps in working condition. MCC in working condition and easily accessible.
	Total	70%

1. Access control to the Storage dam
2. Safety signage overall in the plant, hand rails
3. Dosing of chlorine
4. Absence of security and inadequate lighting at night

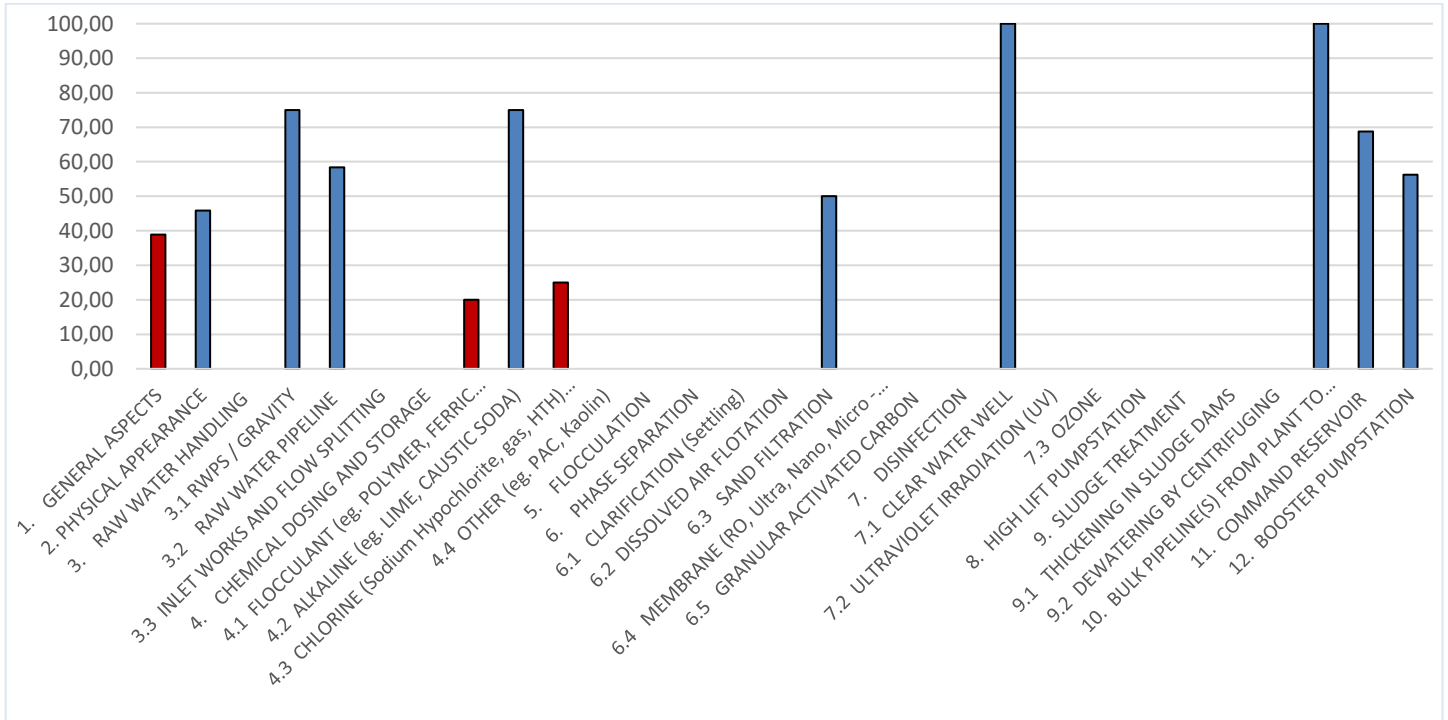
Watch #	Process Unit Assessed	% TSA	Observations
1	General aspects	38.8	Class D plant, operational logbook in place with limited daily entries. Maintenance & repairs logbook not available. O&M manual available. IMPs not available. No process flow diagram displayed, only available in O&M manual. Analytical equipment functional and calibrated.
2	Physical appearance of plant	45.8	No entrance sign. Site fully fenced, but portions of fence stolen. Site generally neat, weeds growing in some places. No dedicated facilities available for employees. Ablution facilities dirty. Safety signs in place.
3	Raw water handling

3.1	Raw water pumpstation/gravity fed	75.0	Screens in place, cleaned regularly. 3 pumps, 2 functional, 1 being repaired. Standby available.
3.2	Raw water pipeline	58.3	Corrosion issues on pipeline. Pipeline too small, needs to be upgraded. Raw water flow meter functional, not calibrated. Regular recording of flow rates.
4	Chemical dosing and storage

4.1	Flocculant (polymer, ferric chloride, alum)	20.0	Flocculant dosed due to deteriorating water quality. Dosing pump functional. No standby. No proper chemicals storage area. Area not bunded. No emergency shower available.

6.2	Sand filtration	50.0	Slow sand filtration. 8 out of 21 filters not functional. Weeds growing between filters. Flow not evenly distributed. No handrails, potential hazard. Valves need replacement/refurbishment. Civils need refurbishment.
7	Disinfection	100.0	>30minutes contact time. Free chlorine measured.
8	High lift pumpstation		Water gravitates to command reservoirs. No high lift pumps.
10	Bulk pipeline from plant to command reservoir	100.0	Pipeline underground. No leaks reported.
11	Command reservoir	68.7	Covered concrete command reservoirs, within plant perimeter. Not secure. Fence stolen/vandalised. Level detection on SCADA. Final flow meter in place, not calibrated.
12	Booster pumpstation	56.2	Two booster pump stations. Station No. 1: duty/standby. Station No.2: only duty, standby pump not in place. Pumps functional. Pump building outside plant perimeter. Not fenced, not secure.
	Total	50%

The Vredendal water treatment plant is relatively old. The infrastructure is generally not in a good condition and significant maintenance and refurbishment work is required. The raw water pipeline is leaking due to corrosion and needs to be repaired and upgraded for additional capacity. Buildings need to be erected for the storage of chemicals, since chemicals are currently stored outside. There are currently no designated lunch facilities for the process controllers.

The site is generally neat and well kept, although weeds are growing between the slow sand filters. Only 8 out of 21 slow sand filters are functional, which is seriously affecting the available treatment capacity of the plant. The filter valves need to be refurbished or replaced and civil refurbishment work is required. Handrails should be installed around the slow sand filters. The process controller on site is very dedicated and passionate and the overall impression is that management is motivated to improve the situation. The WSA faces a major treatment challenge, due to deteriorating raw water quality in the Clanwilliam dam. The current process is no longer appropriate and coagulation/flocculation, clarification (alternatively dissolved air flotation) and back-washable filters are required as a minimum to treat raw water containing algae, organic material, and suspended solids. For this reason, the WSA should urgently undertake a full process audit and to implement the findings and recommendations. The WSA is encouraged to implement the recommendations of the WaSP.

1. Deteriorating water quality from Clanwilliam Dam and Canal necessitates proper evaluation of treatment train to include flocculation, clarification and potentially DAF for algae removal.
2. All chemical handling, storage and dosing need addressing and designed with appropriate facilities.
3. Slow sand filters need to be refurbished and recommissioned since 8/21 were not operational.
4. Theft and vandalism of fencing a serious risk - security must be prioritised.

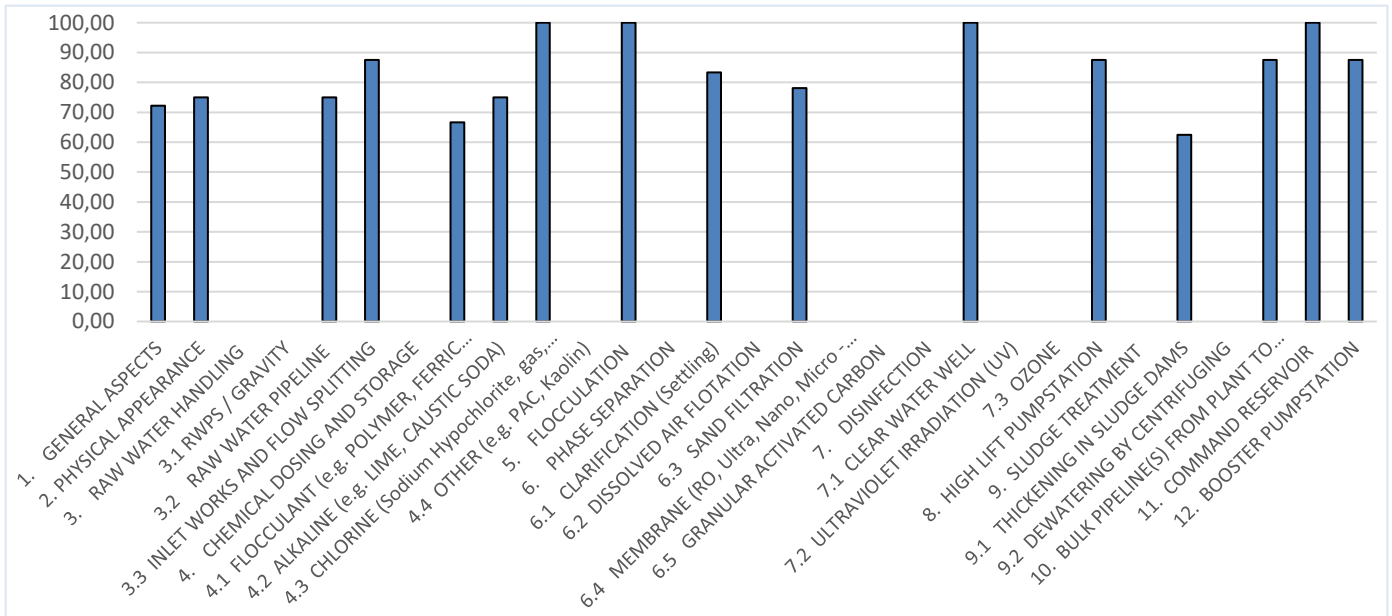
Watch #	Process Unit Assessed	% TSA	Observations
1	General aspects	72.2	Most of the key aspects required for operational control of this type of works are in place. It is also commendable to see some modern upgrades, like inline turbidity measurement on each of the filters, installed
2	Physical appearance of plant	75.0	Minor repairs to buildings and some painting required. Overall however, a well-kept works
3	Raw water handling		
	Raw water pumpstation/ gravity feed	0.0	Gravity feed from Wolwedans Dam. Pumpstation at Klipheuwel is controlled by DWS. (WSA only checks and reports faults to DWS). DWS's response time is reason for concern
	Raw water pipeline	75.0	Occasional leaks do occur. Maintenance is however DWS's responsibility.
	Inlet works	87.5	No flow splitting structure installed. Pipework allows flow to be directed to the different modules on site. Flocculant dosing taking place into the pipework where static mixers are installed. Visible floc in the channels indicate that sufficient flash mixing does occur

4	Chemical dosing and storage		
	Flocculant	66.6	The dosing room should be upgraded to ensure the slippery floor is dealt with. A second safety shower/ emergency eye wash should also be provided closer to the dosing pumps.
	Alkaline	75.0	Lime feeders are in a functional condition but would benefit from refurbishment as to prolong its lifespan.
	Chlorine	100.0	Separate controllers/ injectors feeding different areas of the plant, i.e., no direct standby. This is however mitigated by the fact that not all of the Modules are functional at the same time and that pipework can therefore be changed to allow an unused part of the system to feed into the required line should a failure occur.
5	Flocculation	100.0	Flocculation channels are in a good condition.
6	Phase Separation		
	Clarification (settling)	83.3	Good clarification with minimal floc carry-over. Desludging done daily. Only minor repairs for the settler coverings (roofs) required.

Sand filtration	78.1	Backwashing done every second day. Some of the concrete aggregate in the tanks is starting to show. There are also areas on the walkways where the concrete reinforcing is visible - minor concrete repair work required. The installation of a second blower is advisable
7	Disinfection		
	Clear water well	100.0	In a good condition with sufficient retention time
8	High lift pumpstation	87.5	In a good overall condition
9	Sludge treatment		
	Thickening in sludge dams	62.5	Sludge dams are overgrown with reeds and needs to be cleaned out
10	Bulk pipeline from plant to command reservoir	87.5	Even though there are no major concerns, the age of the pipeline needs to be noted and associated maintenance should be planned for
11	Command reservoir	100.0	In a good condition
12	Booster pumpstation	87.5	The booster pumpstation visited had a 2 x Duty + 1 x Standby arrangement. There were signs of recent maintenance that was performed

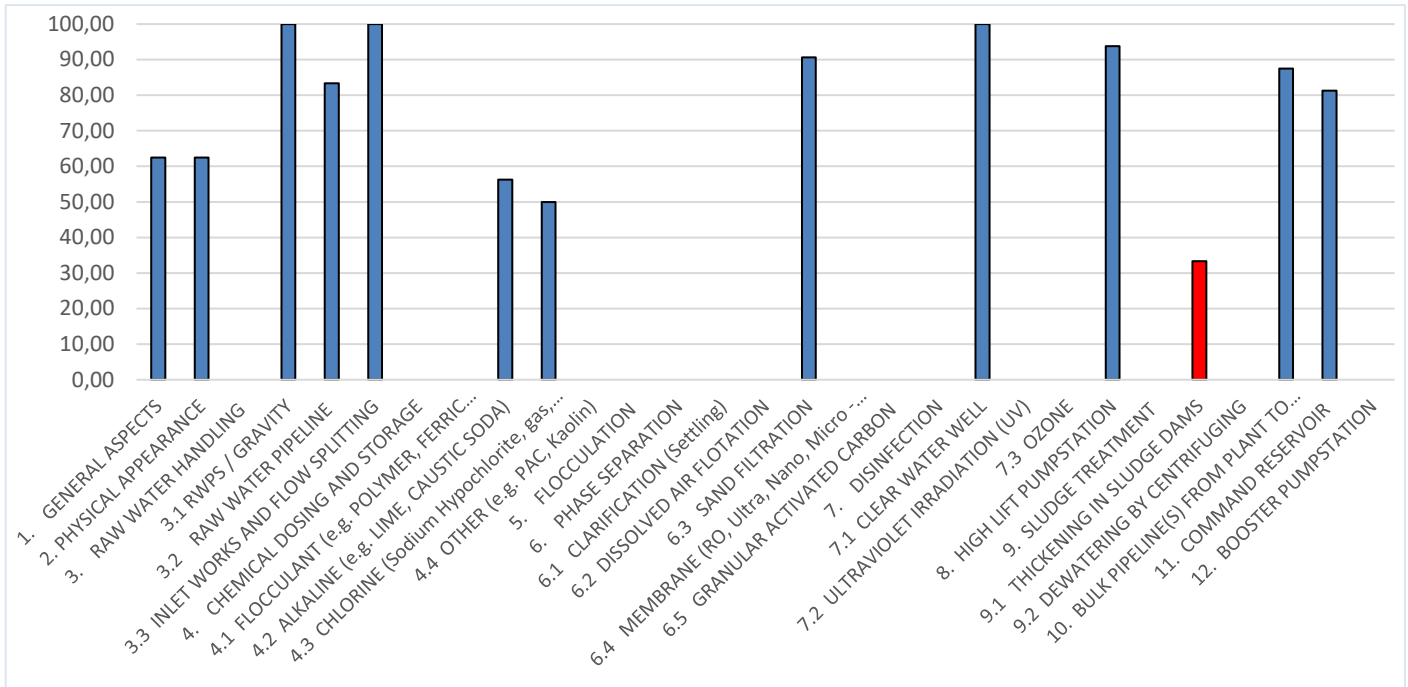
Watch #	Process Unit Assessed	% TSA	Observations
1	General aspects	62.5	Most of the documents and systems that need to be in place to efficiently operate a water treatment works are in place. Turbidity monitoring is however of concern – the plant receives only groundwater, but the in-line meters are out of order and the benchtop meter does not display turbidity values in decimals. The on-site testing of Fe & Mn, SO ₄ and parameters linked to corrosivity of water is commendable.
2	Physical appearance of plant	62.5	The plant is in a fair state and only a few minor repairs are required.
3	Raw water handling		
	Raw water pumpstation/ gravity feed	100.0	8 x Boreholes are available. The plant can produce sufficient volumes of water with only 5 in operation.
	Raw water pipeline	83.3	The wellfield ground level is located higher above sea level than the Works. The boreholes are however quite deep. Pressure control valves are installed and needs to be maintained.

Inlet works	100.0	A cascade is installed at Inlet Works. Aeration provides adequate oxidation for Iron & Manganese removal.
4	Chemical dosing and storage		
	Alkaline	56.5	Repairs to the lime feeder vibrator is required. It is furthermore worth noting that only 1 feeder is installed.
	Chlorine	50.0	Dosing system in good working order. Civil works in chlorine dosing facility has been upgraded, but dosing equipment not yet. This is planned as a follow-up phase and will include all equipment required to make the installation compliant with chlorine safety standards.
5	Flocculation	na	No flocculation in place.
6	Phase Separation		
	Sand filtration	90.3	Newly upgraded pumps and blowers. Backwashing is controlled by a PLC.
7	Disinfection		
	Clear water well	100.0	In a very good condition.
8	High lift pumpstation	93.5	This part of the plant was also recently upgraded and is in a very good condition.
9	Sludge treatment

Thickening in sludge dams	33.3	Desludging takes place to 2 x unlined sludge ponds. One of these was empty and the other in a fair condition. It is however recommended that the ponds be lined.
10	Bulk pipeline from plant to command reservoir	87.0	In a good condition with no issues reported
11	Command reservoir	81.5	There are two reservoirs. The 1 st one has no fencing, only a cage around the access ladder to prevent unauthorised access. The fencing around the 2 nd reservoir was stolen
12	Booster pumpstation	na	Gravity feed only.
	Total	73%

1. Inline monitoring, specifically for turbidity, is to be repaired.
2. A second lime feeder should be installed.
3. Chlorine equipment is to be replaced – this is already part of the WSA's planning.
4. The reservoirs should be secure to prevent unauthorised access.
5. Minor building repairs, such as painting, could be considered.

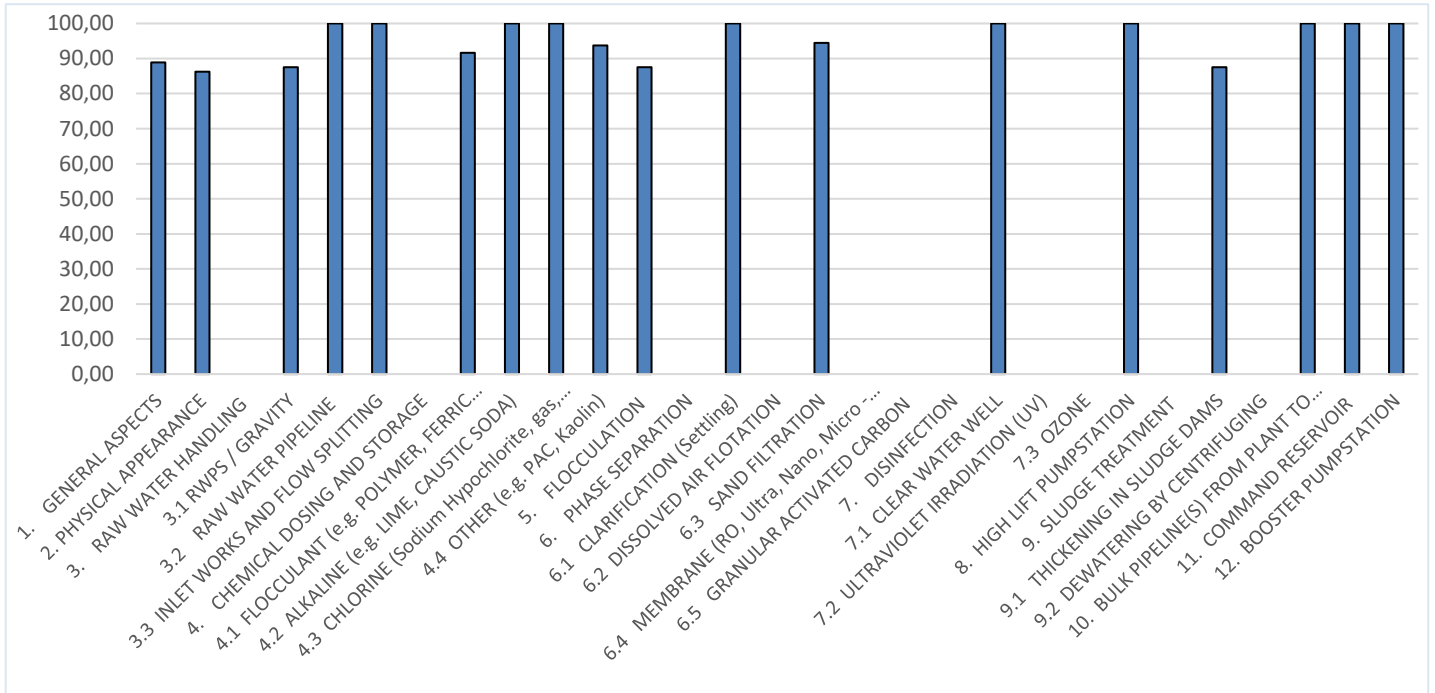
Watch #	Process Unit Assessed	% TSA	Observations
1	General aspects	88.9	Class B plant, O&M manual, and logbooks in place. Emergency contact numbers displayed. Process flow diagram only on the SCADA system, not a hard copy displayed. Monitoring equipment on site, proof of calibration. Electricity meter not accessible by process staff. E-software on site to keep track on maintenance required and done.
2	Physical appearance of plant	86.2	Fenced, entrance and neatly signposted. Security can be improved at the gate, although it is noted that load shedding impacts on the electrically operated gate. Facilities for workers to eat and prepare food is lacking. 90% workplace satisfaction reported. No OHS contraventions seen or reported
3	Raw water handling		
	Raw water pumpstation/ gravity feed	87.5	Raw water from boreholes in fair condition, some corroded valves observed. Raw water pipeline in good condition and well maintained. Abstraction volumes recorded.

5	Flocculation	87.5	Floc formation visible at end of unit, scum is accumulating on the surface.
6	Phase Separation		
	Clarification (settling)	100.0	No visible floc carry-over, weirs are clean, and no debris collected. Once every week desludging. PC noted that it was set on every 2 days, but once a week is sufficient and reduce water losses.
	Sand filtration	94.4	Well maintained facility, air distribution is good, media looks healthy, sufficient handrails. 100% backup for air blower and 5-% for backwash pumps. Slight uneven distribution to individual filters was seen and can be investigated.
7	Disinfection		
	Clear water well	100.0	At 11.2 MI/day, 0.24MI storage on site provides 26 minutes contact time. Chloring dosing at entry of CWW and free Cl ₂ tested after the outlet of CWW.
8	High lift pumpstation	100.0	Gravity fed system. Flow measuring in place and logged.
9	Sludge treatment		
	Thickening in sludge dams	87.5	Sludge/ wash water sump is well maintained - sump is under capacity (return pumps under capacity) and therefore overflows into stormwater system

10	Bulk pipeline from plant to command reservoir	100.0	400mm Asbestos pipeline, maintenance team reported that it is in good condition with no reported leaks
11	Command reservoir	100.0	2 reservoirs are fenced and gated, Telemetry in place and operational. Flows measured and logged. Both structures in good condition
12	Booster pumpstation	100.0	Building is fenced and secured with sufficient ventilation. Two pumps installed, 100% standby, and in good condition. MCC in good condition.
	Total	94%

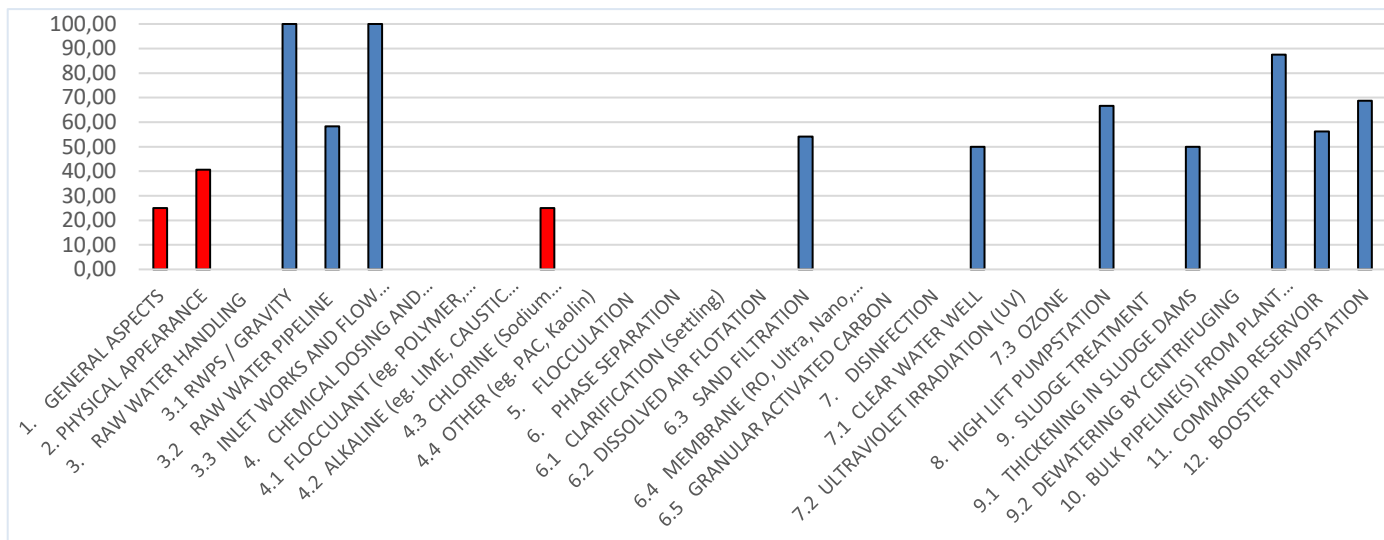
Watch #	Process Unit Assessed	% TSA	Observations
1	General aspects	25.0	Plant is not manned on a continuous basis and many of the aspects typically associated with process control are therefore missing from site. The biggest concern in this regard would be the lack of any operational monitoring – not even residual chlorine levels are monitored.
2	Physical appearance of plant	40.6	The condition of the site reflects the fact that plant personnel spend a limited amount of time on site. The main area of improvement would be the updating of safety signage on site while groundskeeping requires some attention. Basic staff facilities are also lacking
3	Raw water handling		
	Raw water pumpstation/ gravity feed	100.0	9 x Boreholes + Small surface water allocation (gravity feed in channel) provides water to the works
	Raw water pipeline	58.3	Pipework is prone to damage during flooding and needs to be secured in a more sustainable manner

There seems to be a lack of urgency around the provision of safe, potable water on a sustainable basis. This is evident from the lack of basic monitoring equipment, i.e., no residual chlorine measurements are being done, and the fact that disinfection is done ad-hoc by adding an uncontrolled amount of granular chlorine to the reservoir. It needs to be noted that compliance monitoring is done, and that compliance is quite good, including for microbiological parameters. Compliance is however based on a monthly grab sample, and this does not mitigate the risk posed by poor operational control. The non-compliance to SANS 241 with microbiological compliance poses a significant risk for community health in the WSA area of responsibility.

- Operational testing equipment to be obtained as a matter of urgency - not even residual chlorine can be measured.
- Chlorine dosing equipment to be installed as a matter of urgency.
- The need to use the UV system for Iron removal is to be investigated.
- The on-site reservoir roof should be repaired.
- The reservoir in town (from which the booster pumps pump) should be secured to prevent unauthorised access.
